U.S. CHEMICAL SAFETY AND HAZARD INVESTIGATION BOARD

DUST EXPLOSION

**WEST PHARMACEUTICAL
SERVICES, INC.**

KINSTON, NORTH CAROLINA
JANUARY 29, 2003

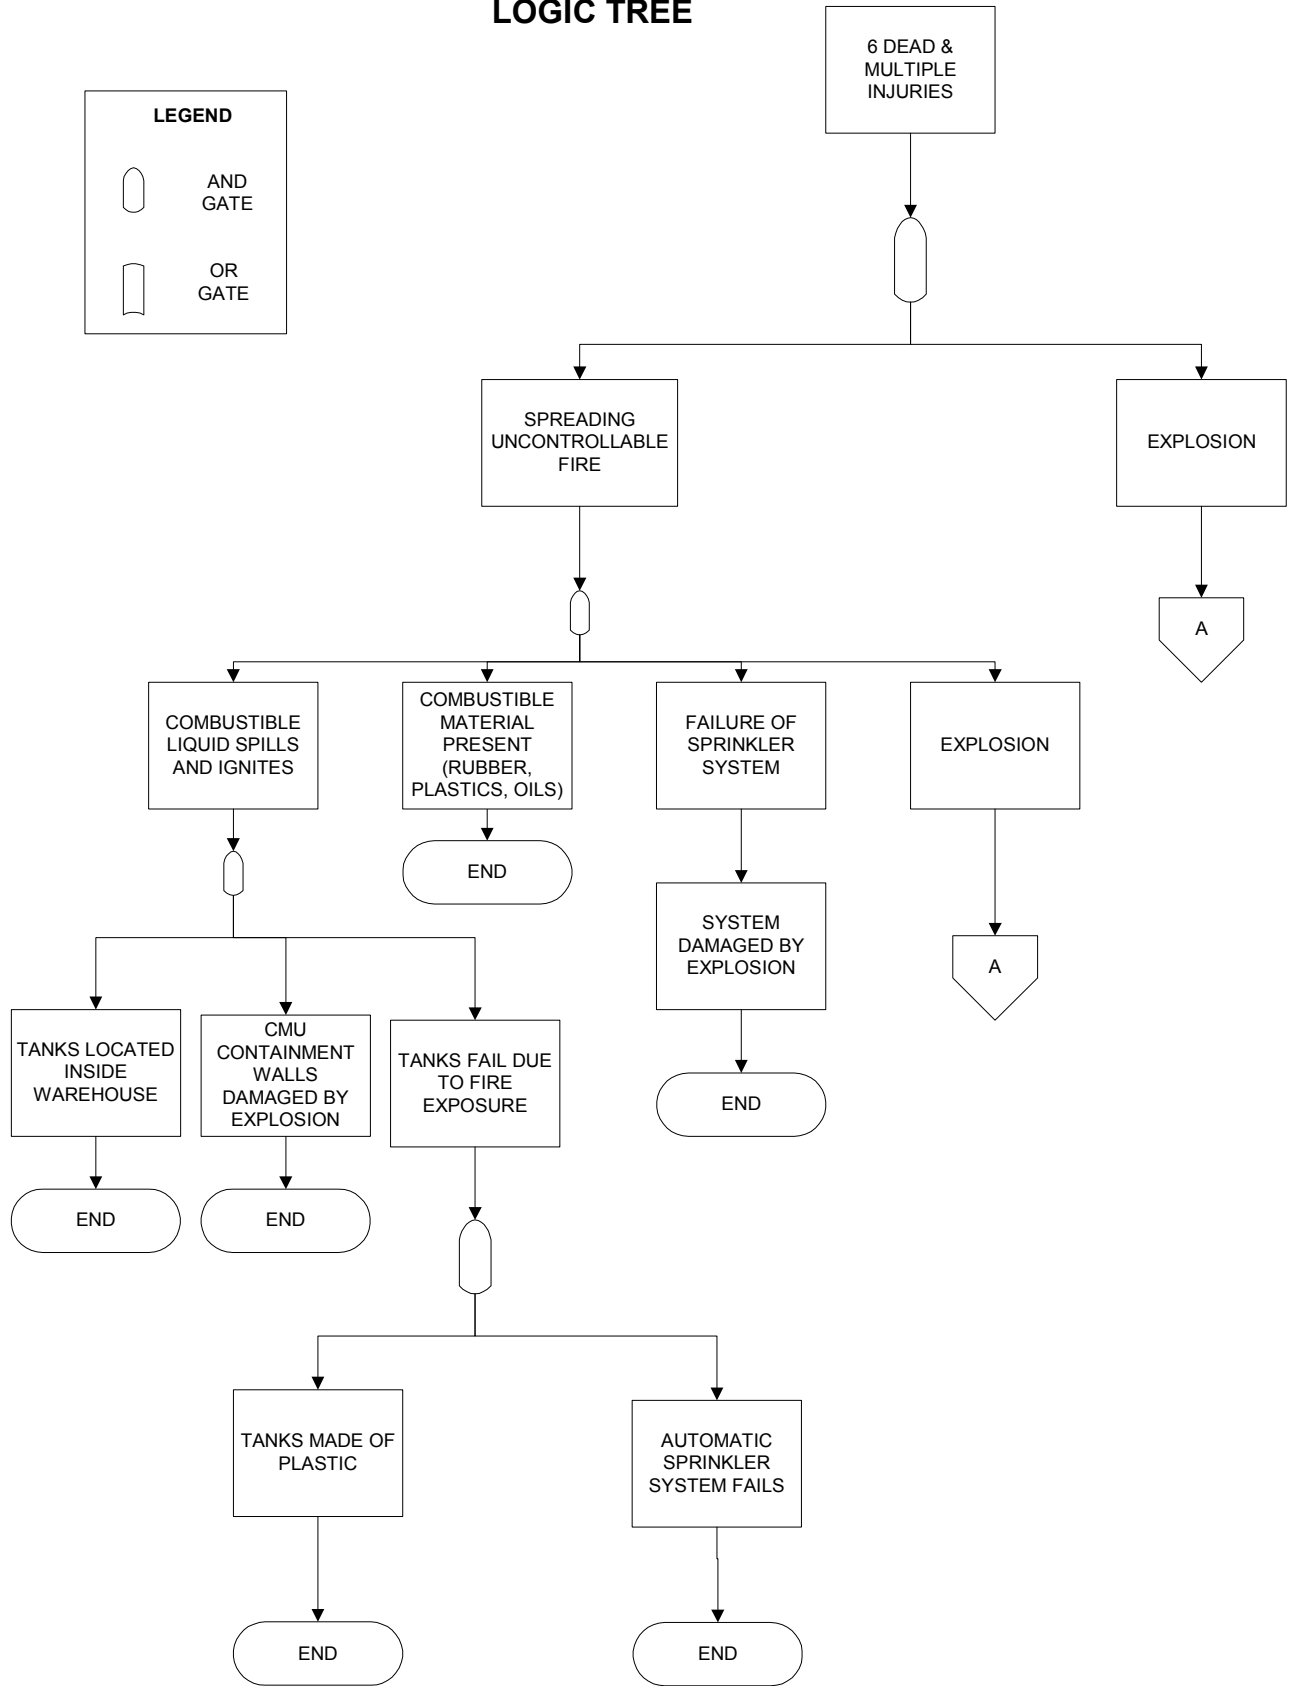
LOGIC TREE

- First, the available information on the case (i.e., witness testimony, field observations, facts from records, etc.) was placed on a timeline with causal factors.
- Second, the team organized the known causes of the event into a cause map (i.e., a modified fault tree wherein the known and presumed causes are shown but the unproven potential causes are not).
