U.S. CHEMICAL SAFETY AND HAZARD INVESTIGATION BOARD

# INVESTIGATION REPORT

## EXPLOSIVES MANUFACTURING INCIDENT

### SIERRA CHEMICAL COMPANY

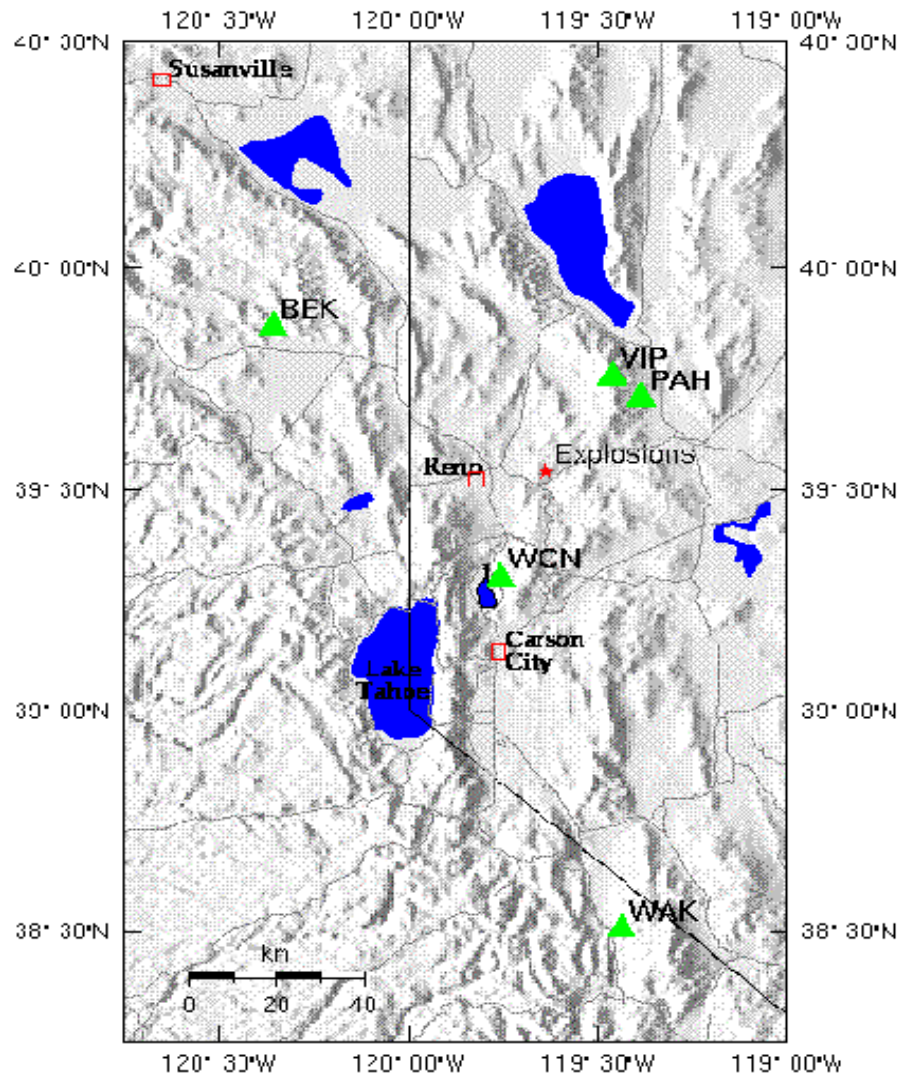
**Figure 1. Westert Nevada digital seismic stations, location of the chemical explosions and the Reno Sparks, and Carson City urban areas.**

The two explosions were recorded on several stations of the western Great Basin seismic network (Figure 1). From these records, the estimated origin time of the first explosion was 15:54:03.300.  $\pm 30$ sec GMT (7:54 AM PDT), with approximate location 39°North 31.8 minutes, 119°West 38.0 minutes. However, based on information provided by the CSB (*John Piatt, personal communication*) the location is 39°North 32.5 minutes, 119° West 38.1 minutes. We used the CSB's location in our subsequent analysis based on seismograms; it is well within normal uncertainties for earthquake locations. Treated as an earthquake, the magnitude of the event is estimated to be  $M \approx 2.0$ . Four of the stations that recorded the explosion were recently installed digital broadband seismographs that were acquired through a grant to the University Nevada Reno from the Keck Foundation. Several of the seismograms are shown in Figure 2. The

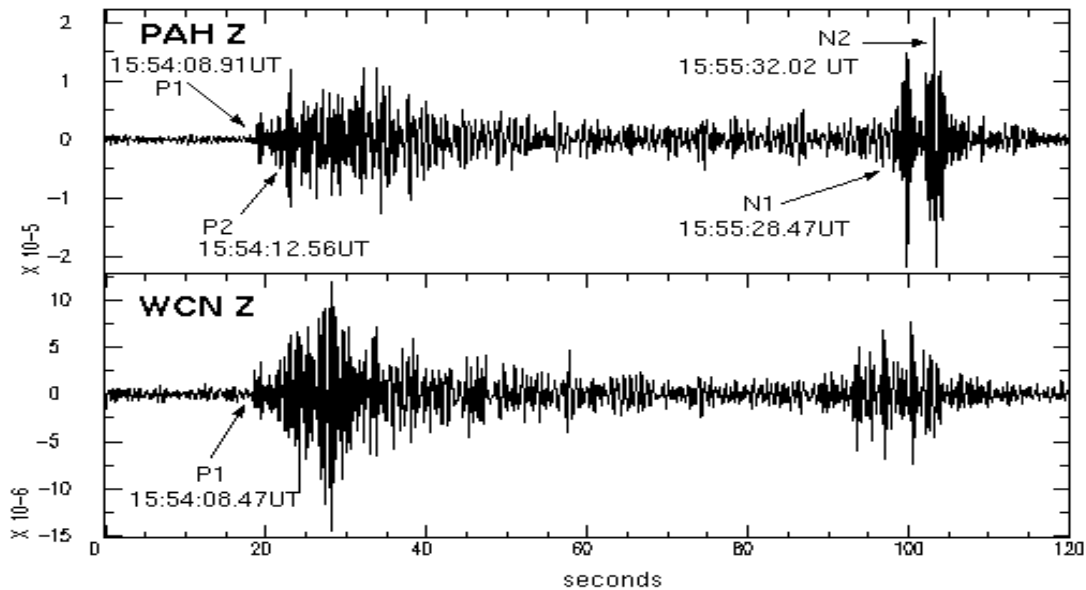
**Figure 2a.**

seismograms include two conspicuous P-wave arrivals, followed by an "N-wave" (Kanamori *et al.*, 1991) that is created by the shock wave traveling in air. An examination of the seismograms (Figure 2) shows that there are two explosions separated in time by about 3.5 seconds. The phase that appears to be an S-wave in Figure 2 is the P-wave arrival from the second explosion, although there may be some amplitude contribution from an Lg phase. The station geometry relative to the source area is such that the P-wave arrival from the second source is nearly coincident with the expected Lg arrival from the initial event at both PAH and WCN. Evidence for the interpretation of these phase arrivals is based on the nearly same time separation observed in the air-wave arrivals at several stations. The larger amplitude of the P-wave and air-wave phases for the second event suggests that this was the larger of the two explosions, although the coupling of the explosion must also be taken into account in this interpretation.

Figure 2a. Vertical component seismograms from station PAH and WCN. The P1 and P2 labels indicate P-wave arrivals for explosion A and B. N1 and N2 labels indicate the N-wave (air wave) arrivals for explosion A and B.

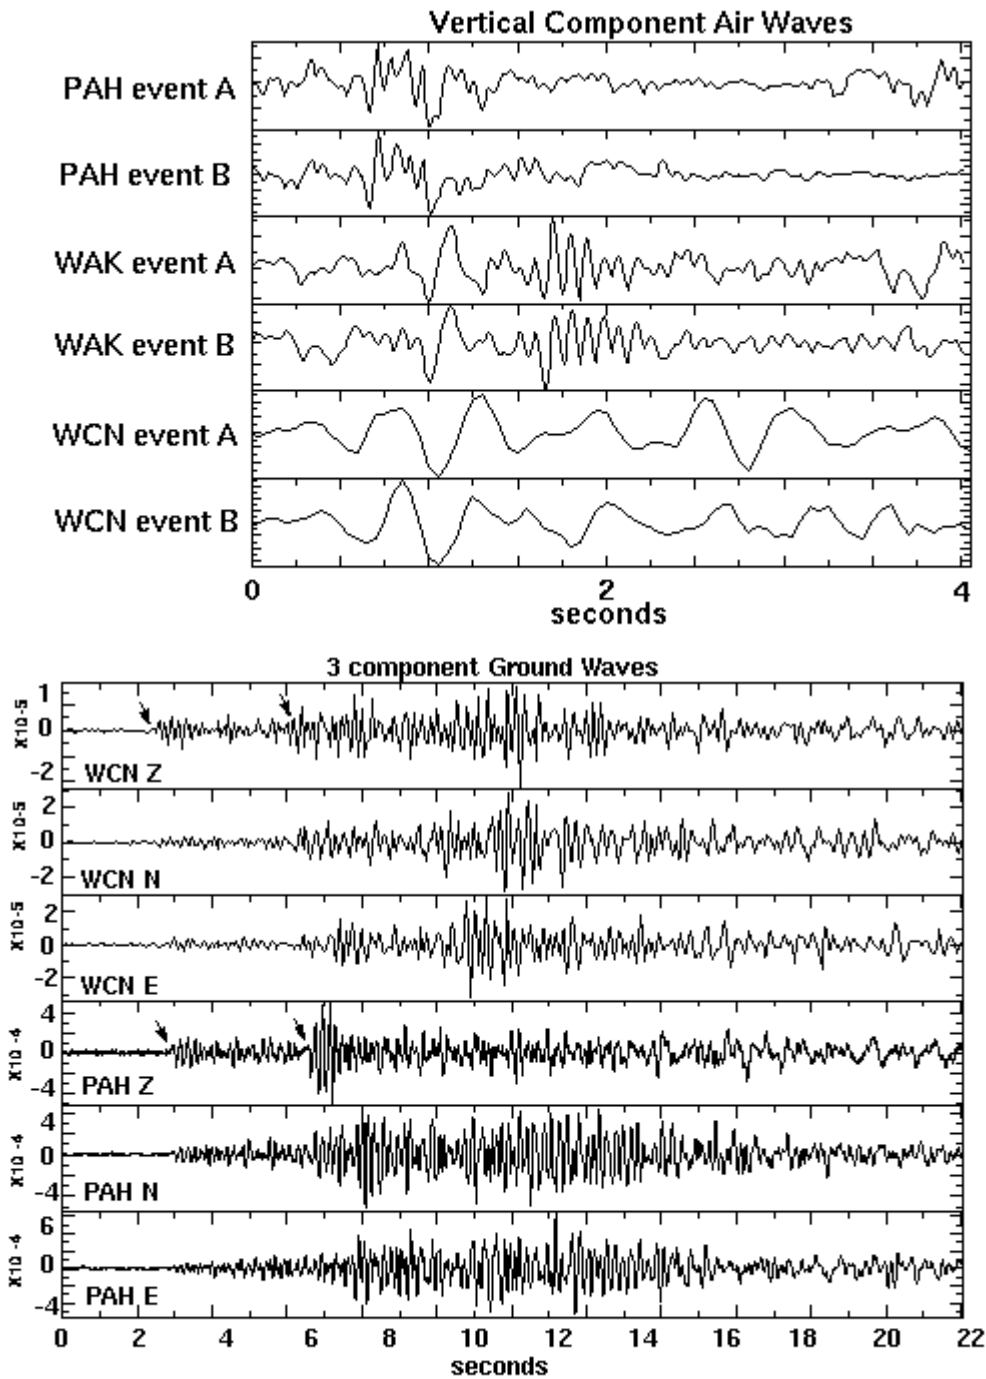
Figure 2b. Seismograms of low-passed filtered vertical component air waves and 3 component seismic waves used in this analysis. The arrows point to the arrival of P-wave of explosion A and B.

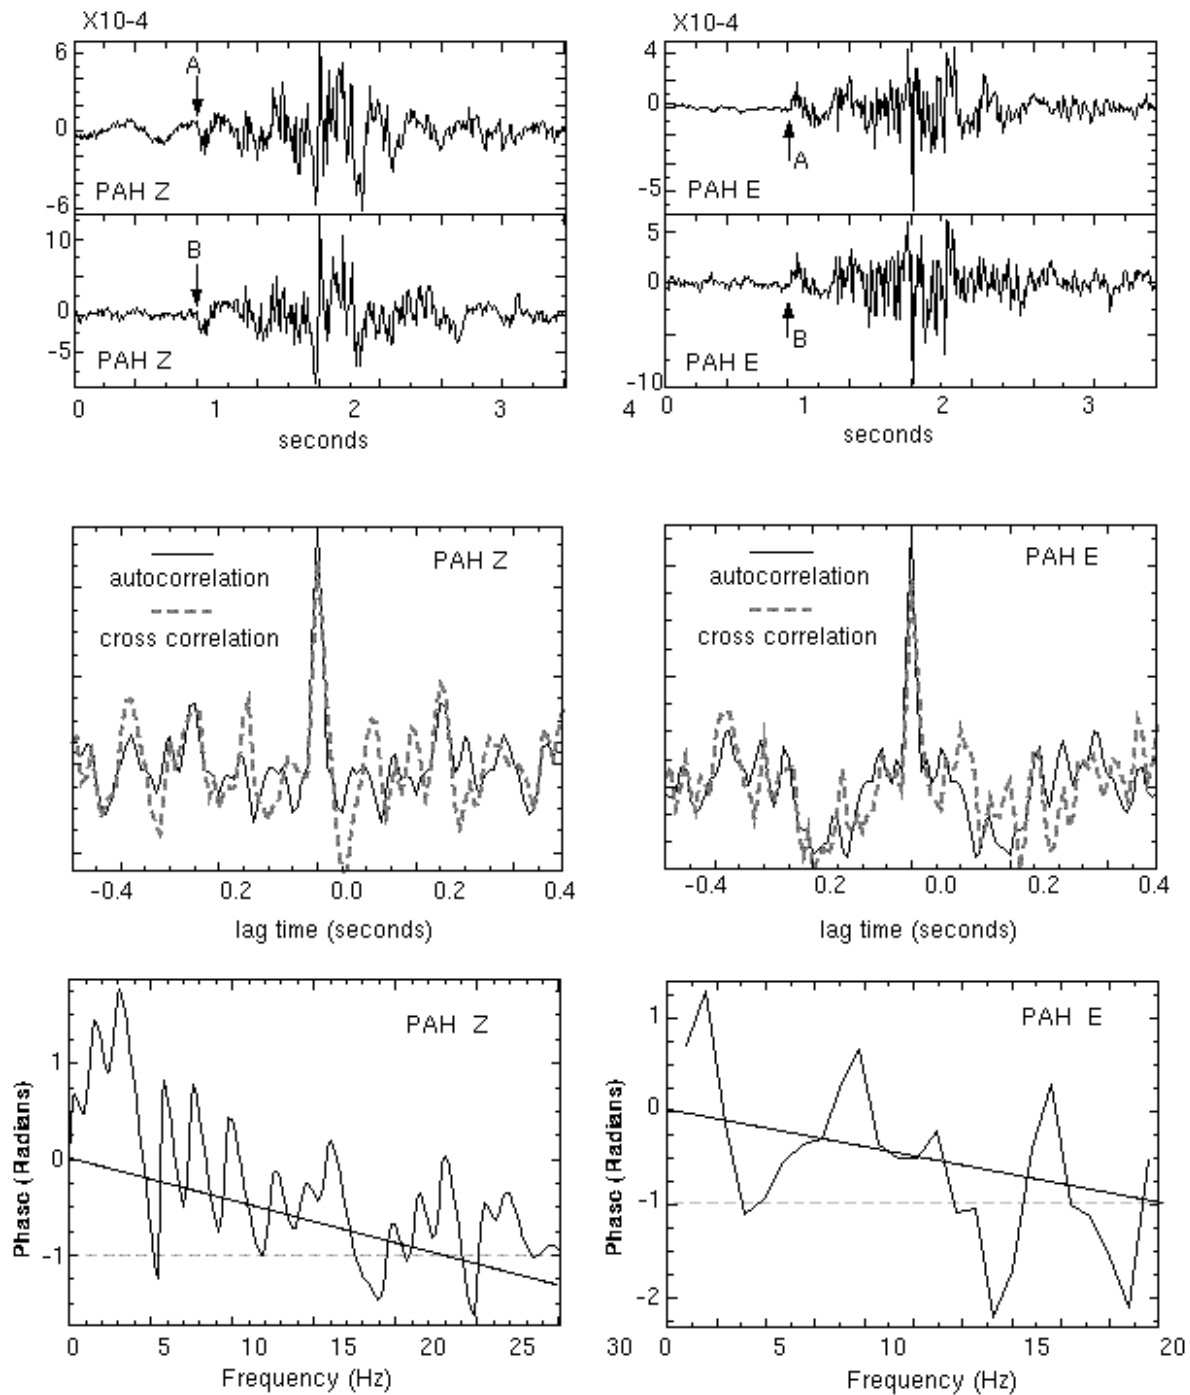
**Figure 3.**

The vertical and east-west component of air-waves recorded from PAH with the cross- and auto-correlation functions. The bottom panels show the slope of the phase of the cross spectrum are fit over the frequency range of > 80% coherency.

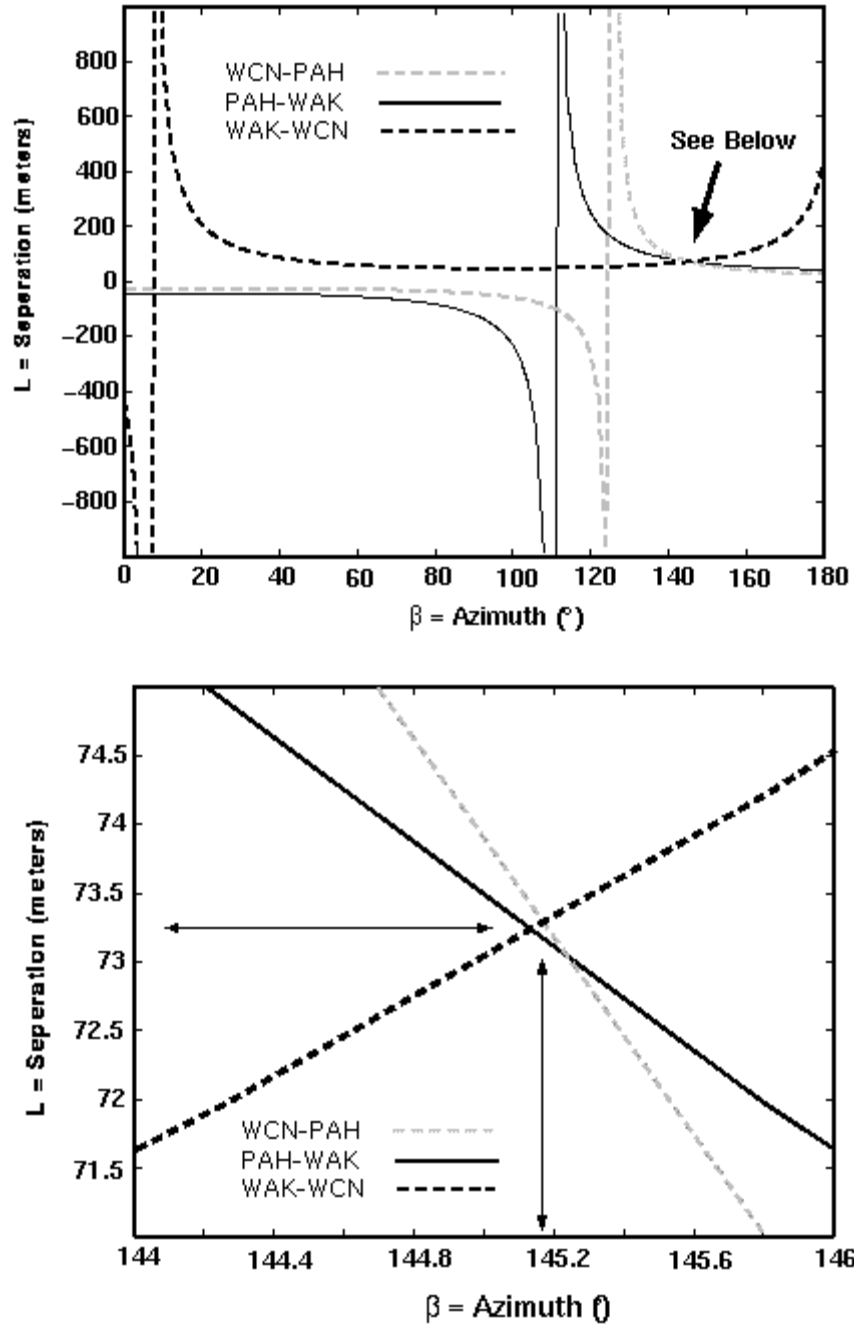
where  $c$  is either the air velocity of 343 m/s or P-wave velocity of 3000 m/s,  $\Delta t_{ij}$  is the difference in the times between the explosions at stations  $i$  and  $j$ , and  $\theta_i$  is the azimuth from the first explosion to the  $i$  th station. The better resolution results from an analysis of the air-wave arrivals because of the substantially slower air velocity.  $L_{ij}$  is computed from values of ranging from 0 to 180° for the 3 station pairs to find a simultaneous best solution at  $\theta \approx 145.1^\circ$  (S35° E) and  $L \approx 73.2$  meters (Figure 4). The relative location estimates based on the P- and air-waves are shown in Figure 5 along with the error estimates. The results for the air-wave unambiguously indicate that the second explosion B was southeast of the first explosion A. This result leads to the conclusion that the initial explosion was at the northern site, which is consistent with the analysis of the CSB.

**Figure 4.** A plot of  $L$ , the source separation versus  $\beta$ , the azimuth between sources. The arrows point to the best solution for  $L$  and  $\beta$ .

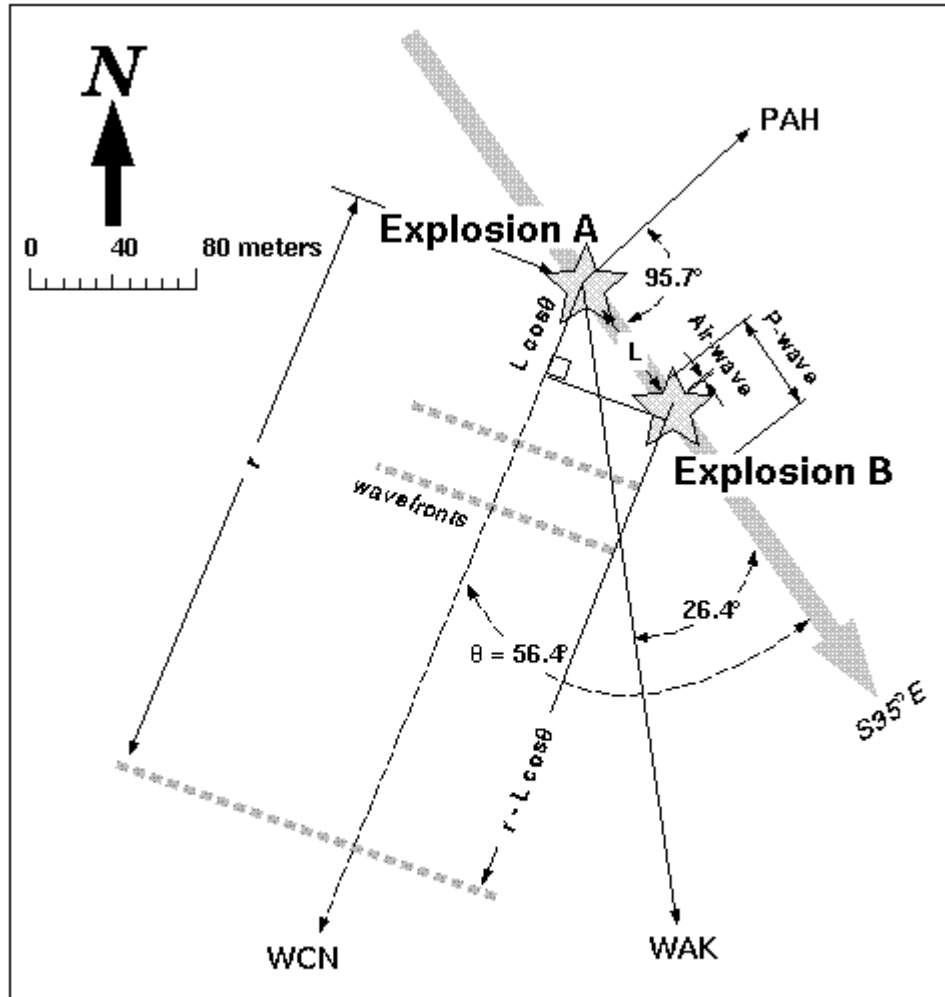
The relative locations based on the moveouts of these phases are, within error bars, consistent with the location of the second event based on the CSB investigation. The differences in separation between our estimate (73.2 meters) and the CSB estimate (76.2 meters) is small compared to the source dimensions, and the difference in azimuth between our estimate of  $S35^\circ$

**Figure 5.** A Schematic map of the explosion site with likely geometry of explosions marked as "stars" and the estimated relative separations shown as uncertainties along azimuth of S35°E. See equation (3) in text for variable definitions. The

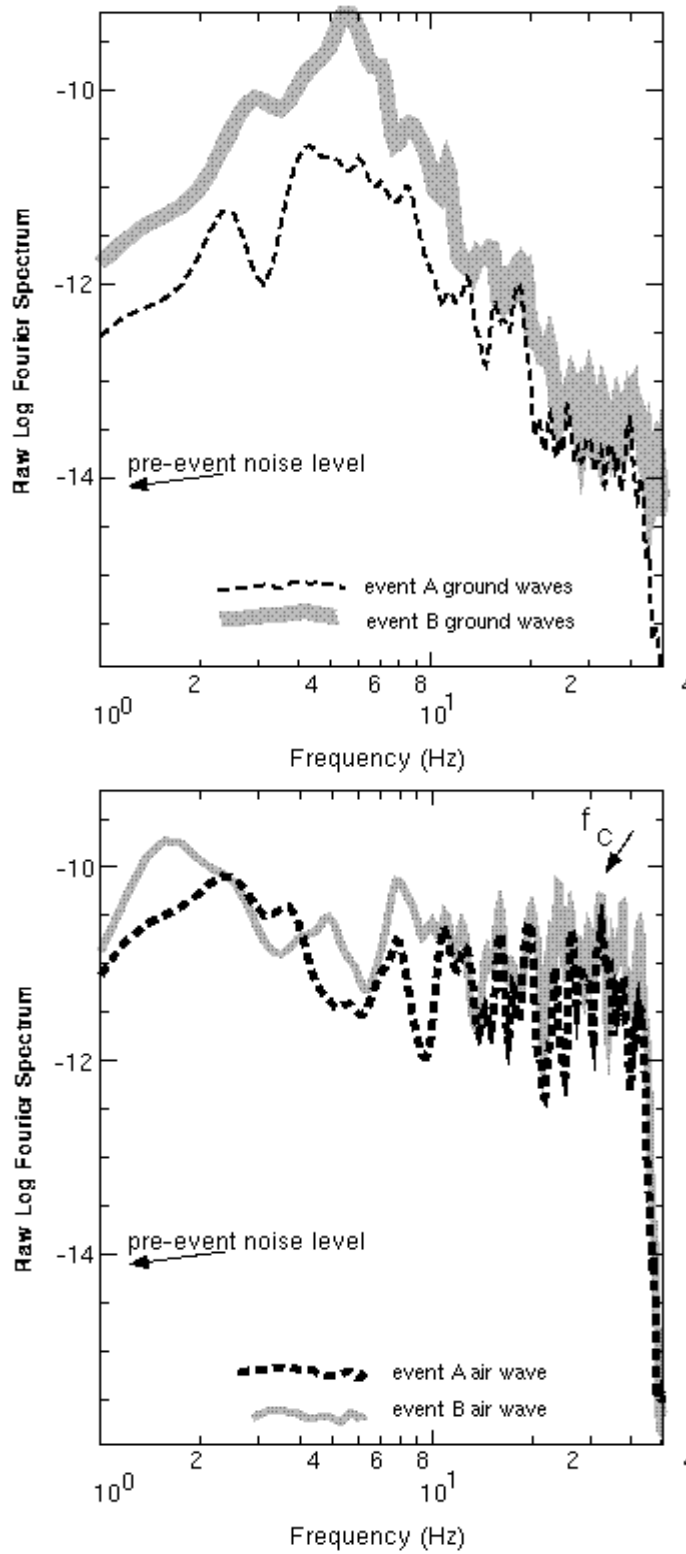
**Figure 6.** Uncorrected P-wave and air-wave

Figure 6 shows the uncorrected spectra of the P-wave and the air-wave from the two explosions at PAH (Guralp CMG-40 velocity sensor). The three components are log averaged and then smoothed. Based on the P-wave at PAH, explosion B was 3 to 4 times larger than explosion A, consistent with reports that the second site "B" contained more explosives. The spectrum of air-waves of explosion B is only a little larger than explosion A. This may suggest that explosion B was more coupled to the ground, allowing more energy to be partitioned into the ground than into the air. The CSB hypothesized that the second explosion was triggered when debris from the first explosion crashed through the ceiling or skylight at the second site. If so, we speculate that the second explosion may have been triggered at the top of the stockpile, resulting in downward directivity and a different partitioning of energy between the ground and the air.

The spectral curves are the smoothed log average of the three components of motion. The arrow points to peak spectral value of a noise window before explosion A.
