METALLURGICAL EVALUATION OF SAMPLES FROM THE CHEVRON U.S.A. INC., RICHMOND #4 CRUDE UNIT 8-INCH AND 12-INCH 4-SIDECUT PIPING INVOLVED IN THE AUGUST 6, 2012, HYDROCARBON RELEASE AND FIRE

Prepared for: The Chemical Safety and Hazard Investigation Board (CSB)

Report No. 5004.7920 B

February 11, 2013

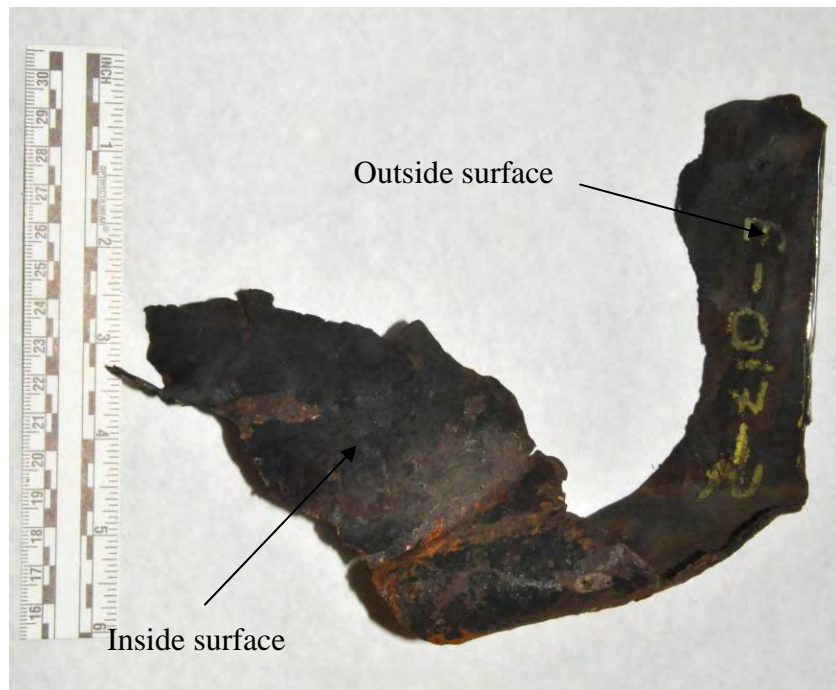
Flaps E-017-1 and E-017-2 are shown after sectioning in Figure 7 through Figure 10. Following examination in the as-sectioned condition, the bends and curvature of the flaps were straightened by hand so their shape and area could be recorded. Thickness measurements were taken within 0.100-inch of the edges of the specimens at the locations indicated in Figure 8 and Figure 10 using a pointed anvil micrometer. The maximum thickness measured was 0.070-inch and the minimum thickness measured was 0.012-inch. It was reported that the 4-sidecut piping had been made from Schedule 40 pipe, which means that the original thickness of the 8-inch (NPS 8) line had been 0.322-inches. The thickness measurements indicate that extensive wall loss had occurred. In Figure 8, small perforations inside of the specimen edges were visible, which suggest that through-wall leaks were likely present prior to rupture.

Figure 8 Section E-017-1 after flattening. Thickness measurements were made with a pointed anvil micrometer within 0.100-inch of the edge at the locations indicated before cleaning.

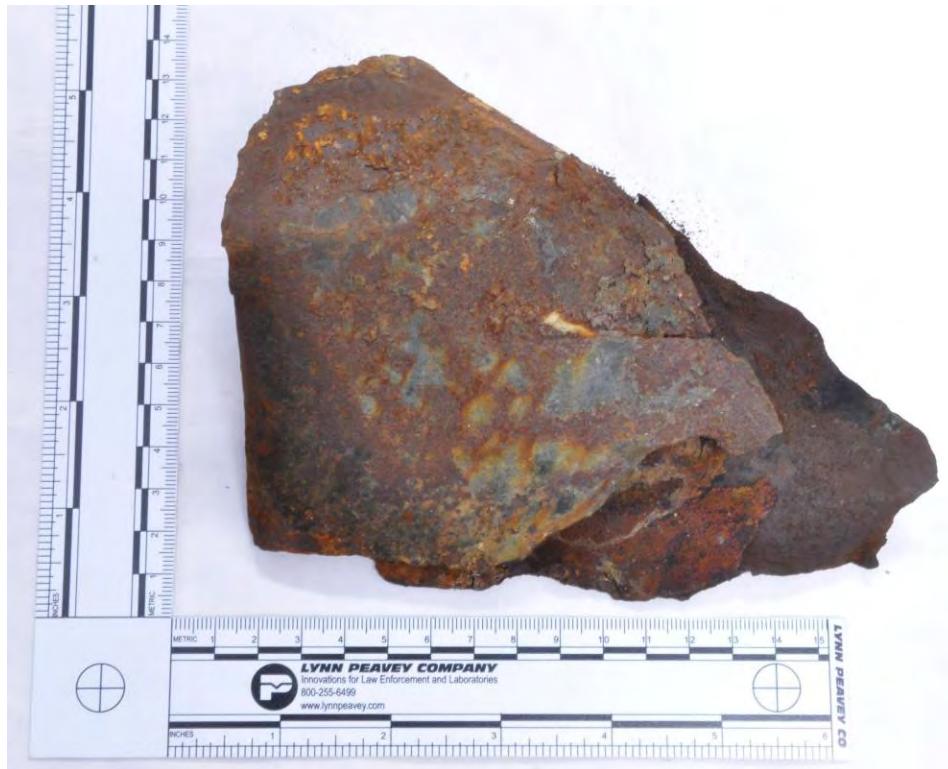
Figure 10 Section E-017-2 after flattening. Thickness measurements were made with a pointed anvil micrometer within 0.100-inch of the edge at the locations indicated before cleaning.

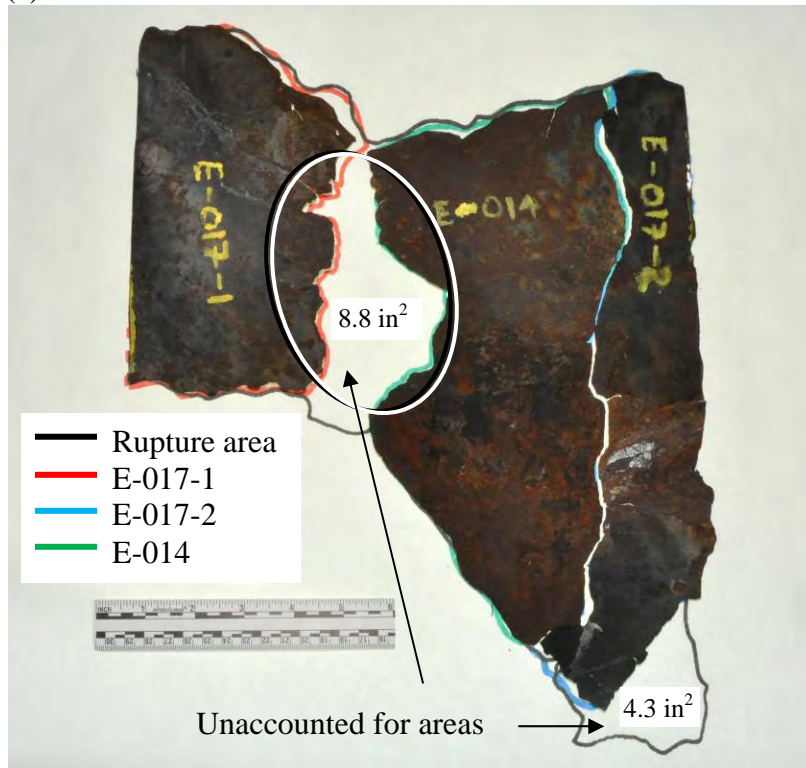
(b)

The total rupture area was determined from the tracing to be between 94 and 106-square inches. The smaller number was obtained directly from the tracing and the larger number was determined from the tracing adjusted slightly so that E-017-1, E-017-2, and E-014 did not overlap the traced lines in the longitudinal direction. Some of the overlap can be accounted for by a slight buckle in the pipe, indicated in Figure 6. Two areas of the ruptured pipe wall that were not accounted for, one between E-017-1 and E-014, and one at the downstream end of E-017-2, measured 8.8 and 2.4-square inches, respectively, indicated in Figure 13b.

Edges of E-017-1, E-017-2, and E-014 were examined using an optical stereomicroscope. The edges were covered with rust and dark colored scale, consistent with having been exposed to the fire and water from the fire suppression efforts. Two general edge morphologies were present. In the thinnest areas, the edges tapered to a rounded edge. In the thicker areas, the edges were relatively flat with steps and facets. Representative macrographs are shown in Figure 14 through Figure 16. As described in Section 2.5, corrosion of the rupture edges destroyed evidence of the fracture origin. However, rupture likely originated in the thinnest region and initially followed a longitudinal path driven by the hoop stress. Therefore, the location of the initial leak and rupture origin was likely within the circled area in Figure 13b.

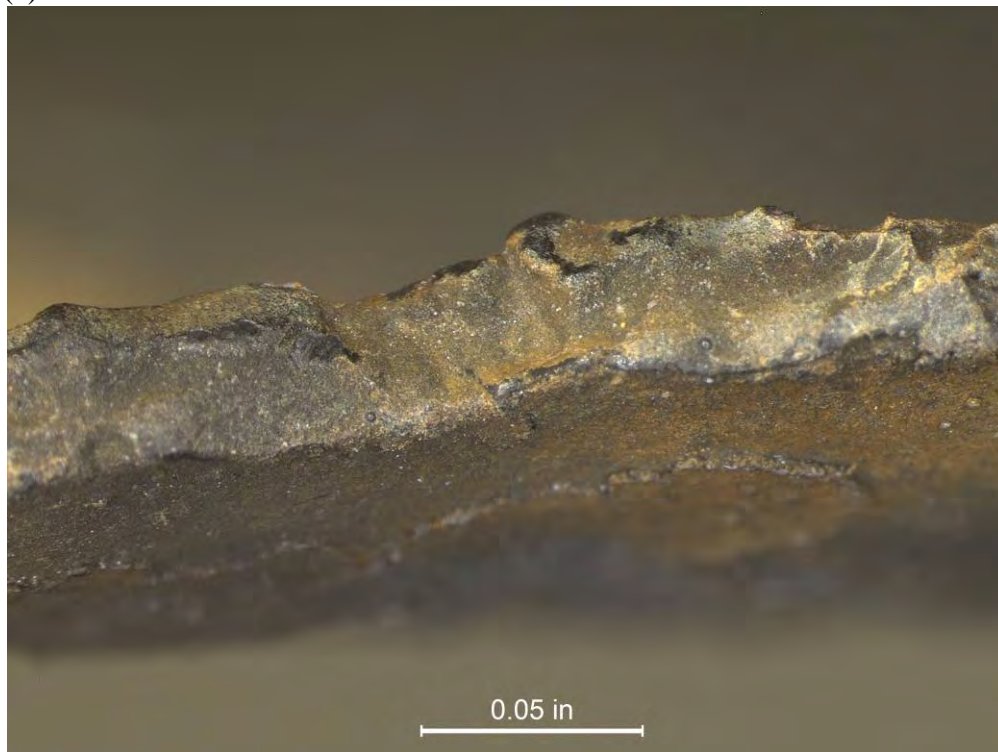
(b)

Figure 14 Representative optical macrographs of tapered edges on the rupture edge of specimen E-017-1. The locations from which these macrographs were recorded are indicated in Figure 8.

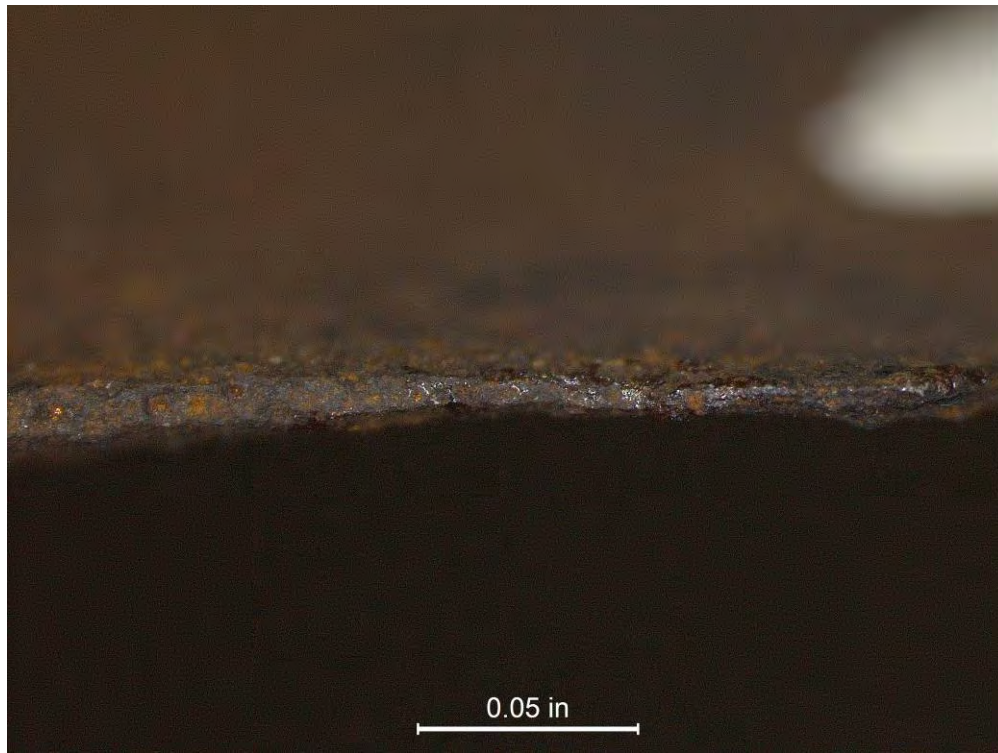
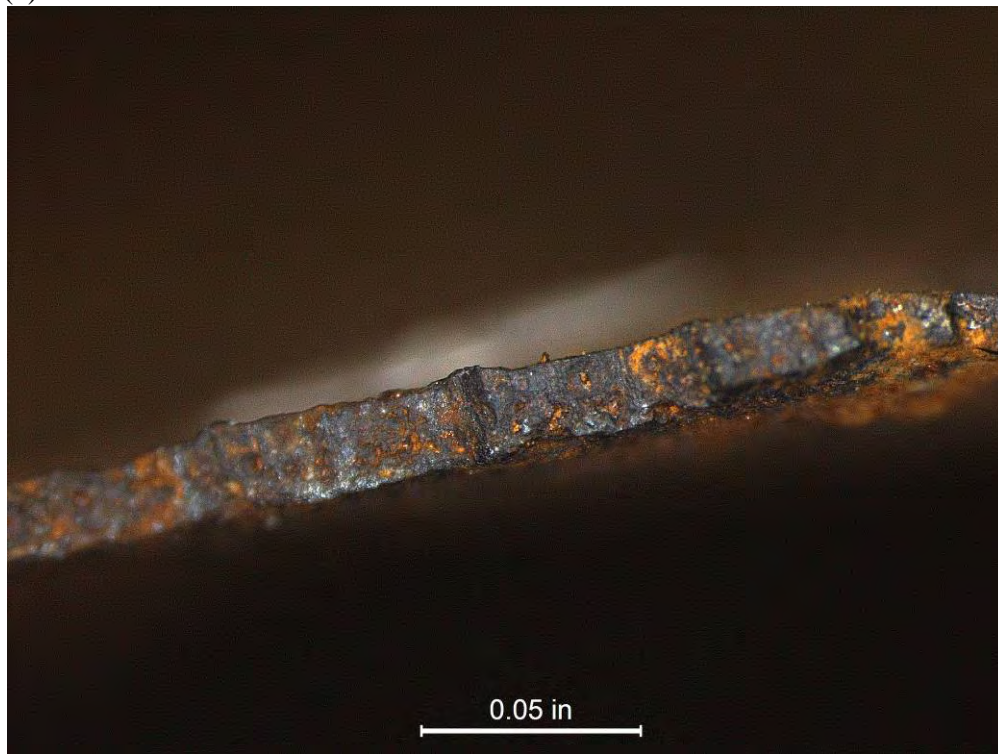
Figure 15 Representative macrographs of flat edges along thicker regions of specimen E-017-2. The locations from which these macrographs were recorded are indicated in Figure 10.

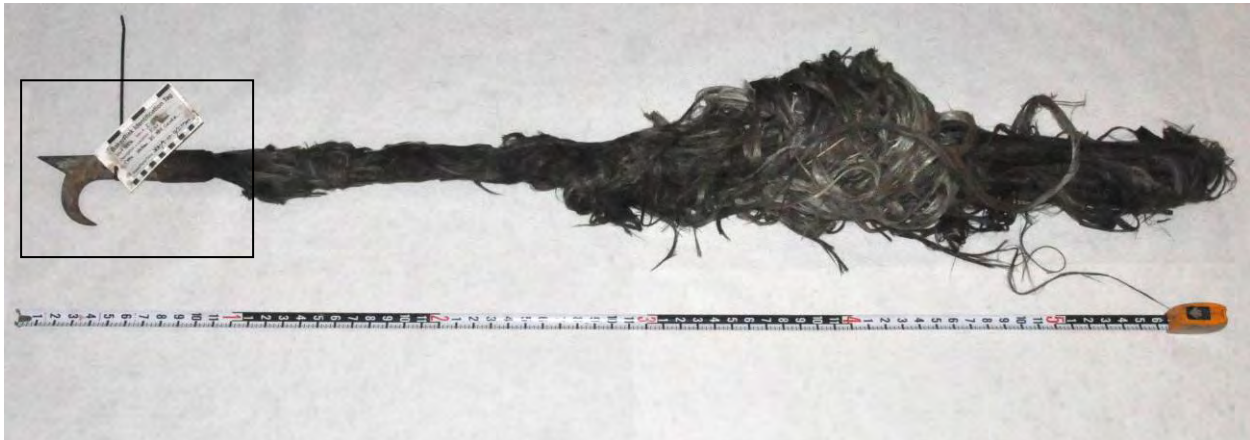
(a) Sample E-099

A region of ruptured edge deformation toward the inside surface of the pipe on specimen E-017-1 is shown in Figure 17. The deformation, located at the 6 o'clock position or bottom side of the pipe, was consistent with mechanical force applied to the outside surface of the pipe. The CSB requested that the morphology of the deformation be compared to the shape of two tools, referred to here as fire pikes, recovered from the post incident scene. Photographs of the fire pike samples E-099 and E-082-2 are shown in Figure 18 through Figure 21. Both pike tips had essentially the same geometry. The deformed region of specimen E-017-1 was compared to the tip of both fire pikes and a good physical fit between the pike tips and the inward deformation of the specimen was found, as shown in Figure 22. The orientation of the fire pike, with respect to the ruptured section, that would have been required to produce the observed fit between the tip and the inward deformation of the rupture edge is shown in Figure 23.

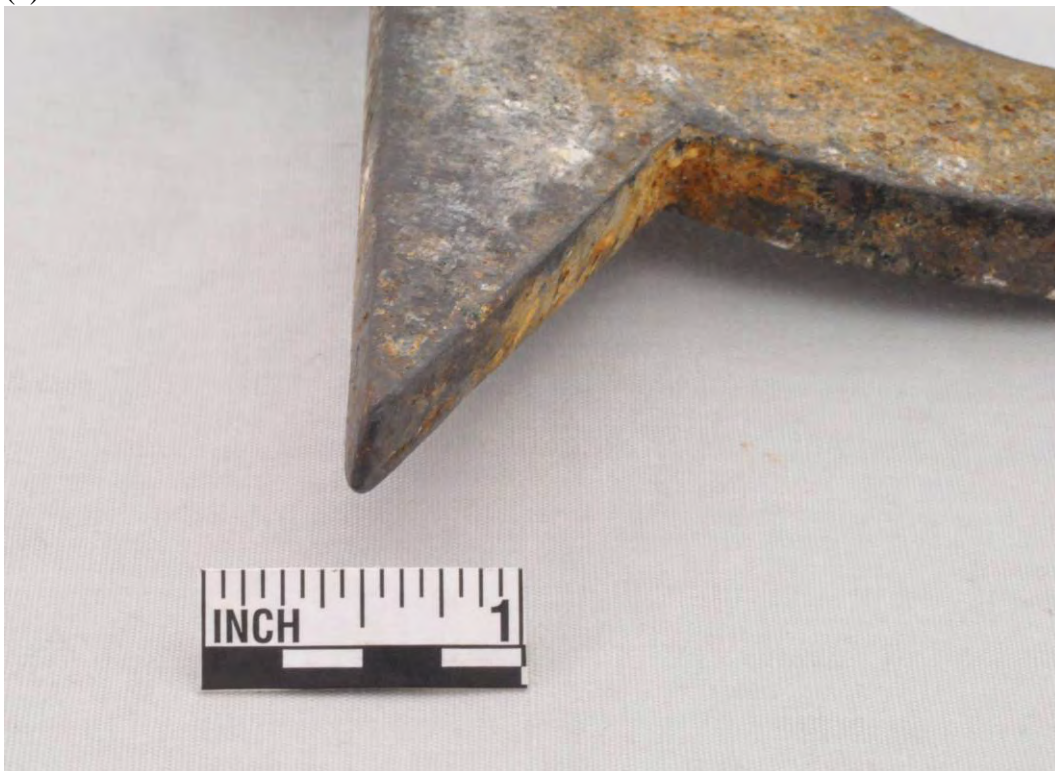
Figure 19 Photographs of the tip of the pike pole E-099 shown in Figure 18.

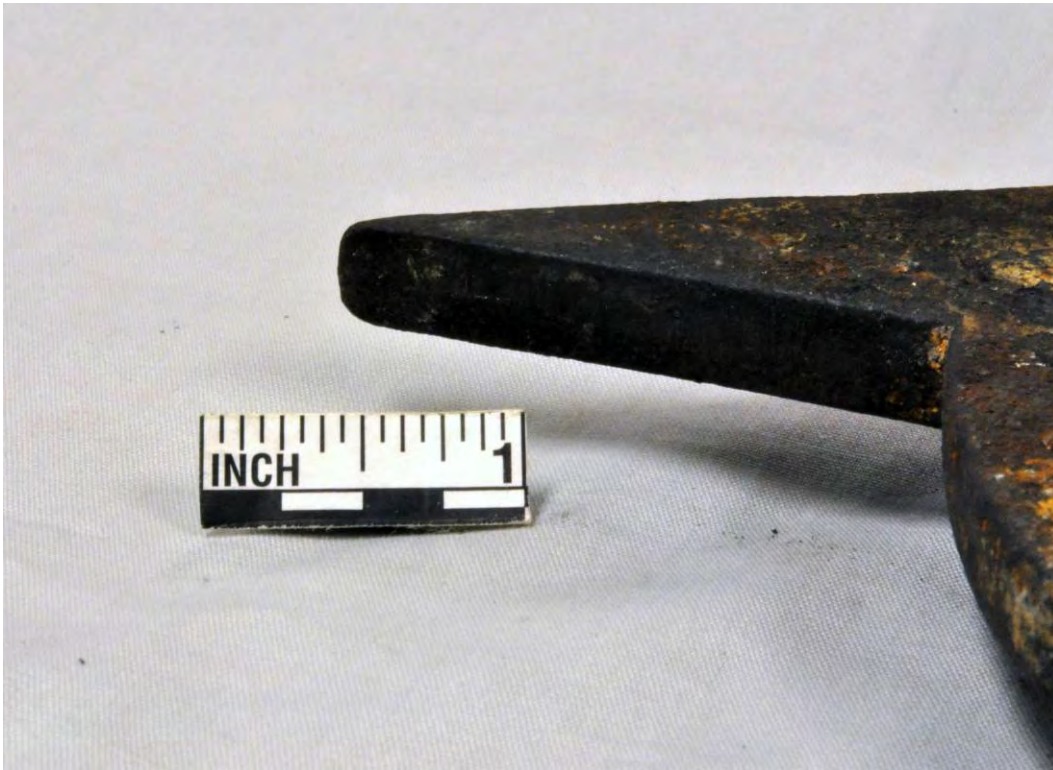
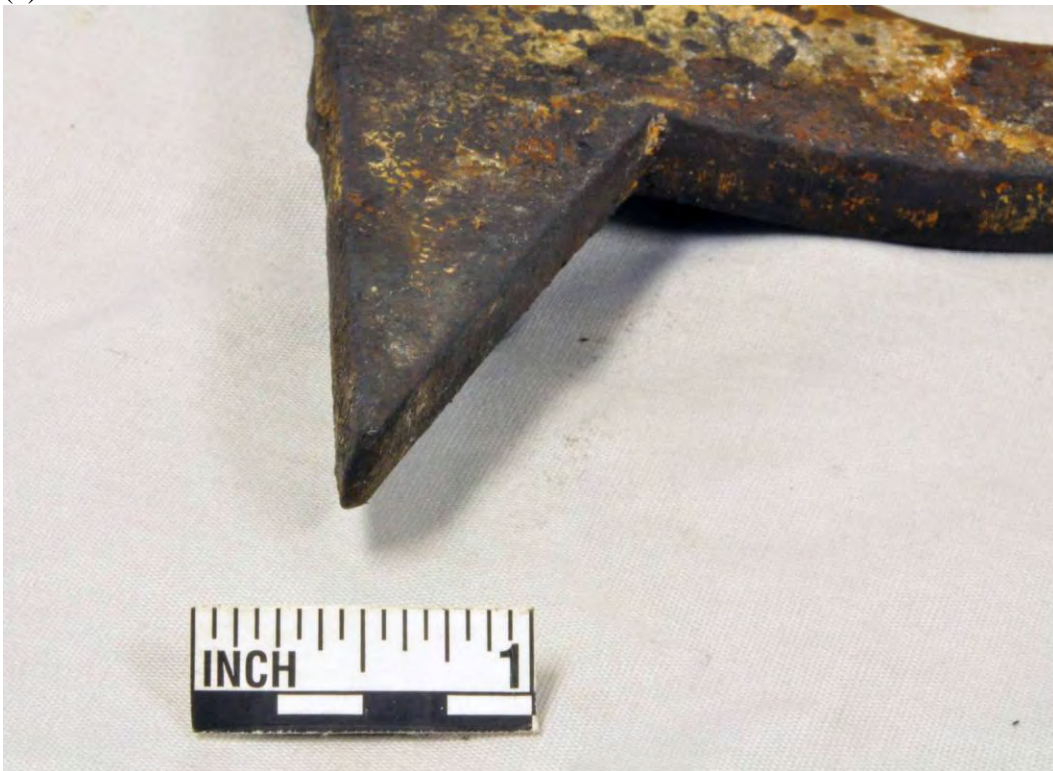
Figure 21 Photographs of the tip of the pike pole head E-082-2 shown in Figure 20.

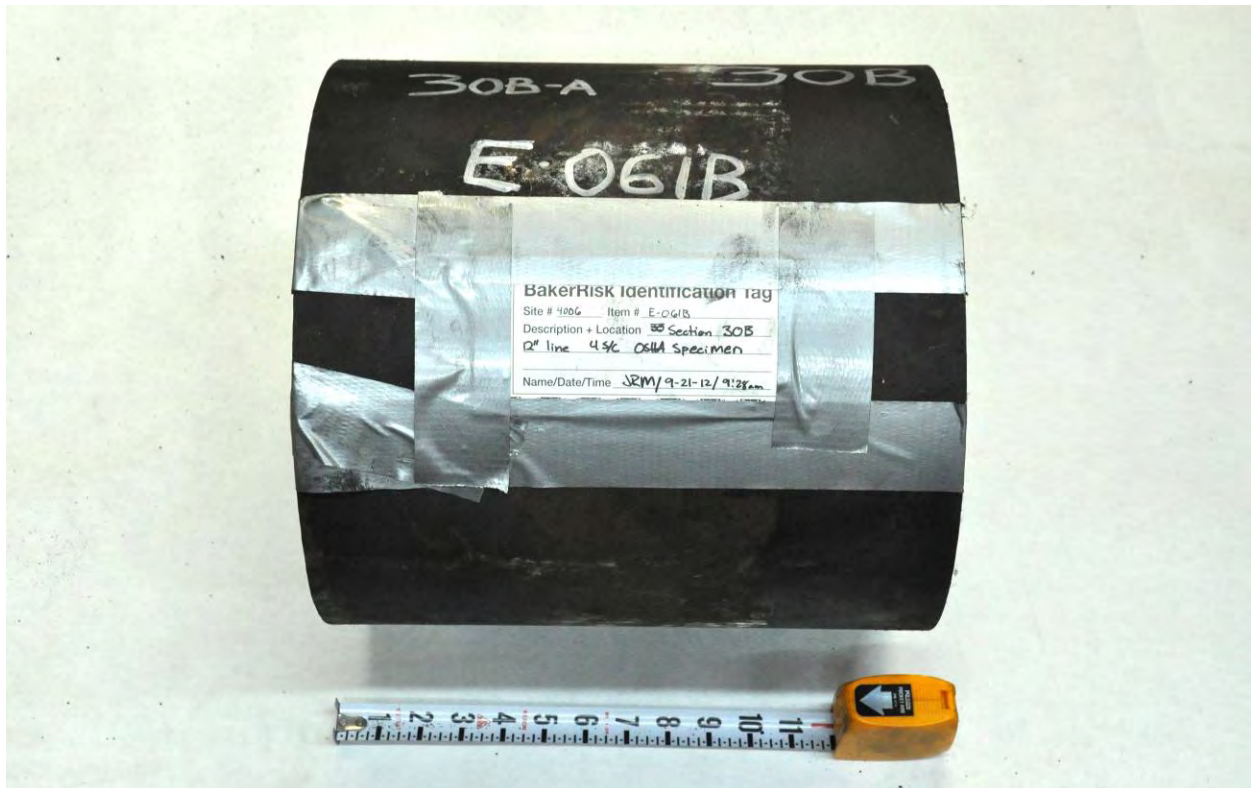
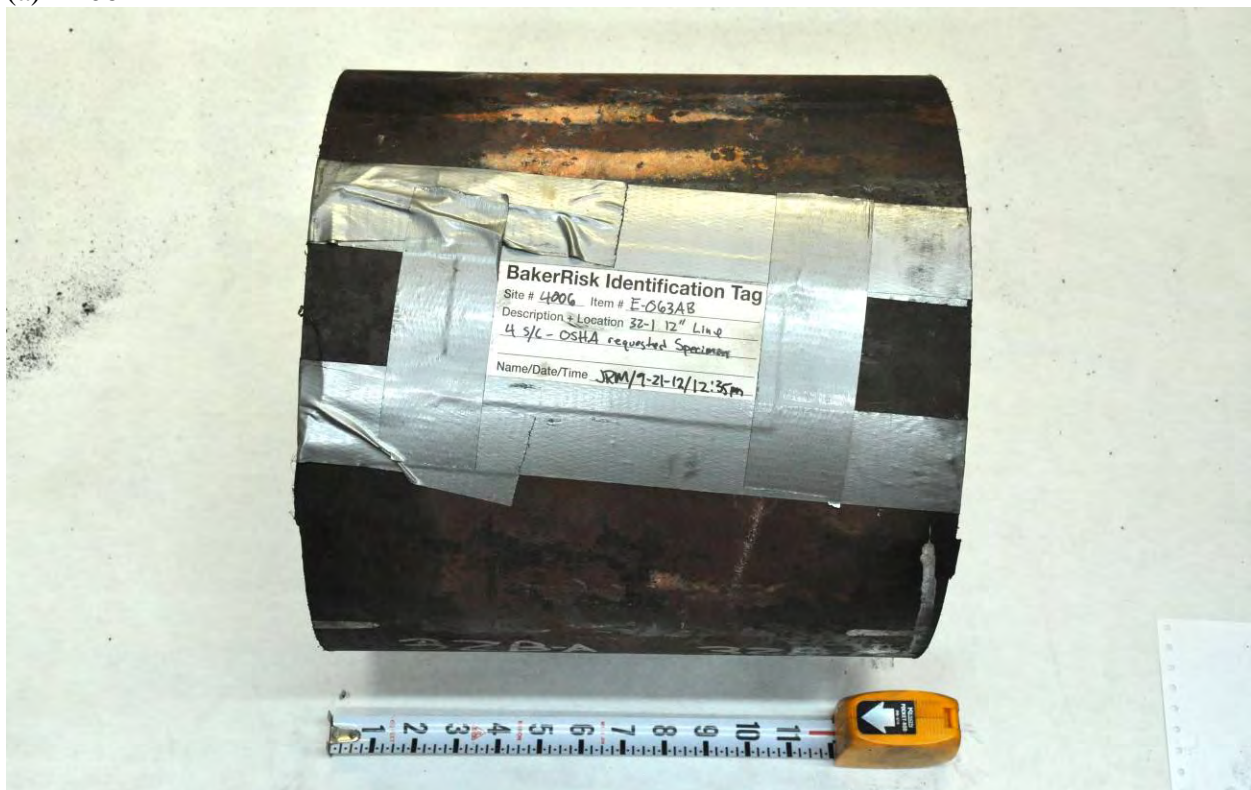
Segments of the 12-inch 4-sidecut sampled from various locations in the line under the combined direction of Cal/OSHA, CUSA, and the CSB are shown in Figure 27b through Figure 29. All five of the 12-inch 4-sidecut samples consisted of short sections of pipe without welds. It was reported that samples E-059B and E-061B were cut from sections of pipe installed in 2011. Most of the scale present on the outside surfaces of the 12-inch samples was dark colored and adherent, but there was some friable rust. Dark gray to black scale was present on the inside surfaces of all the 12-inch samples. The inside scale was friable at the surface, and adherent under the surface, where it had a shiny metallic appearance when scraped with a metal spatula. All of these characteristics are consistent with sulfidation corrosion product.

Figure 28 Photographs of 12-inch 4-sidecut samples E-061B and E-063AB as-received.

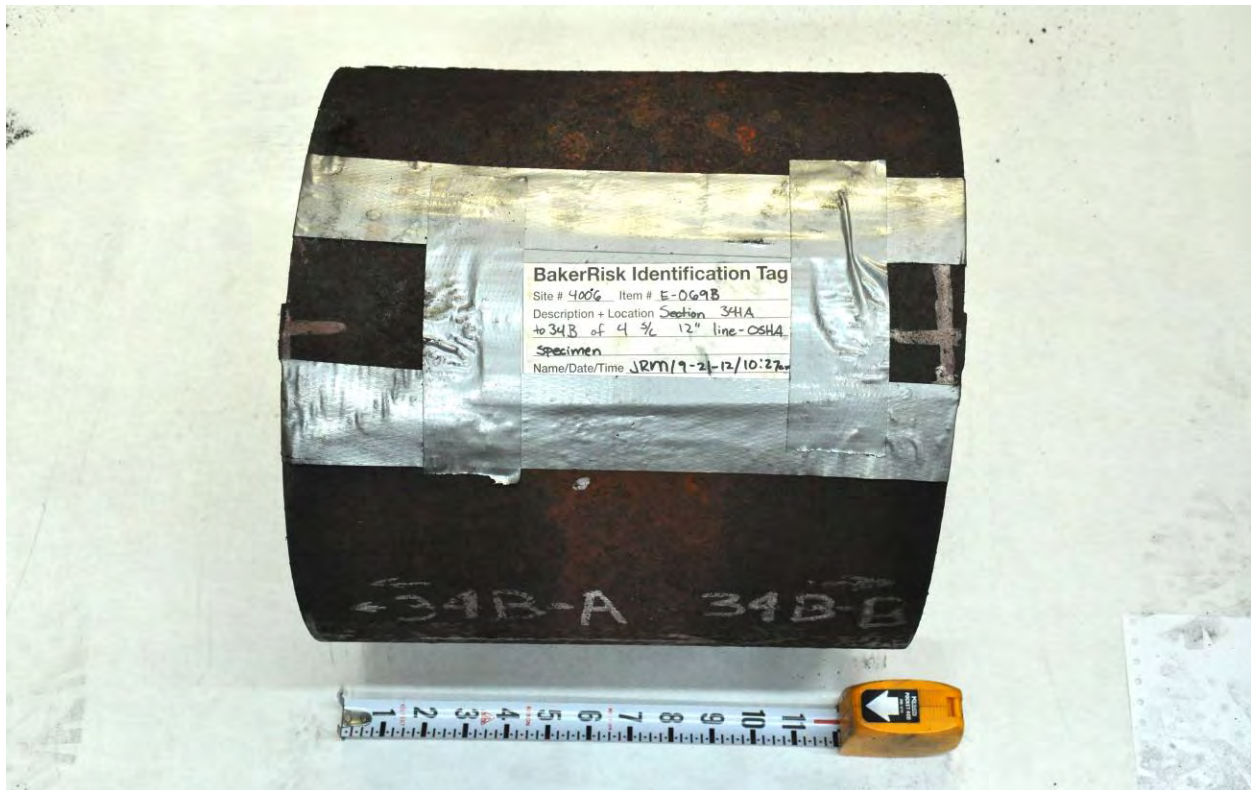
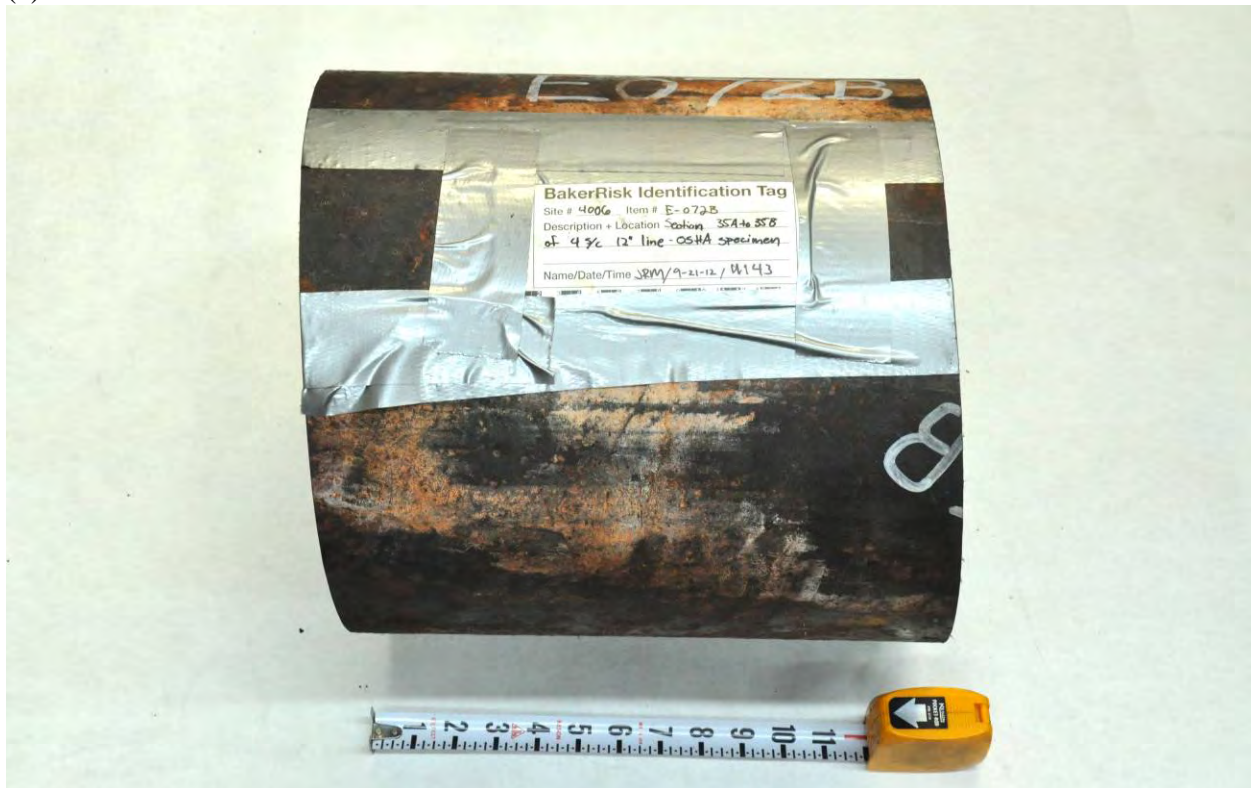
Figure 29 Photographs of 12-inch 4-sidecut samples E-069B and E-072B as-received.

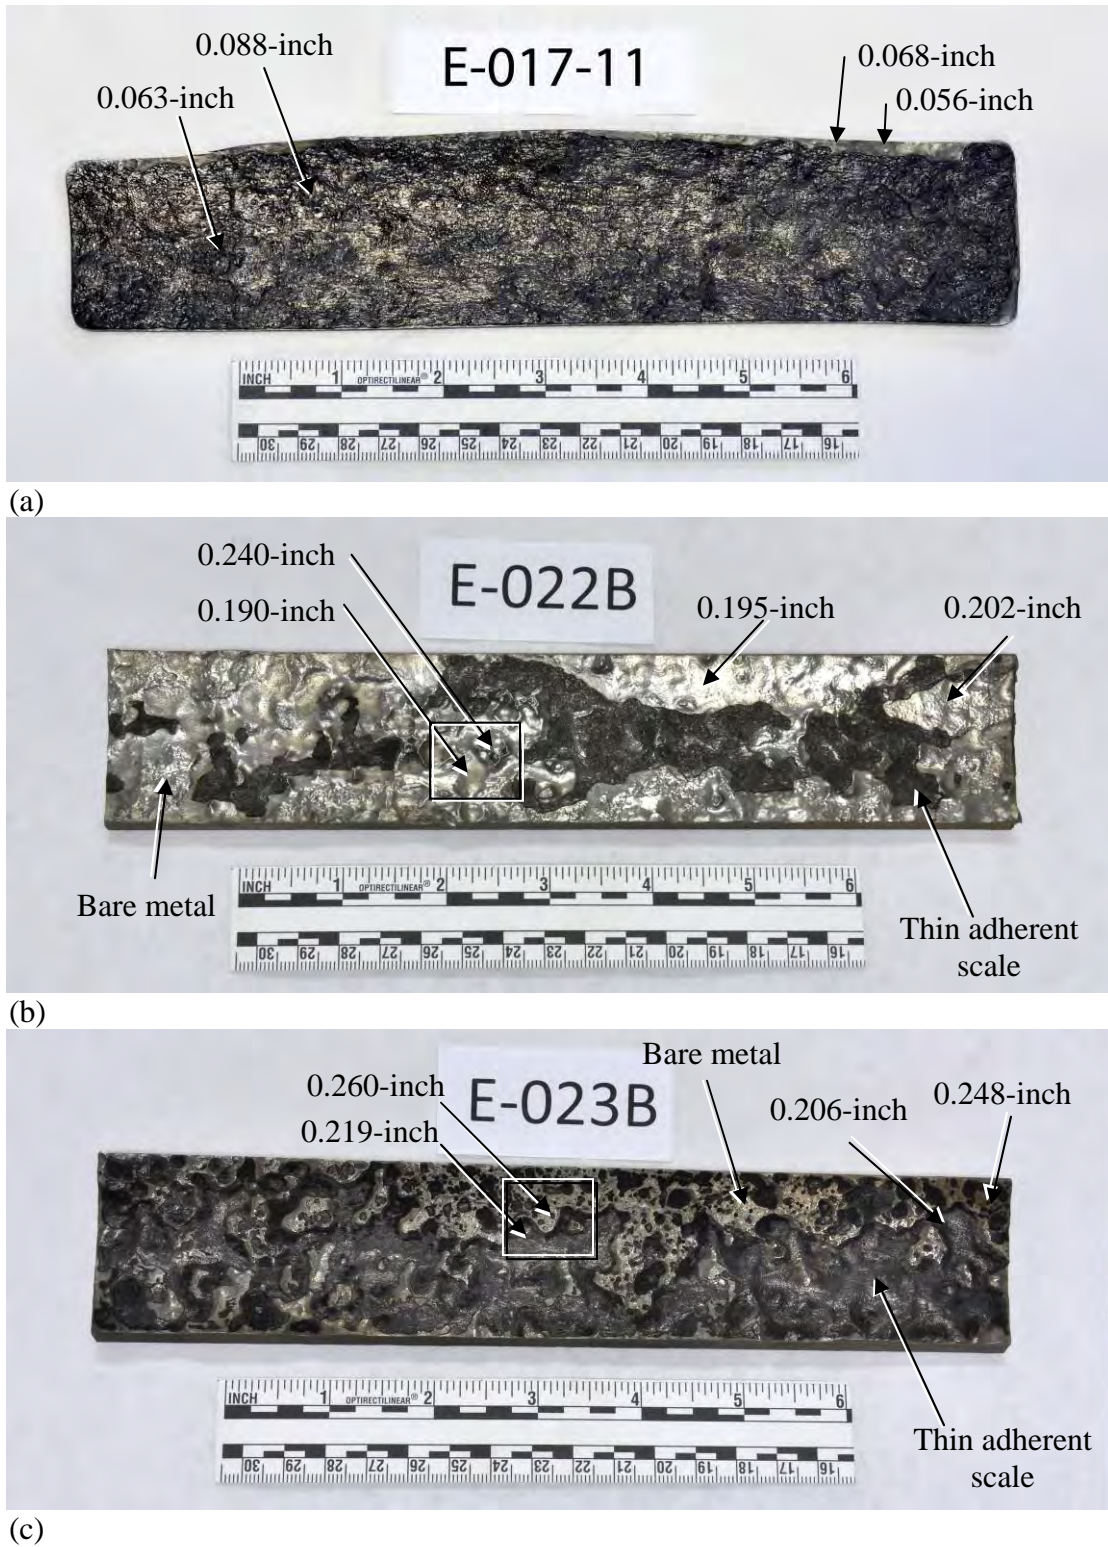
Uneven or wavy wall loss was investigated by cleaning specimens from the 8-inch 4-sidecut and 12-inch 4-sidecut by immersion in a 25% solution of Oakite® 33 and water. Alternating cycles of immersion in the solution and wire brushing the inside and outside surface scale removed the majority of the scales present. A control specimen was subjected to the same exposure and lost 0.002-inch of thickness. Photographs of the inside surfaces after cleaning are shown in Figure 30 through Figure 33. Uneven or wavy wall loss was present on specimens sectioned from the pipe samples E-022B, E-023B, E-063AB, E-069B, and E-072B. Thickness measurements were performed using a pointed anvil micrometer at locations selected to demonstrate the range of thickness associated with uneven wall loss on the cleaned specimens. Measured wall thickness values are annotated on the figures. In some cases, a thin, adherent layer of scale remained on the inside surface of the specimens after cleaning. The remaining scale thickness was estimated from measurements made along the edges of specimens E-030B, E-059B, and E-061B where the scale had spalled from the inside surface and closely spaced measurements could be compared. The remaining adherent inside surface scale was about 0.015-inch thick.

Figure 30 Photographs of the inside surface of cleaned specimens sectioned from the 8-inch 4-sidecut samples. The location from which specimen E-017-11 was sectioned is indicated in Figure 2. The boxed areas in (b) and (c) are shown in Figure 34.

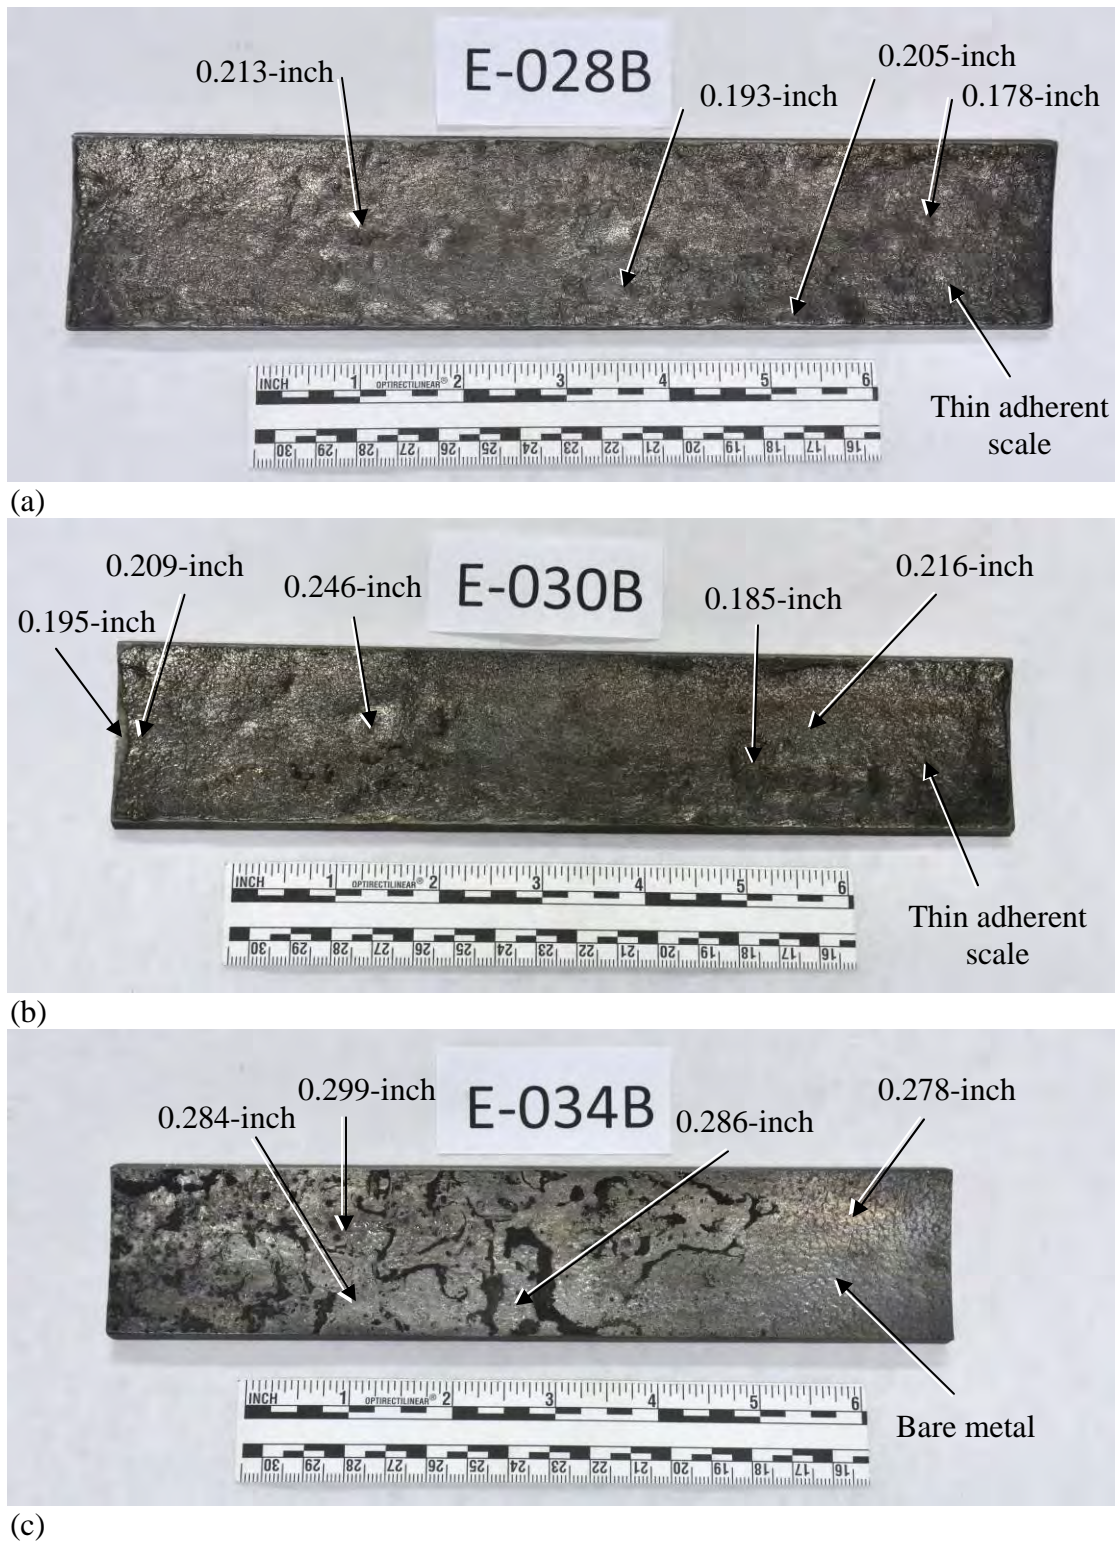
Figure 31 Photographs of the inside surface of cleaned specimens sectioned from the 8-inch 4-sidecut samples.

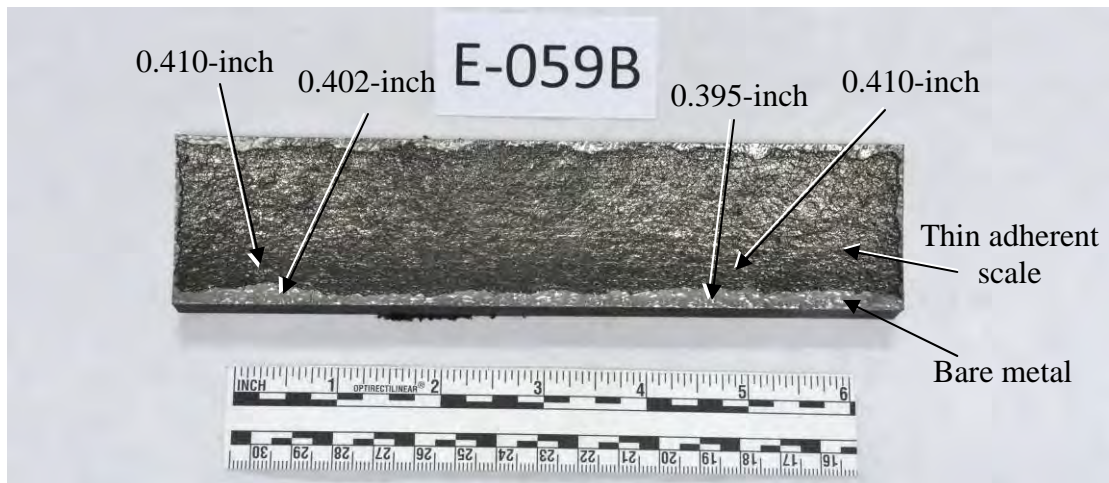
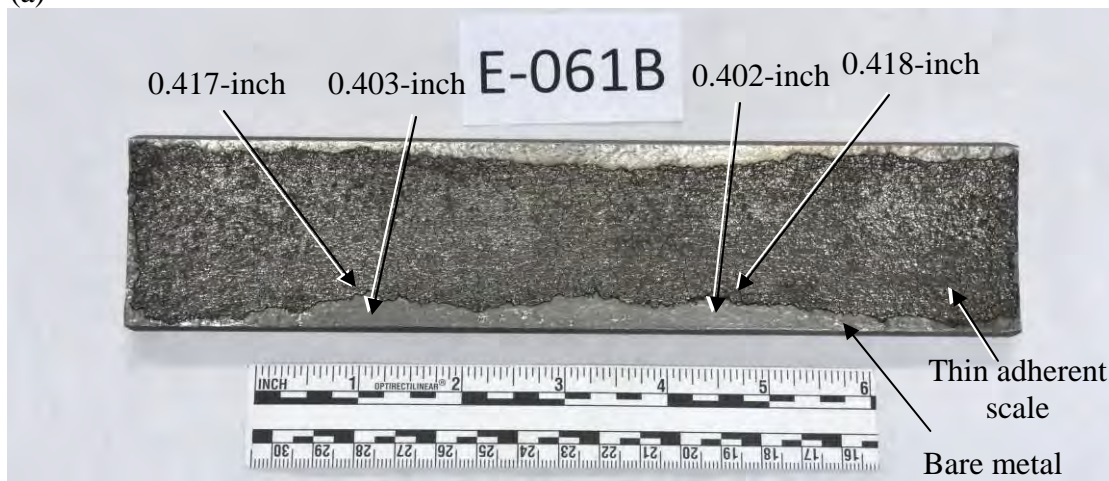
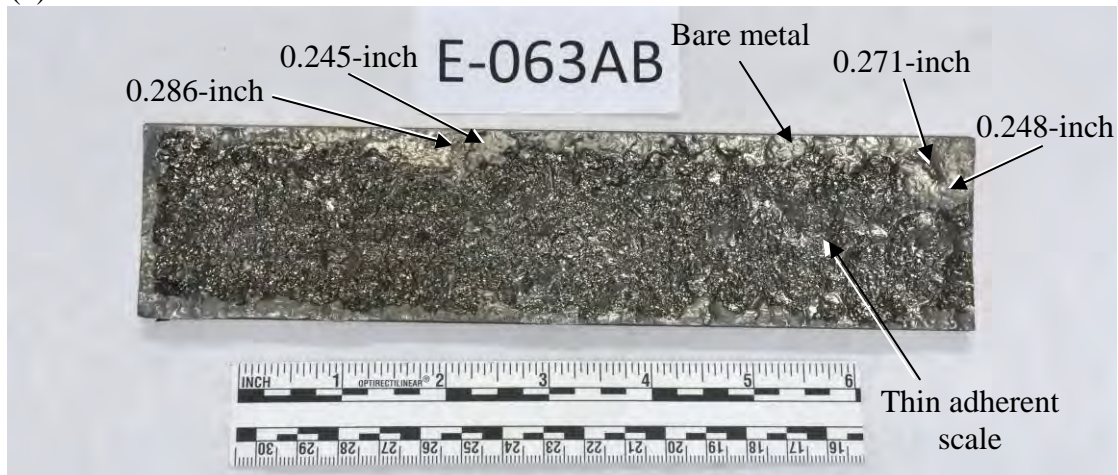
Figure 32 Photographs of the inside surface of cleaned specimens sectioned from the 12-inch 4-sidecut samples.

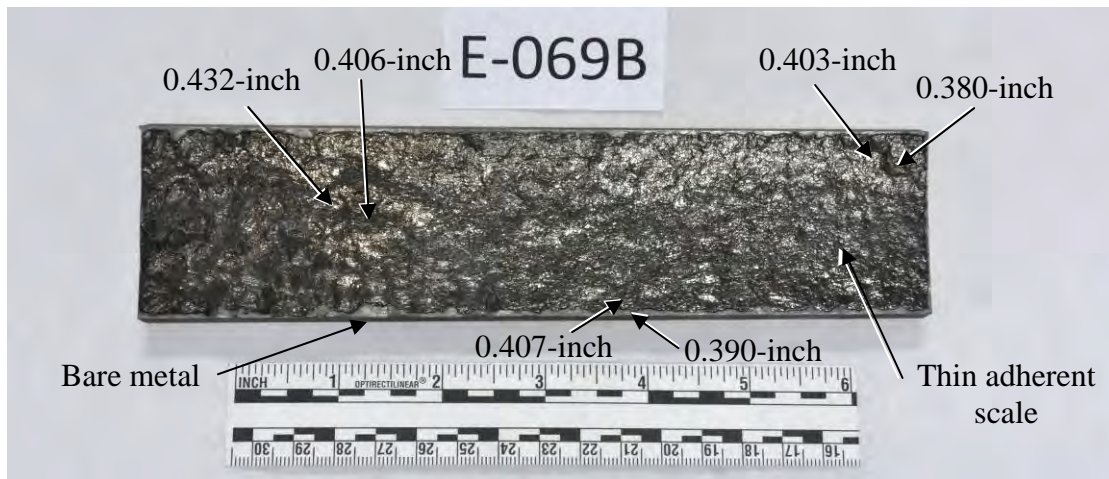
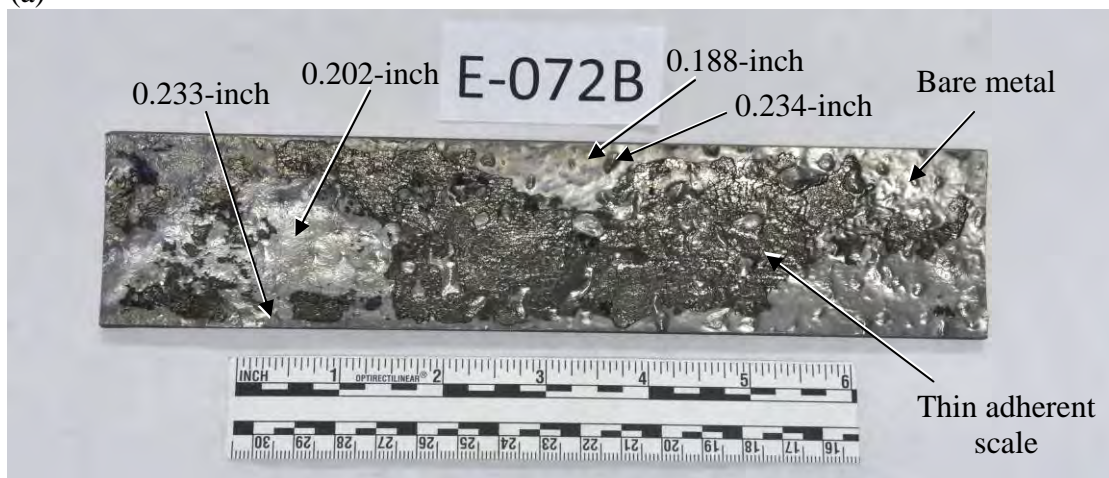
Figure 33 Photographs of the inside surface of cleaned specimens sectioned from the 12-inch 4-sidecut samples.

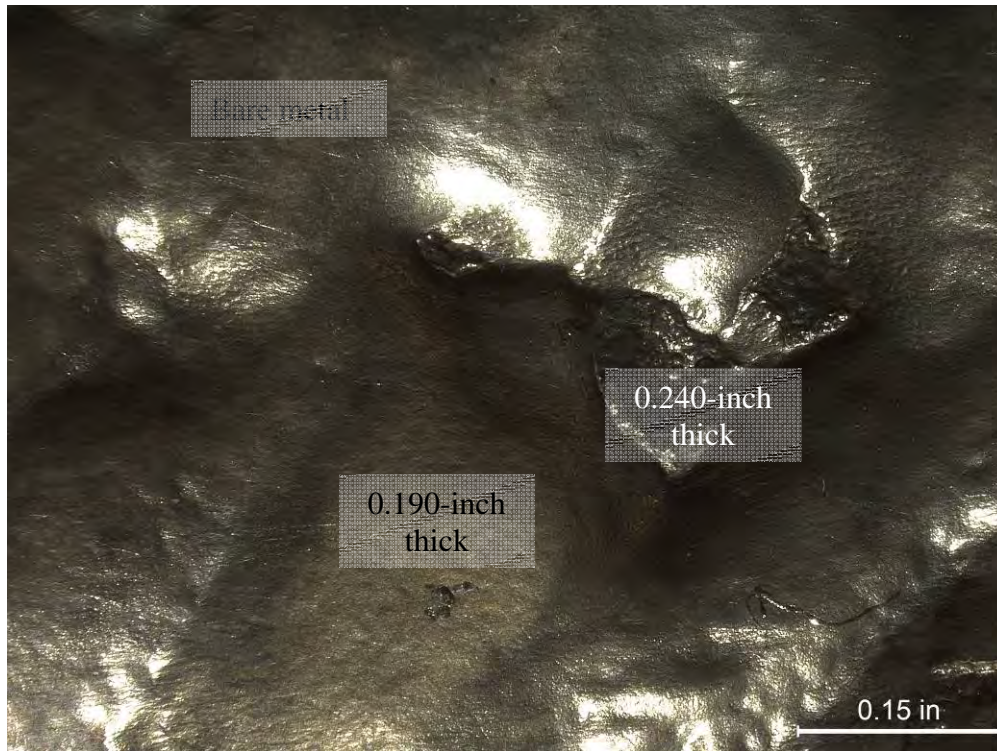
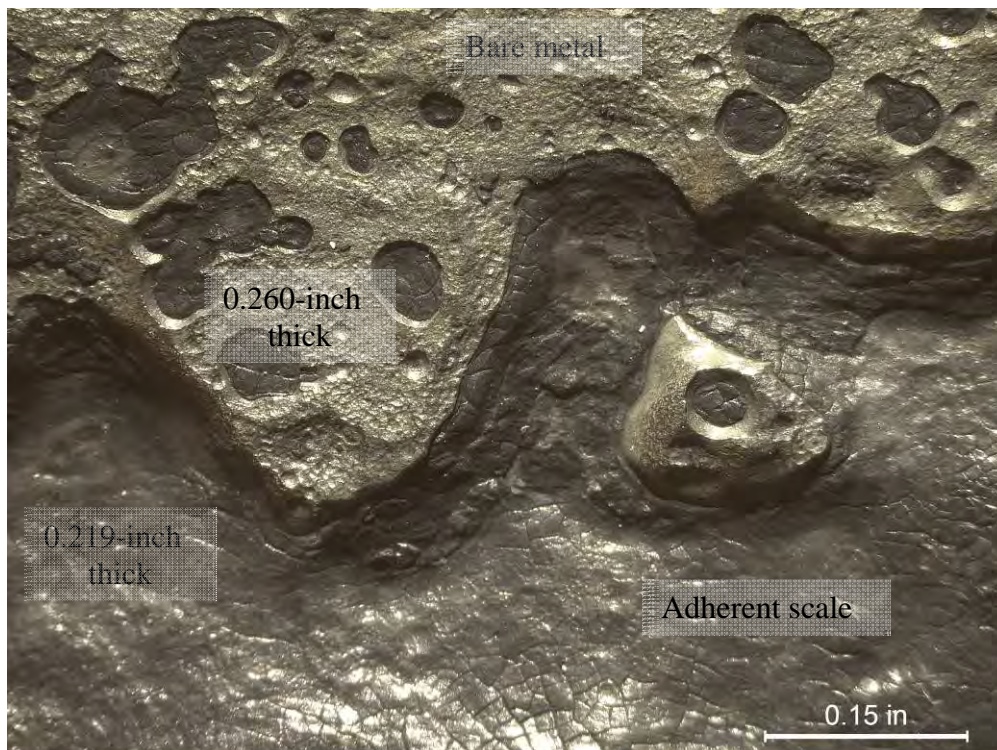
Figure 34 Macrographs of the inside surface of cleaned specimens from samples E-022B and E-023B from the boxed areas shown in Figure 30a and Figure 30b, respectively.

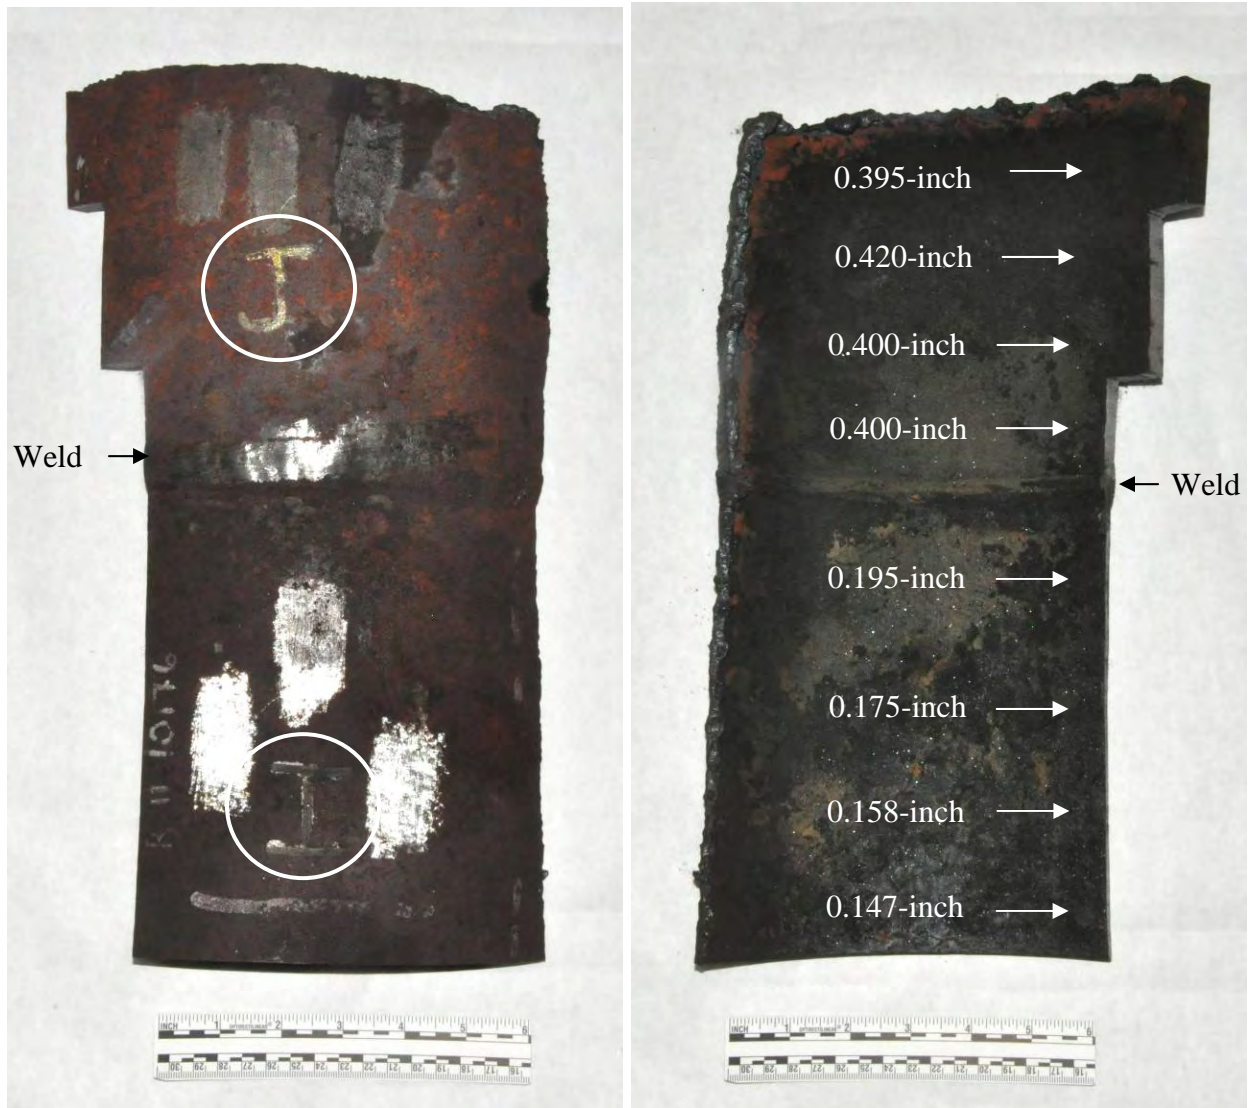
Figure 35 Photographs of 2011 12-inch samples I and J, joined by a circumferential weld. Measured thickness values are indicated in (b).
