METALLURGICAL EVALUATION OF SAMPLES FROM THE CHEVRON U.S.A. INC., RICHMOND #4 CRUDE UNIT 8-INCH AND 12-INCH 4-SIDECUT PIPING INVOLVED IN THE AUGUST 6, 2012, HYDROCARBON RELEASE AND FIRE

Prepared for: The Chemical Safety and Hazard Investigation Board (CSB)

Report No. 5004.7920 B

February 11, 2013

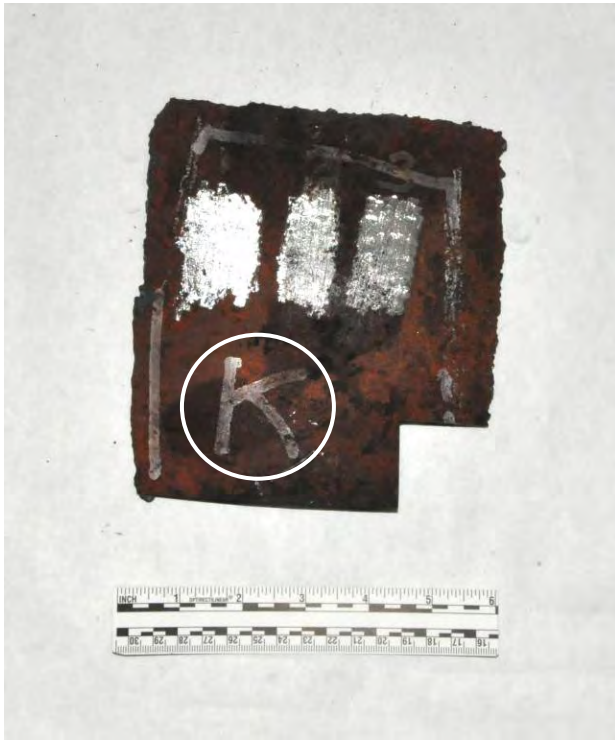
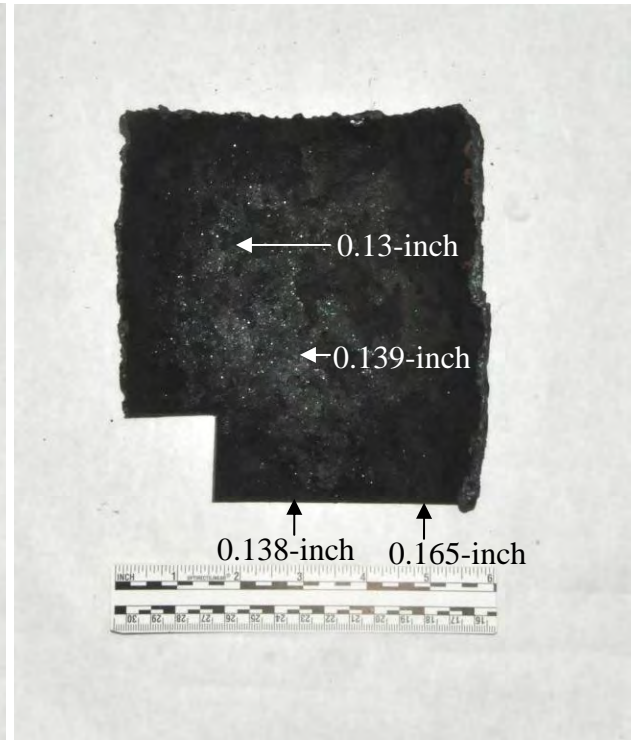
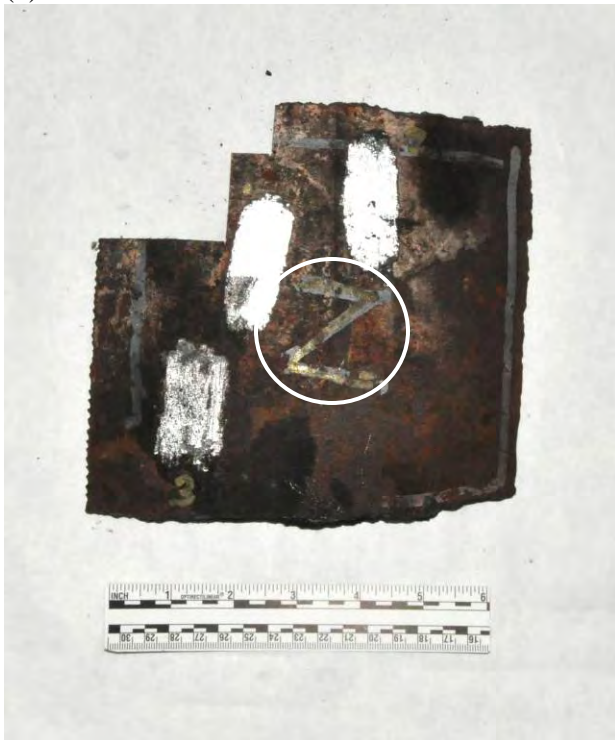
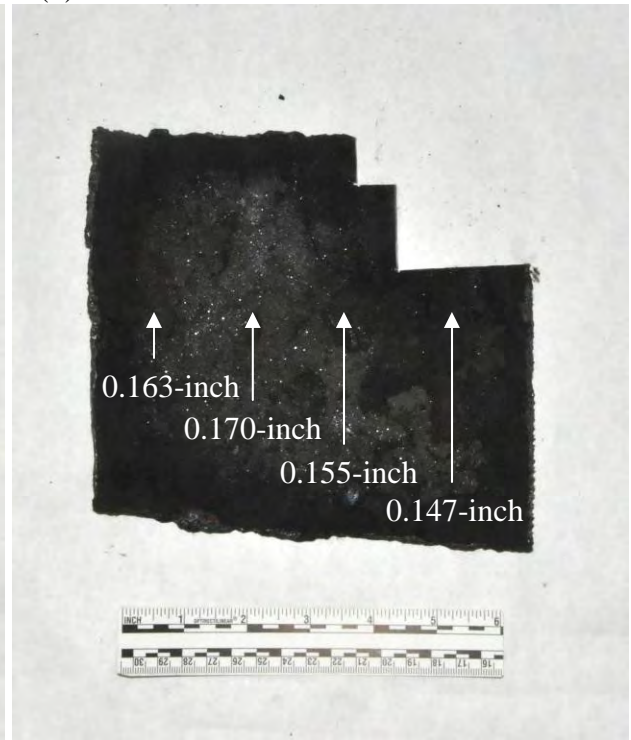
Figure 36 Photographs of 2011 12-inch samples K and N. Measured thickness values are shown in (b) and (d).

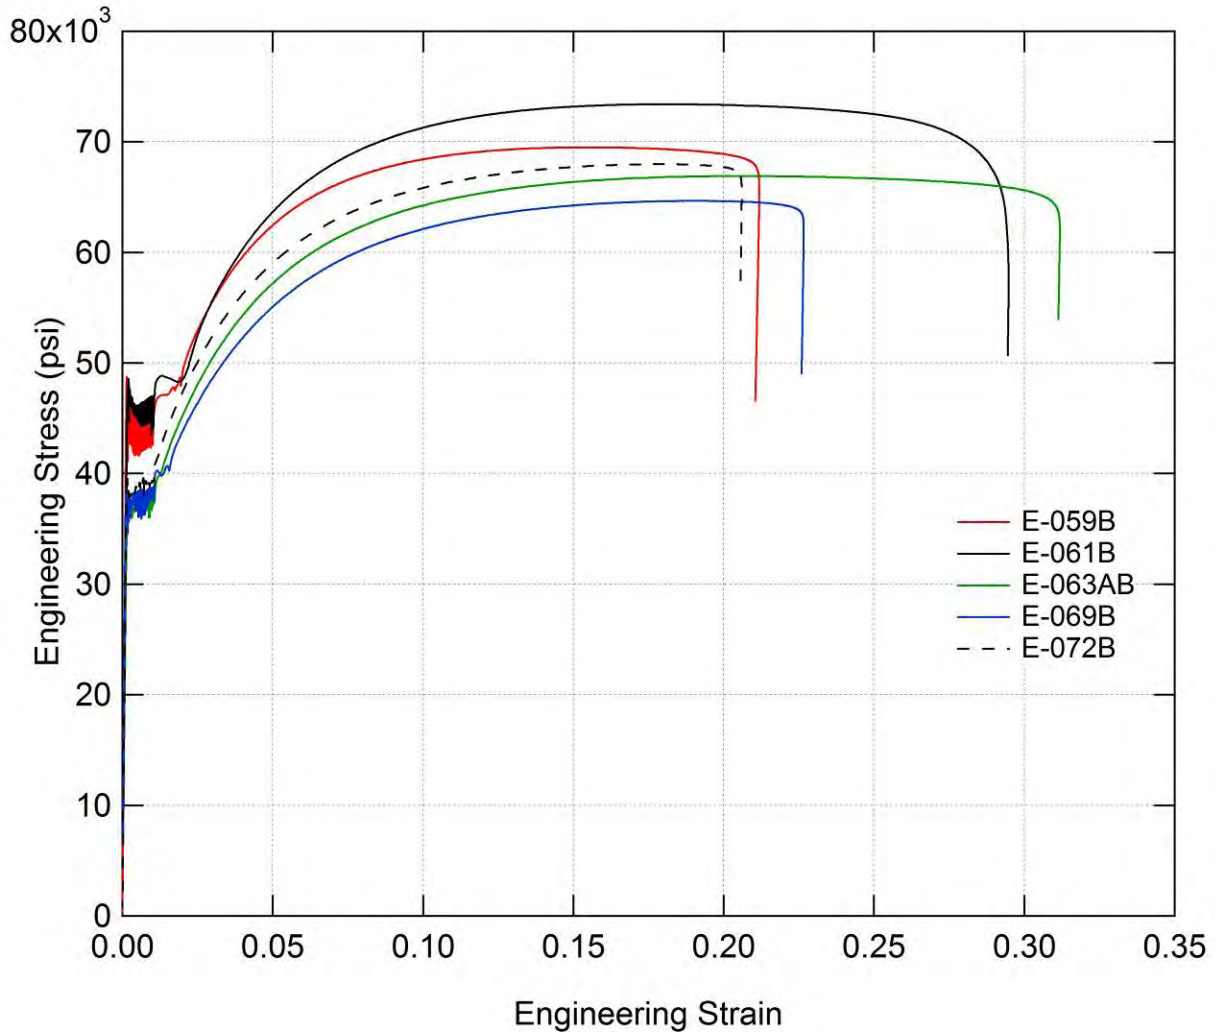
Figure 39 Stress-strain curves from tests performed on specimens machined from 12-inch pipe sections. Tabulated values of tensile strength, yield point, and total elongation are listed in Table 10.

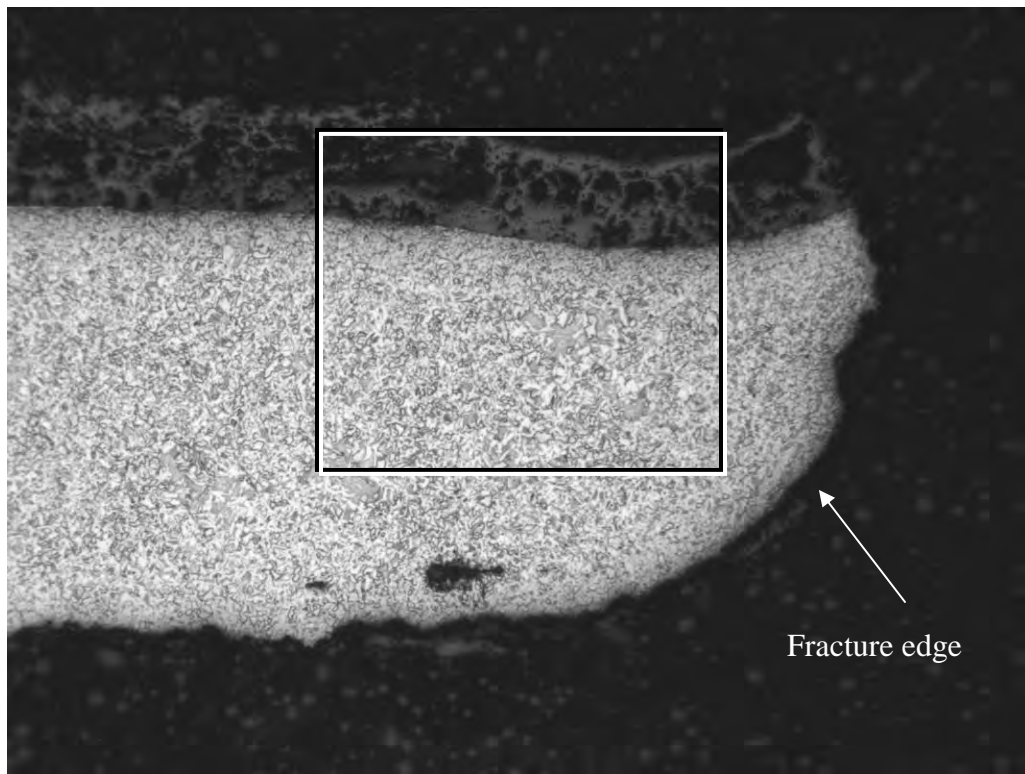
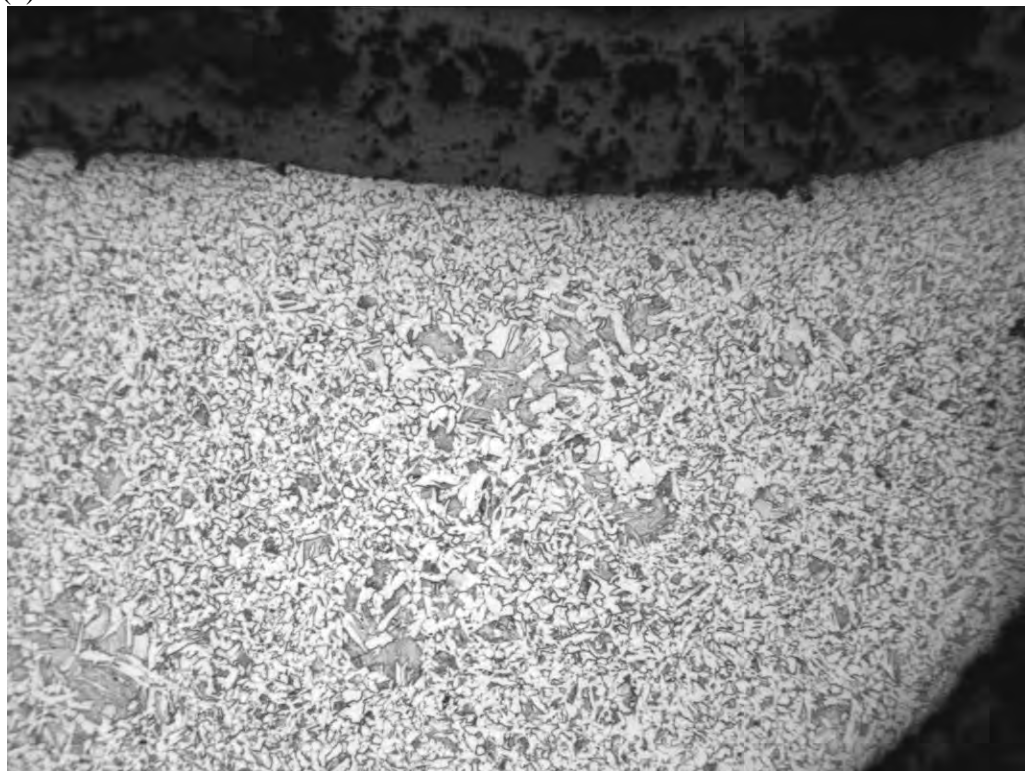
Figure 40 Optical micrographs of specimen E-017-2A prepared from the section indicated in Figure 10 before cleaning. The entire specimen had been recrystallized by the heat of the fire.

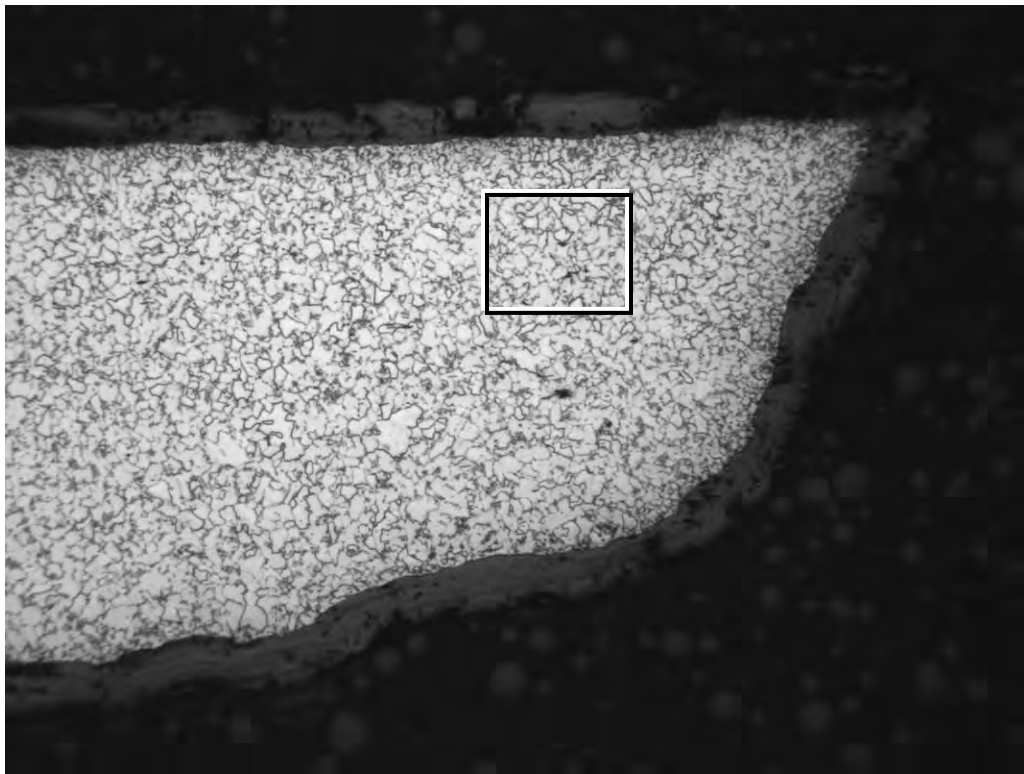
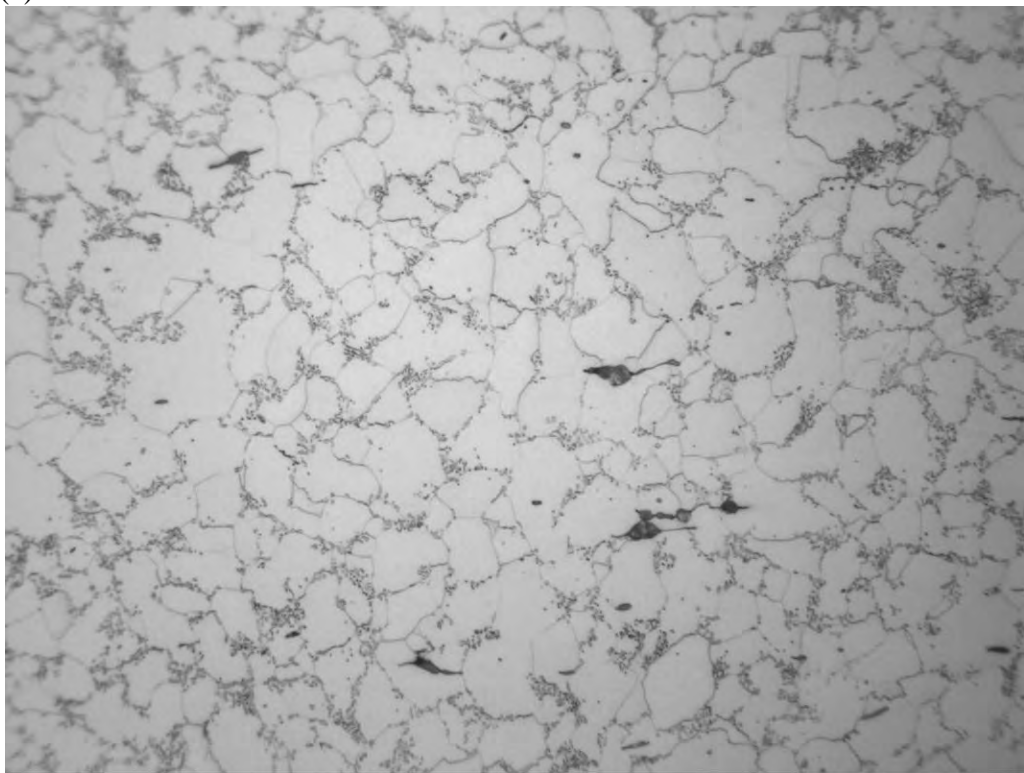
Figure 41 Optical micrographs of specimen E-014-C prepared from the section indicated in Figure 12 before cleaning. The entire specimen had been recrystallized by the heat of the fire.

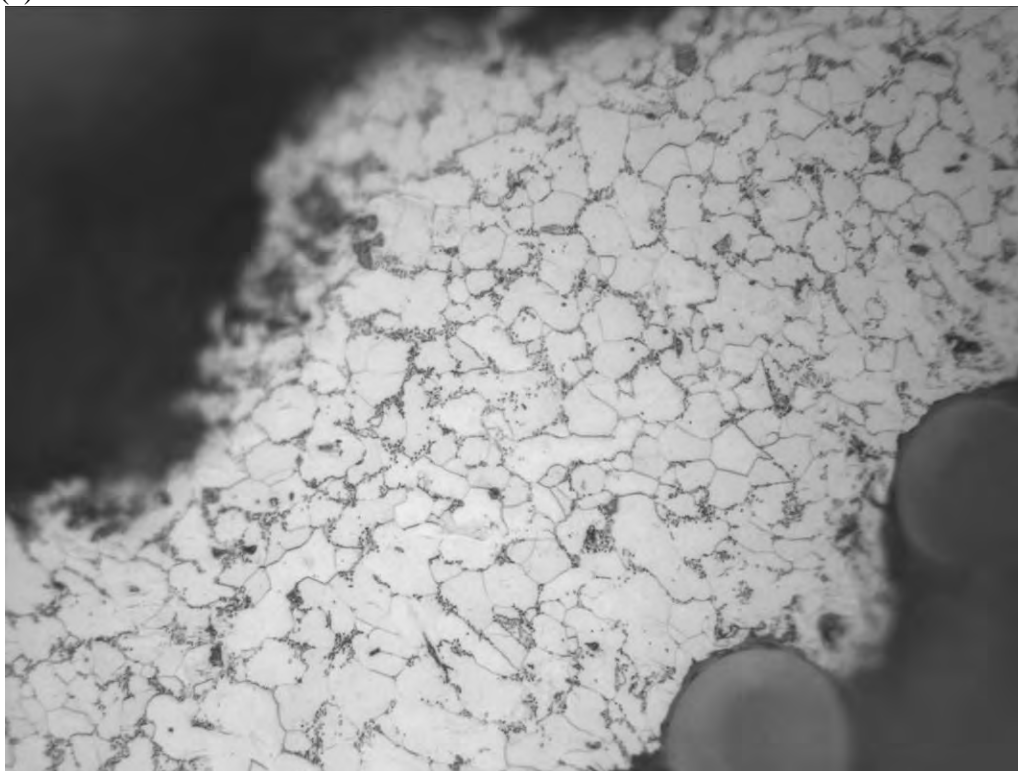
Figure 42 Optical micrographs of specimen E-017-1F, prepared from the section indicated in Figure 8 after cleaning. The entire specimen had been recrystallized by the heat of the fire.

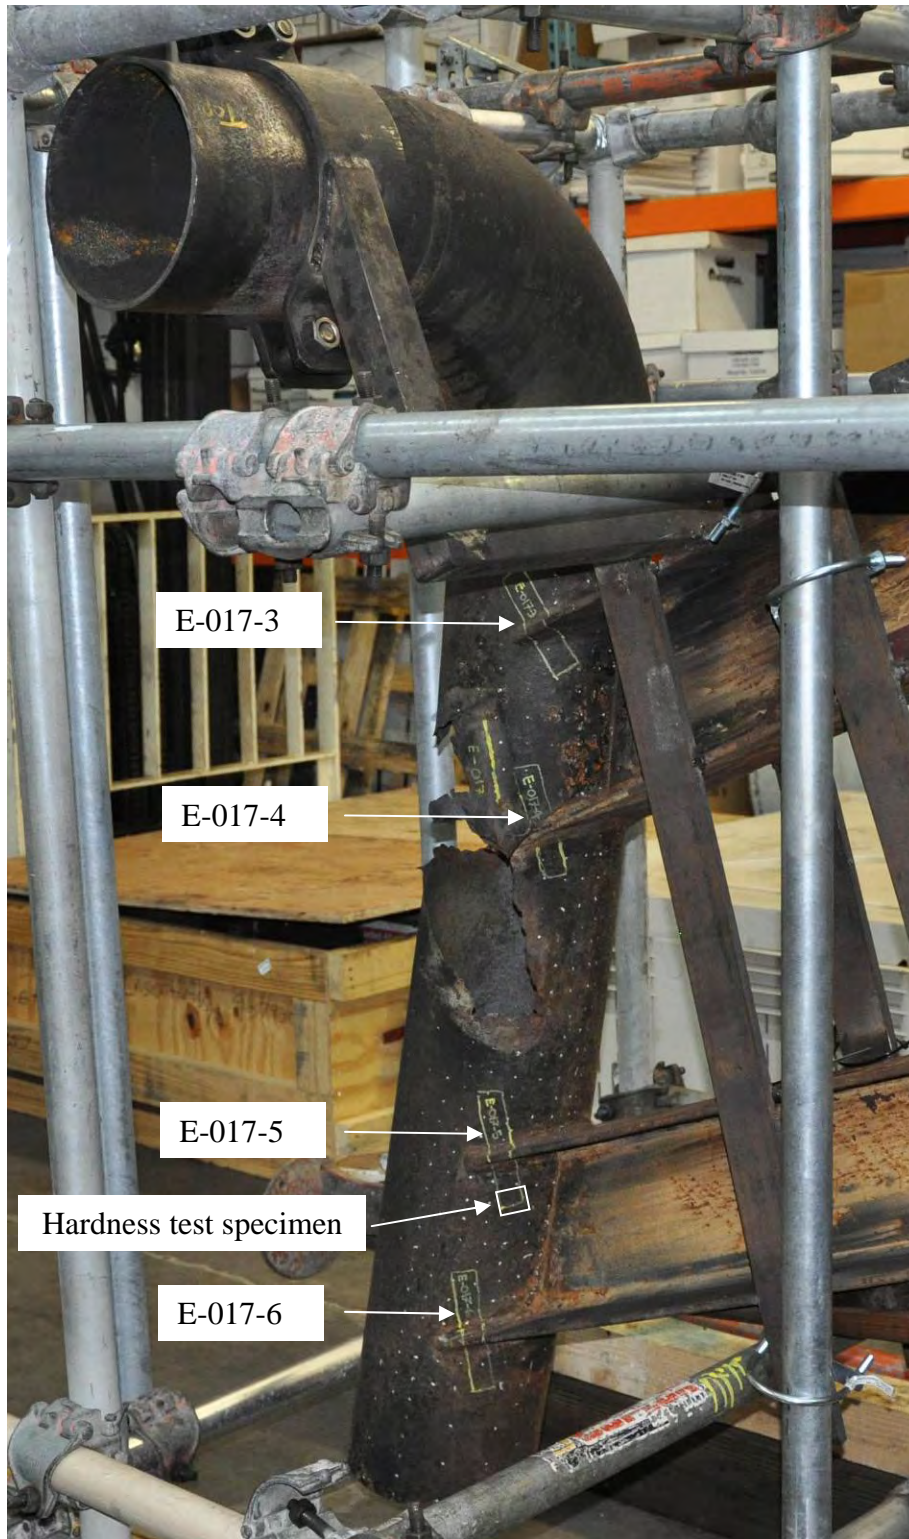
Figure 46 Photograph of sample E-017. Locations from which specimens were sectioned through the pipe guide welds are indicated.

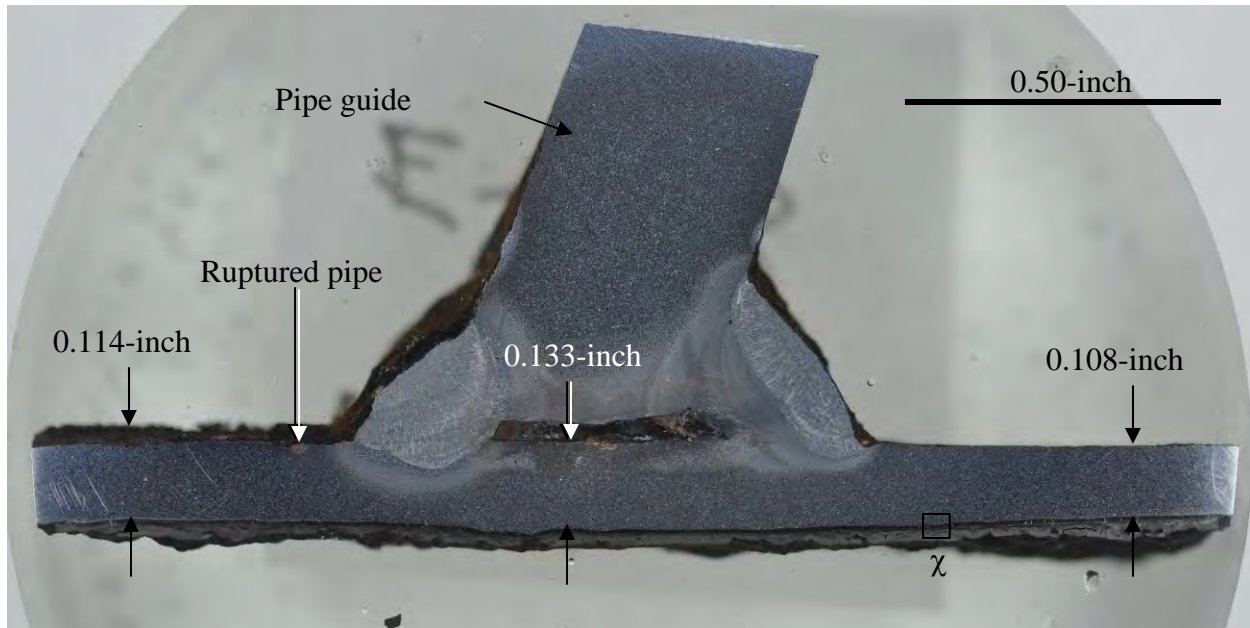
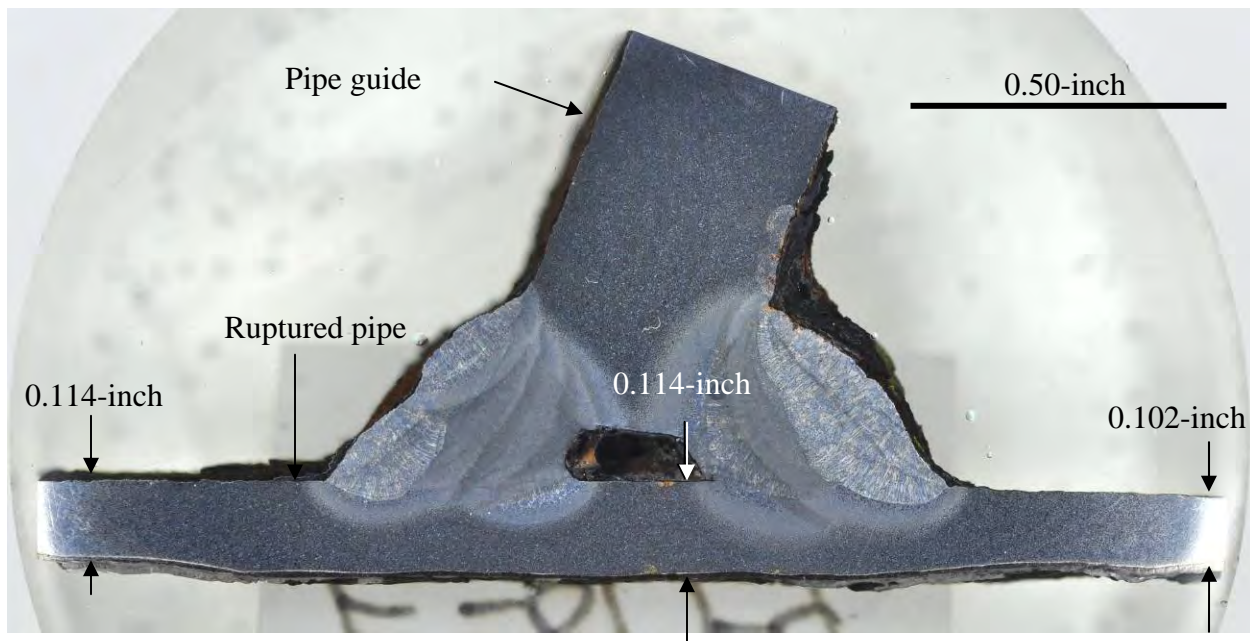
Figure 47 Specimens prepared from sections through the pipe guide welds indicated in Figure 46.

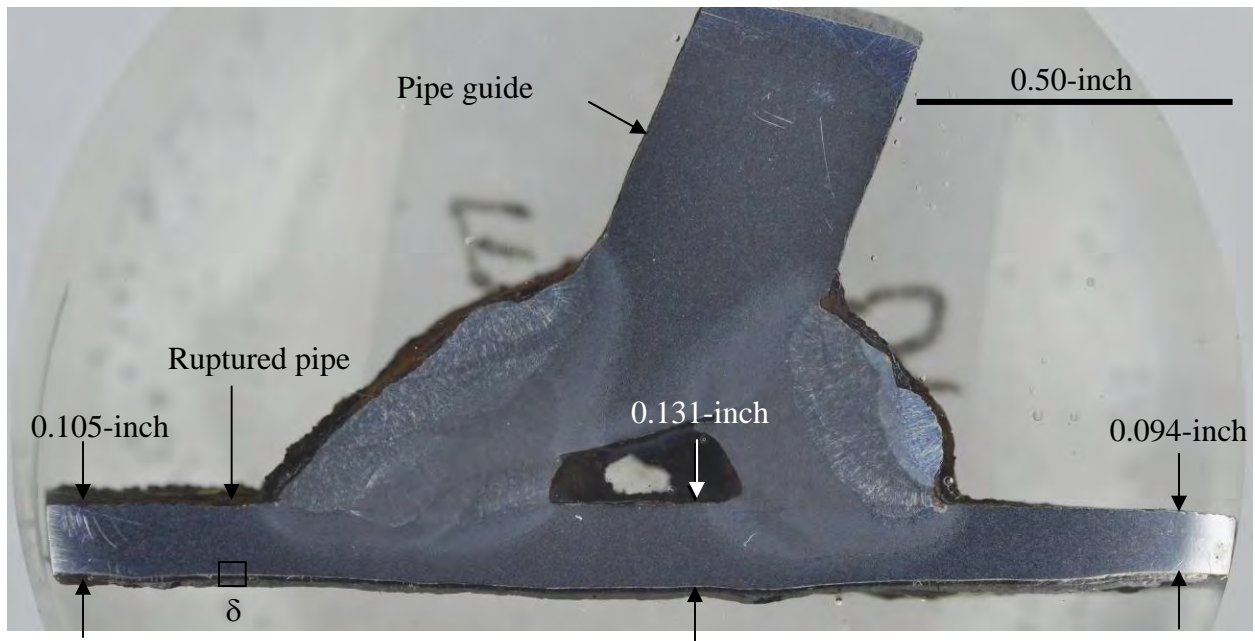
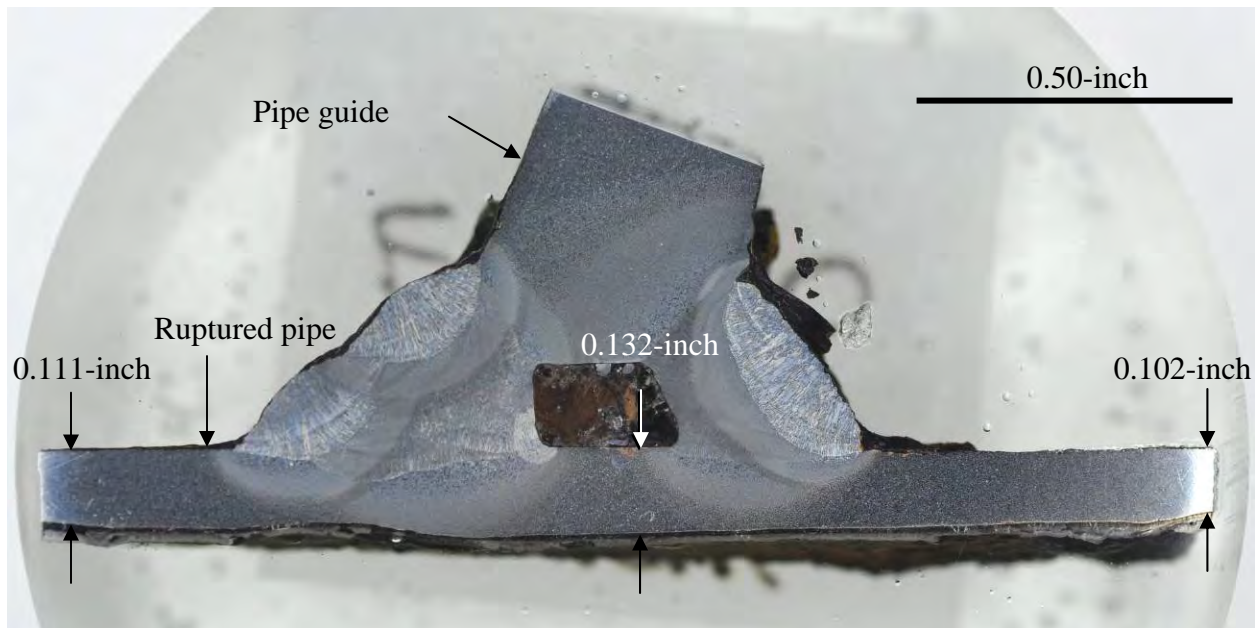
Figure 48 Specimens prepared from sections through the pipe guide welds indicated in Figure 46.

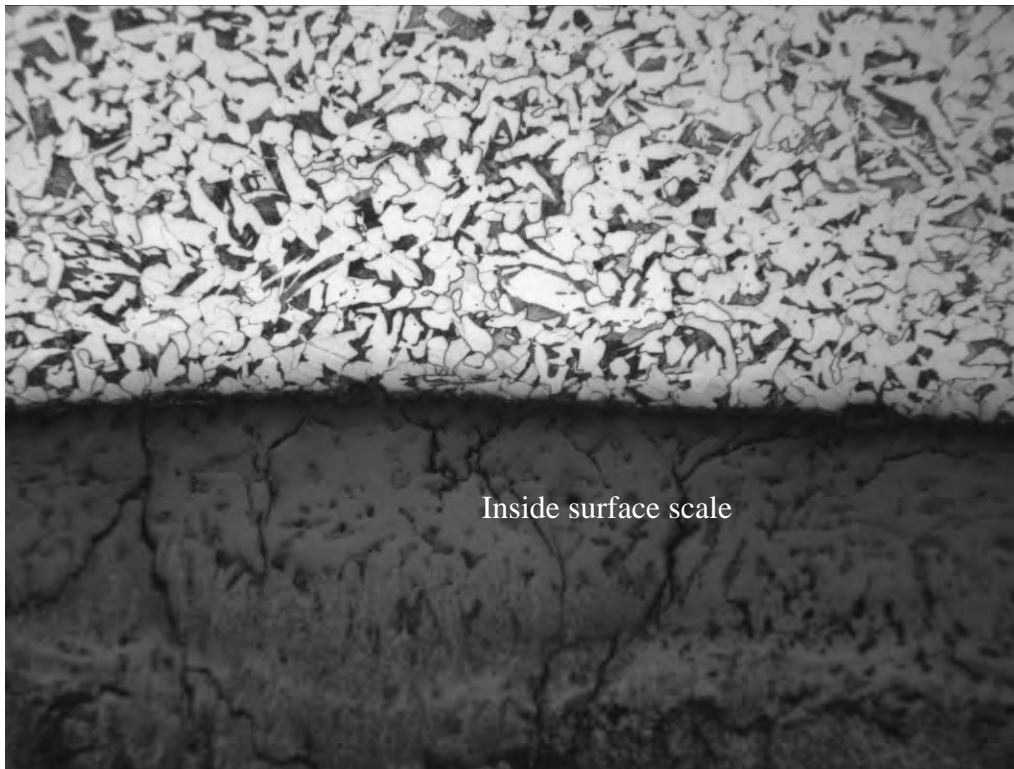
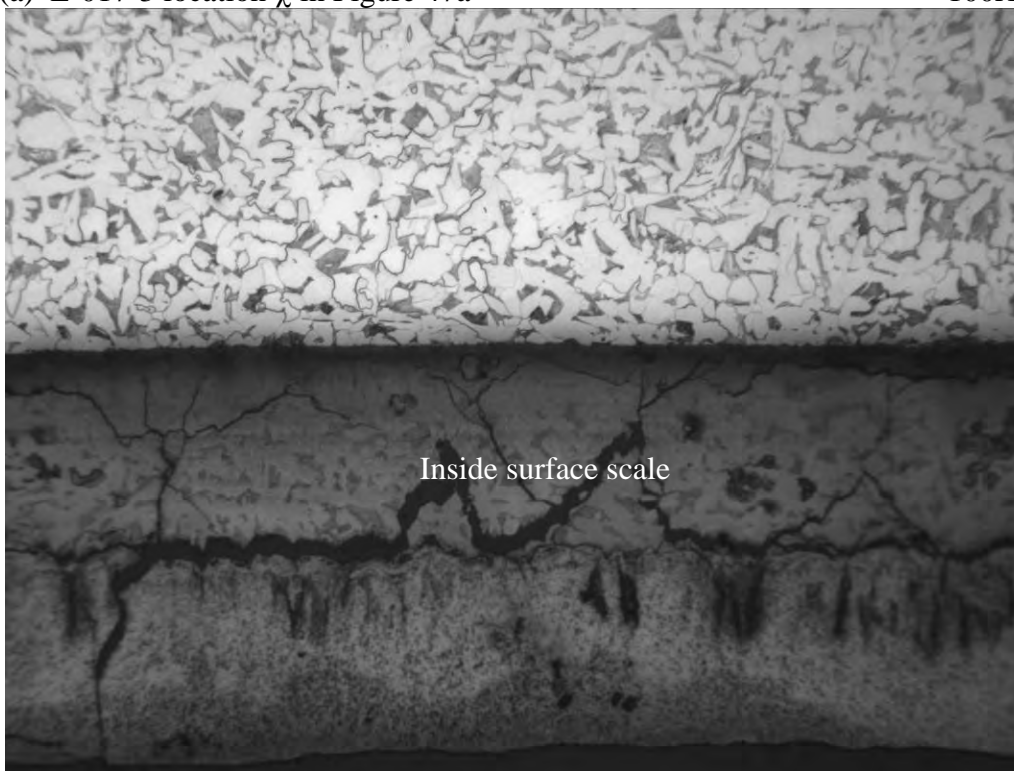
Figure 49 Optical micrographs of specimens prepared from sections of guide welds E-017-3 and E-017-5.

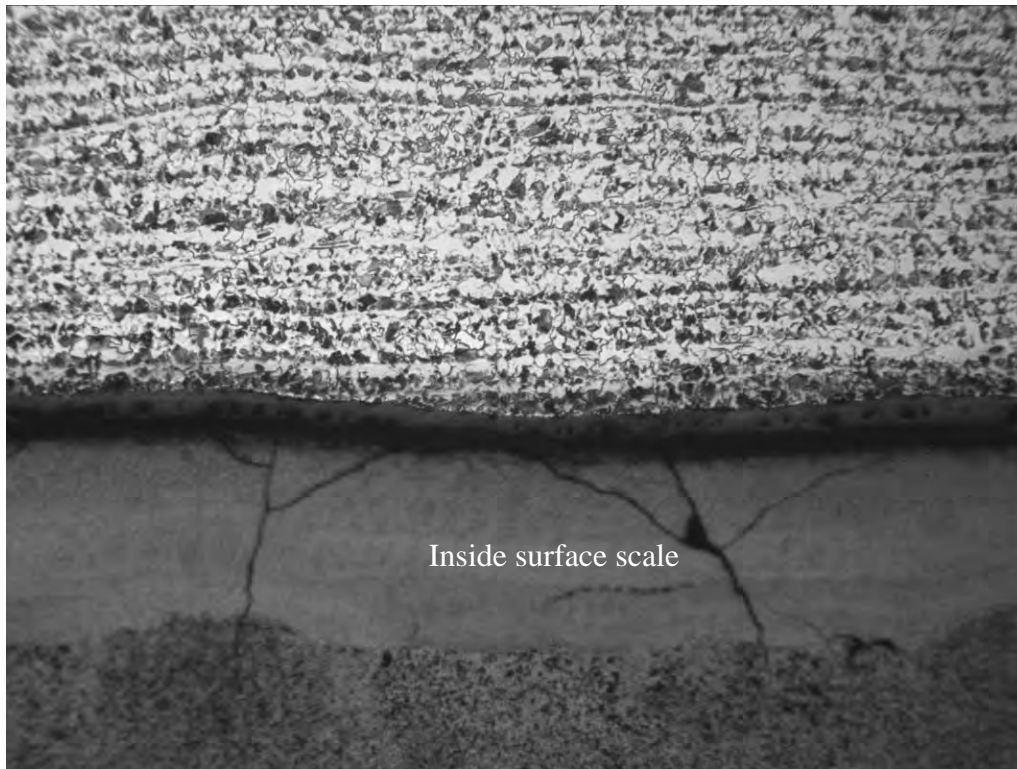
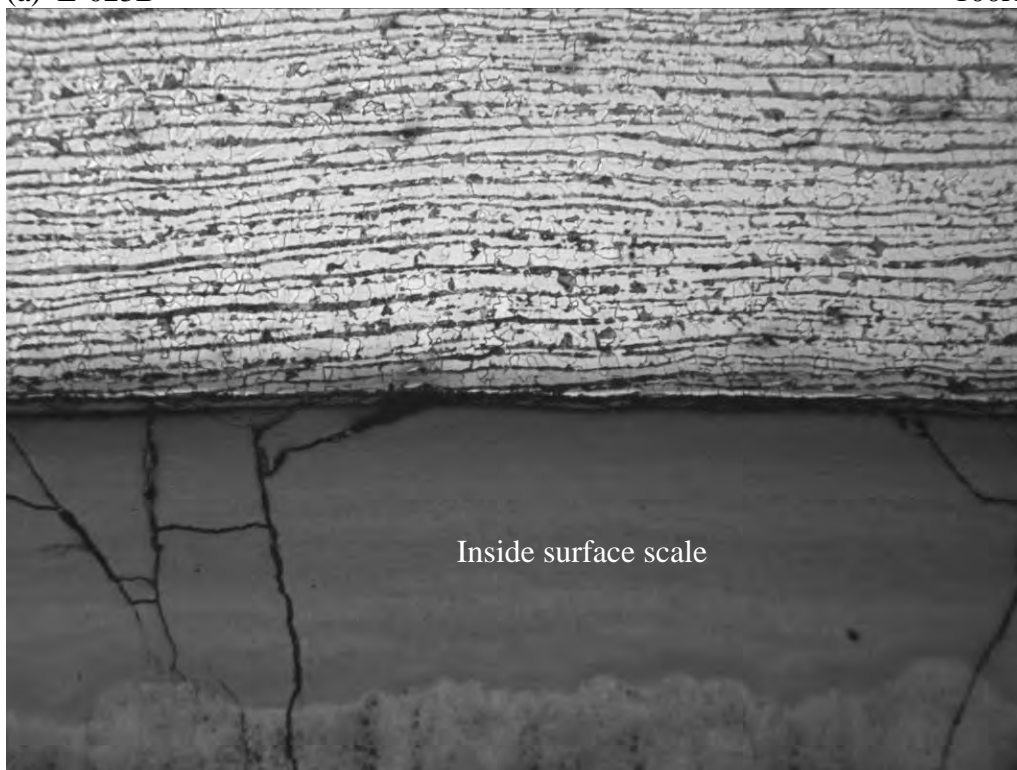
Figure 50 Optical micrographs of longitudinal sections through 8-inch 4-sidecut sample E-023B and 12-inch 4-sidecut sample E-061B.

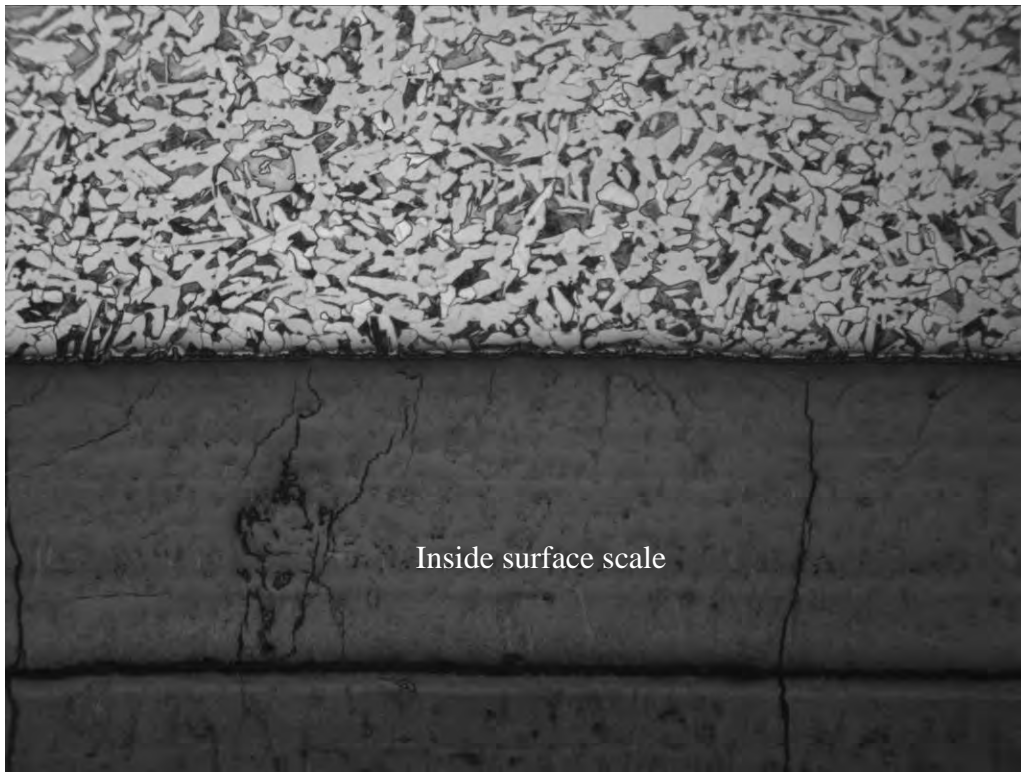
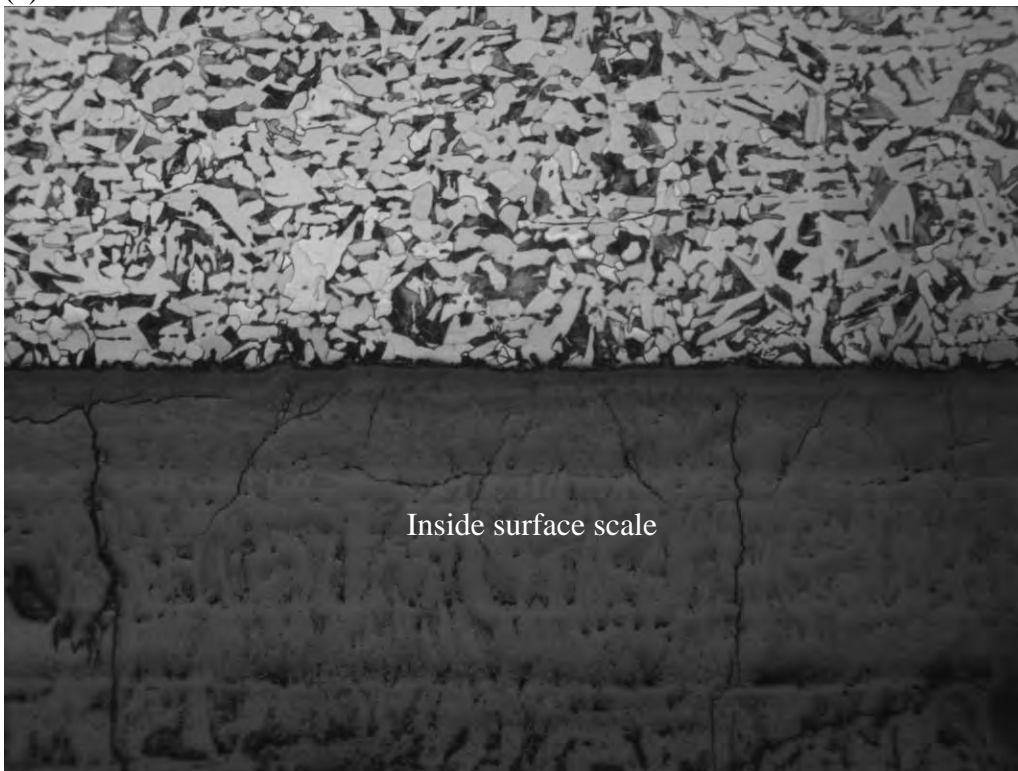
Figure 51 Optical micrographs of longitudinal sections through 2011 12-inch samples I and K.

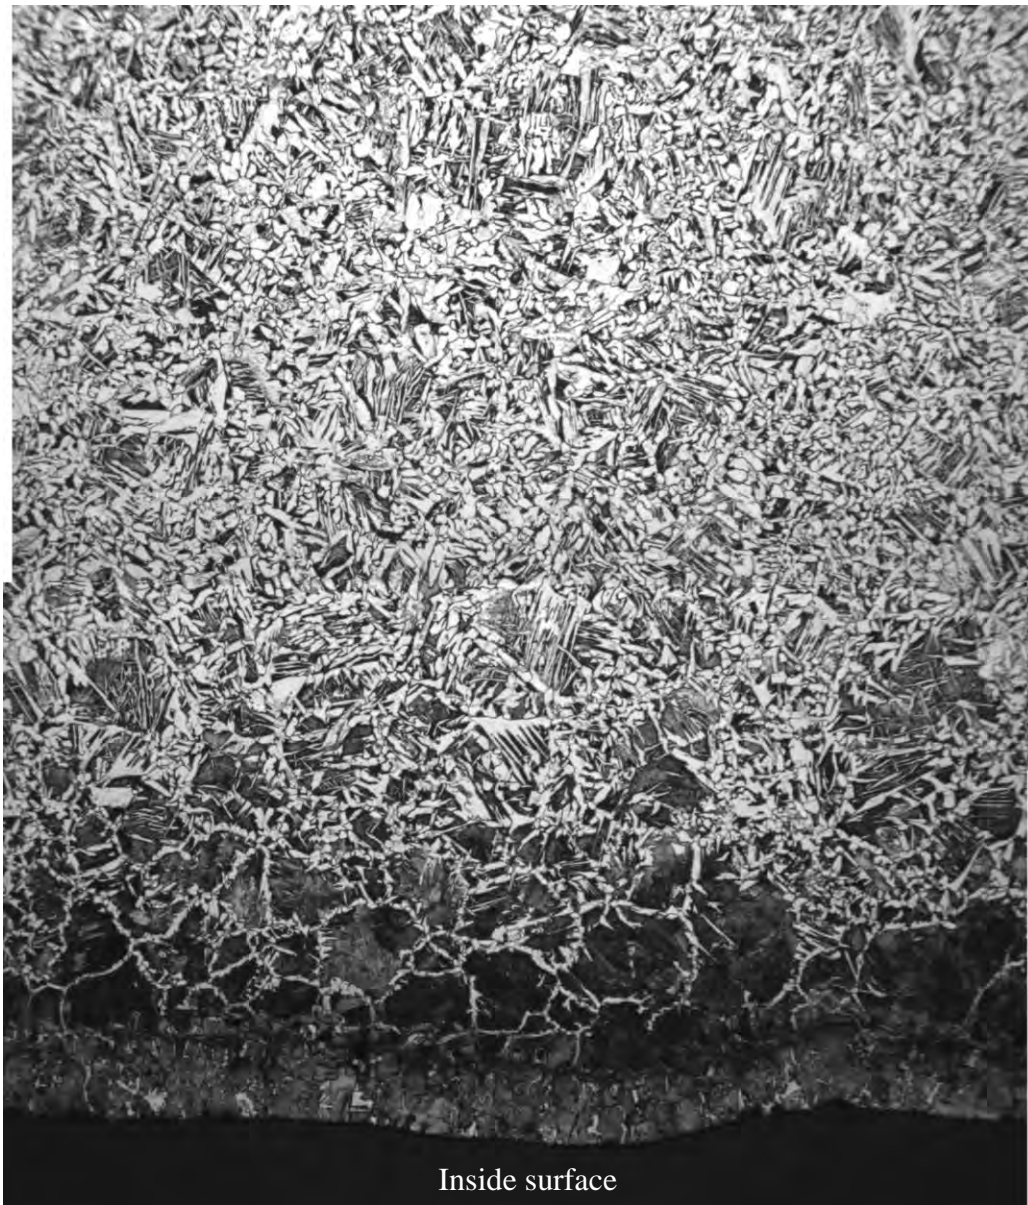
Figure 52 Optical micrograph montage of a transverse specimen prepared from sample E-034.

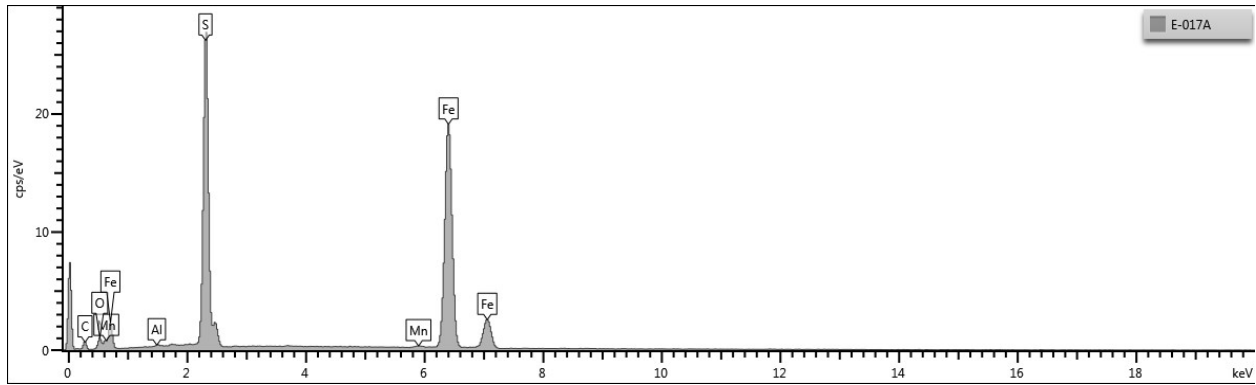
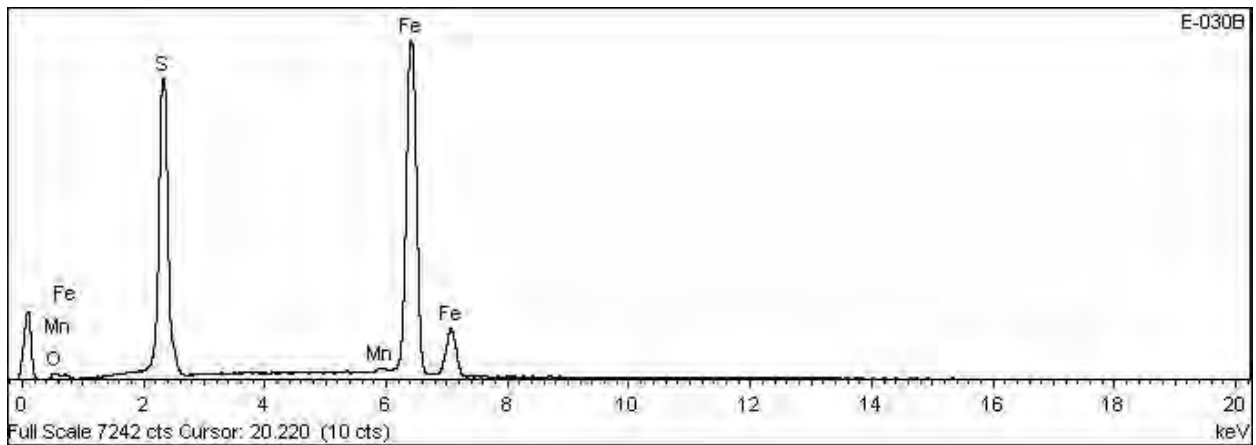
inside surface scale was comprised mostly of iron and sulfur, consistent with sulfidation corrosion product.

Element	Wt%	Wt% Sigma	Atomic %
O	8.46	0.37	20.05
Al	0.30	0.07	0.42
S	34.87	0.22	41.24
Mn	0.33	0.06	0.23
Fe	56.04	0.29	38.06

Element	Weight %	Weight % Sigma	Atomic %
O	4.68	0.36	12.04
S	32.23	0.22	41.41
Mn	0.63	0.08	0.47
Fe	62.47	0.30	46.08

Figure 54 EDS spectra and semi-quantitative analysis results for specimens E-017B-A scraped from the inside surface of the ruptured section and E-030B scraped from the inside surface of the 8-inch 4-sidecut sample E-030B.

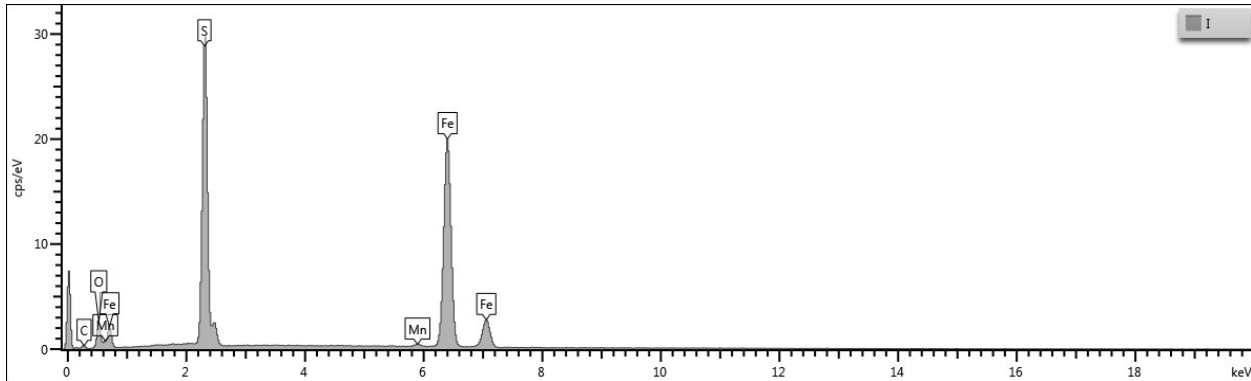
Element	Wt%	Wt% Sigma	Atomic %
O	17.94	0.39	37.13
S	32.27	0.21	33.33
Mn	0.47	0.06	0.28
Fe	49.32	0.28	29.25

Figure 55 EDS spectra and semi-quantitative EDS results for specimens E-069B scraped from the inside surface of 12-inch 4-sidecut sample E-069B and 2011 12-inch sample I.

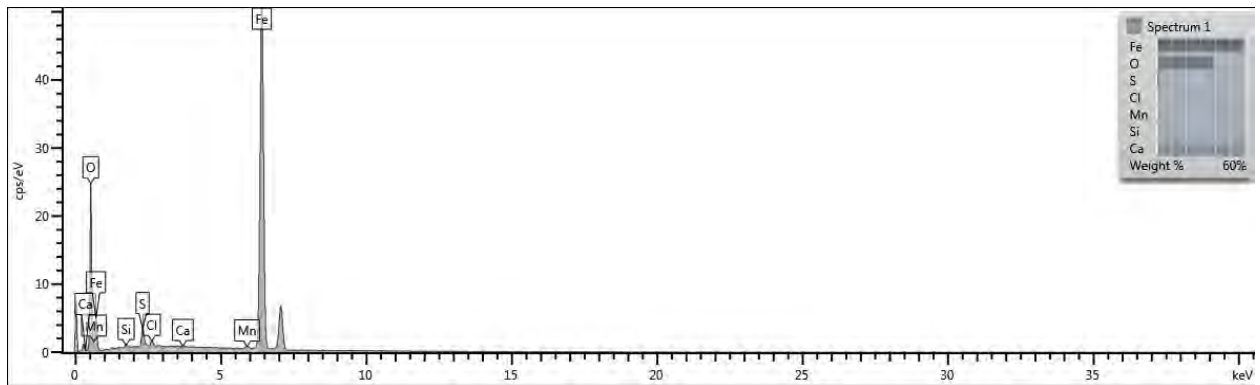
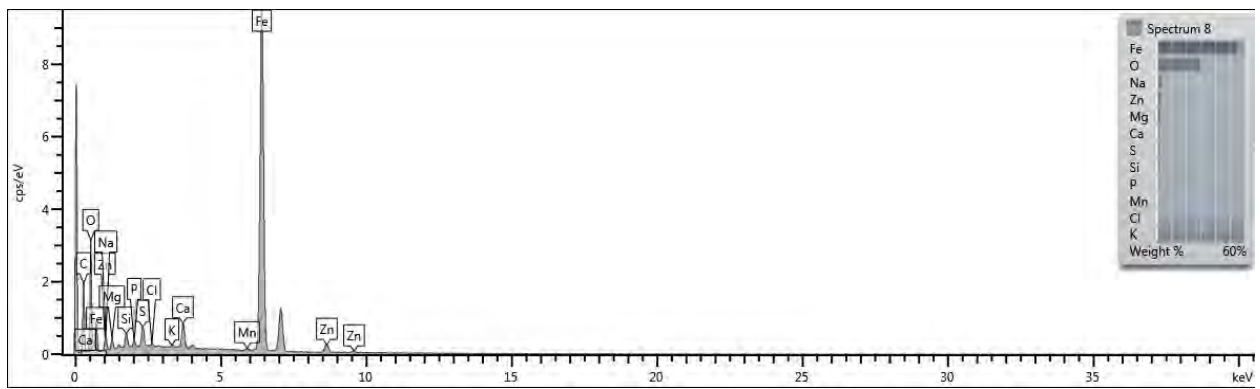
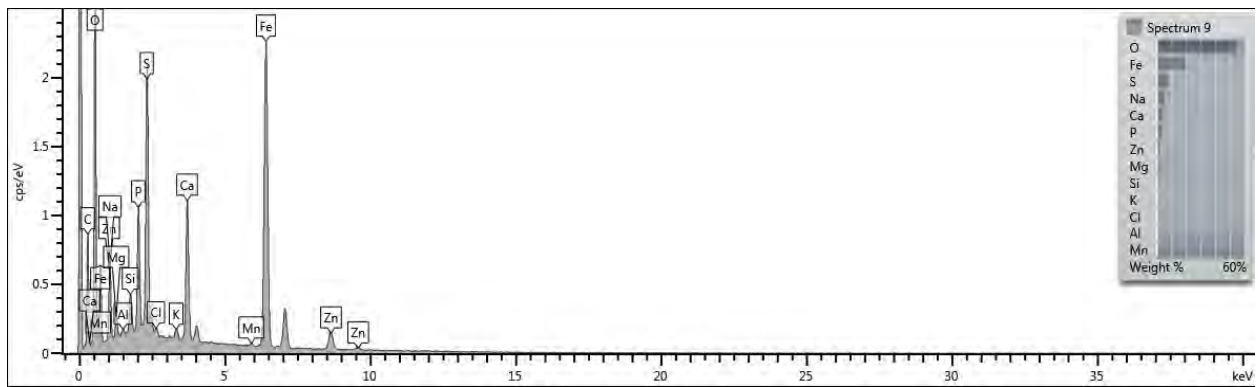
Figure 56 Representative EDS spectra from the inside surface of specimen E-017-1 near the rupture edge.

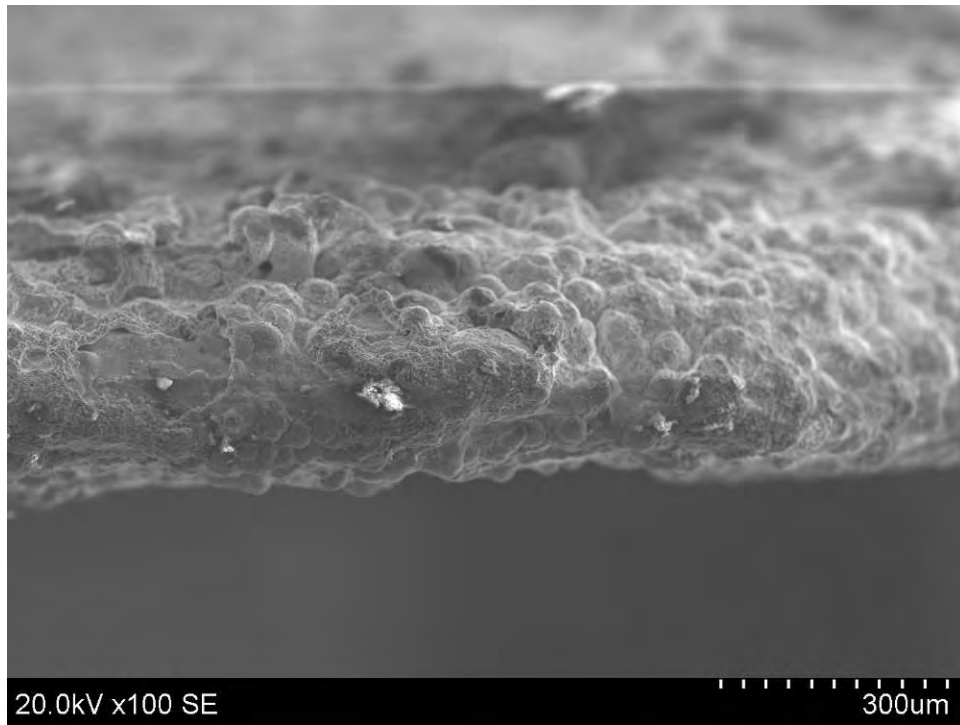
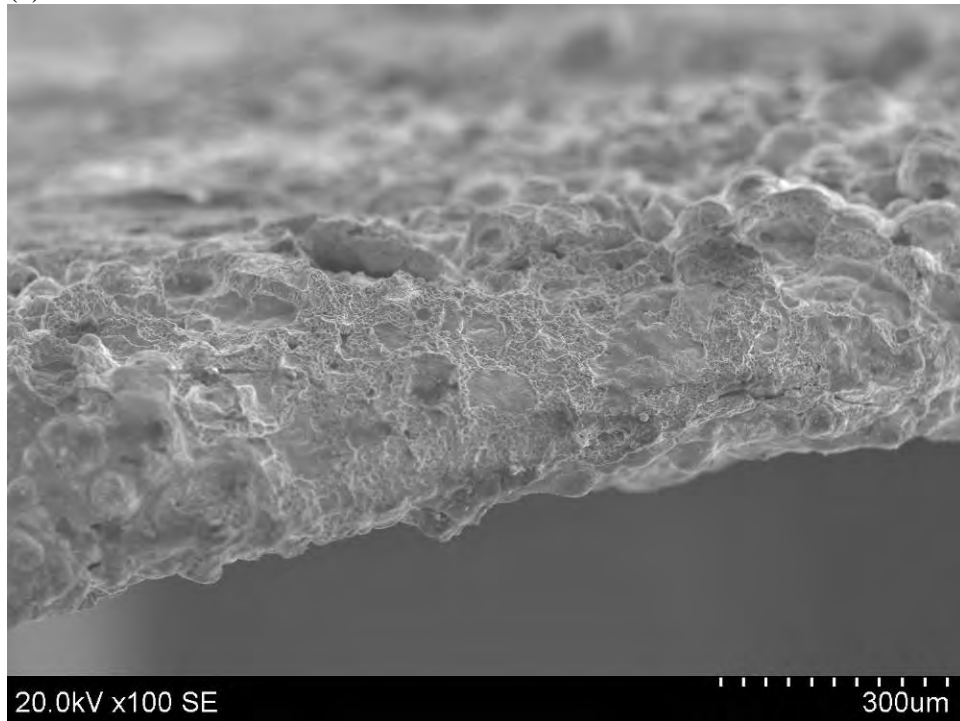
Figure 58 SEM micrographs of the rupture edge of sample E-017-1 after cleaning in Micro90™ with ultrasonic agitation.
