METALLURGICAL EVALUATION OF SAMPLES FROM THE CHEVRON U.S.A. INC., RICHMOND #4 CRUDE UNIT 8-INCH AND 12-INCH 4-SIDECUT PIPING INVOLVED IN THE AUGUST 6, 2012, HYDROCARBON RELEASE AND FIRE

Prepared for: The Chemical Safety and Hazard Investigation Board (CSB)

Report No. 5004.7920 B

February 11, 2013

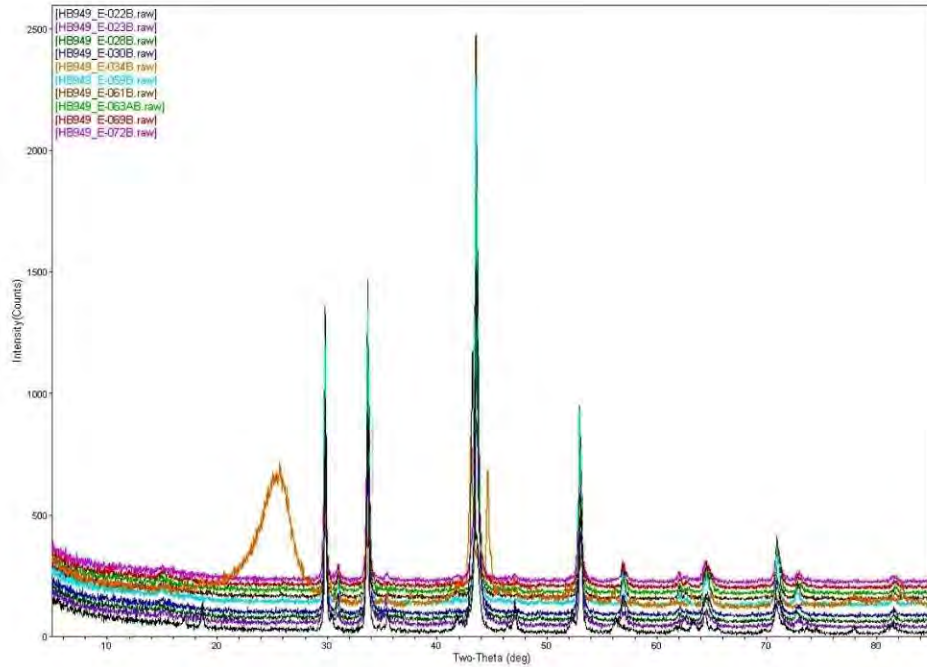
Figure 1: Comparison for ten samples

Figure 1 show the XRD data overlaid from the ten samples. The intensity has been offset for clarity. While many of the peaks are similar, there are significant differences between samples. In particular, the broad peak near 25 degrees two-theta in sample E-034B indicates that this sample is composed of a mixture of crystalline and amorphous materials.

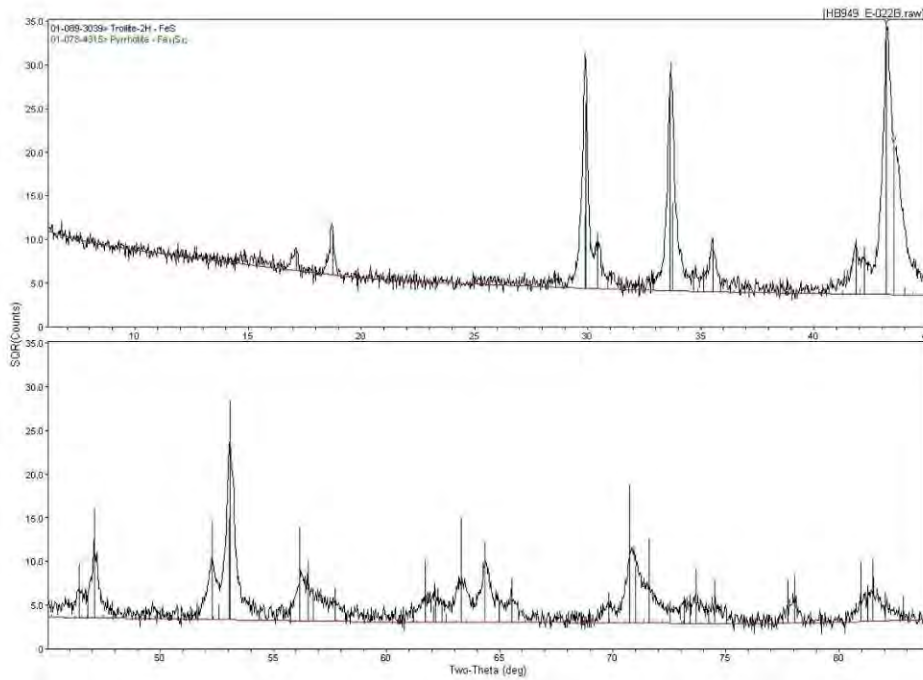
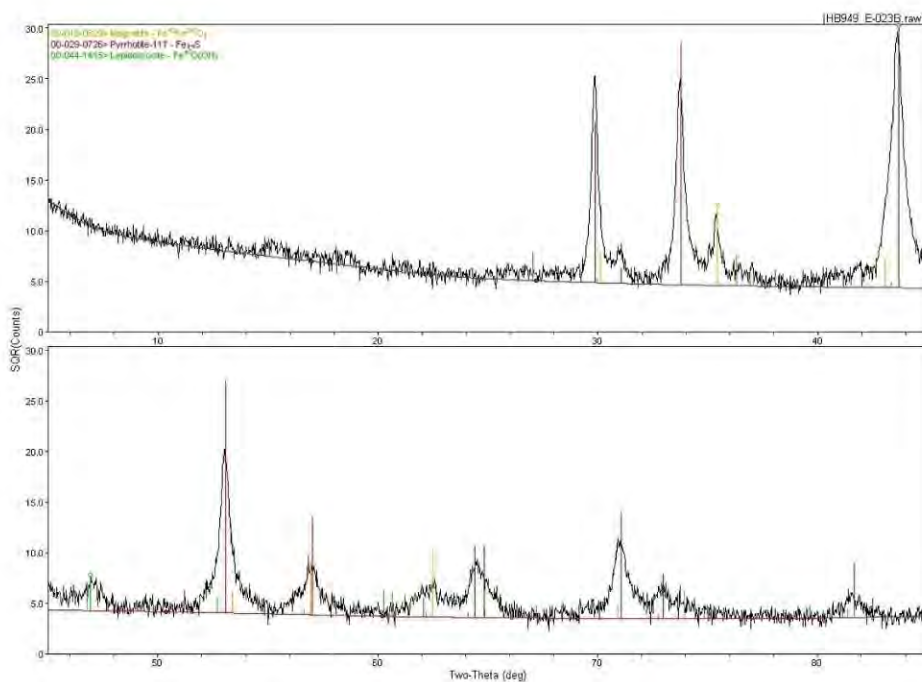
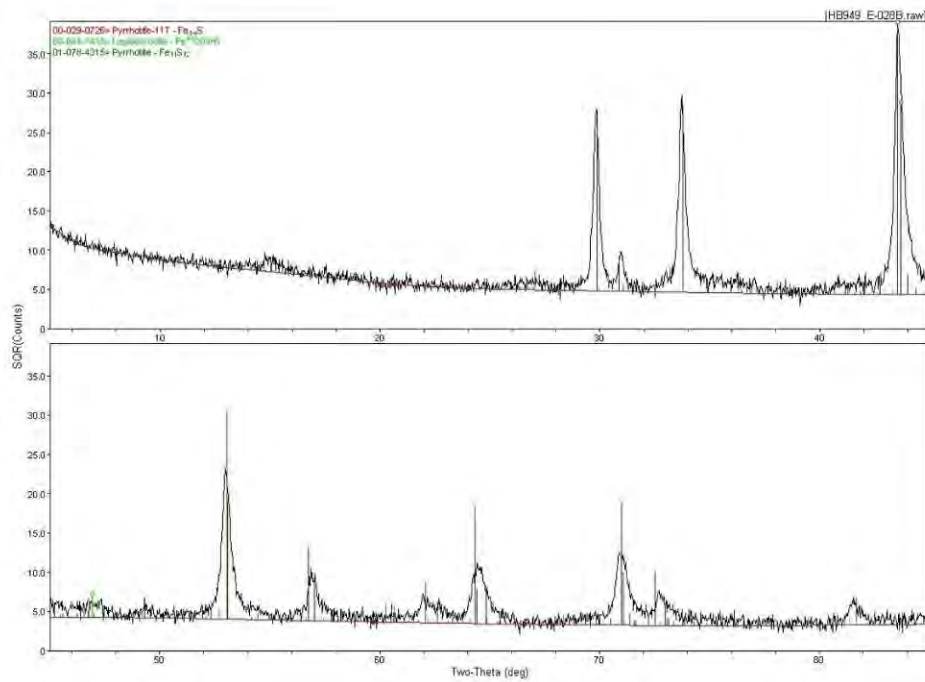
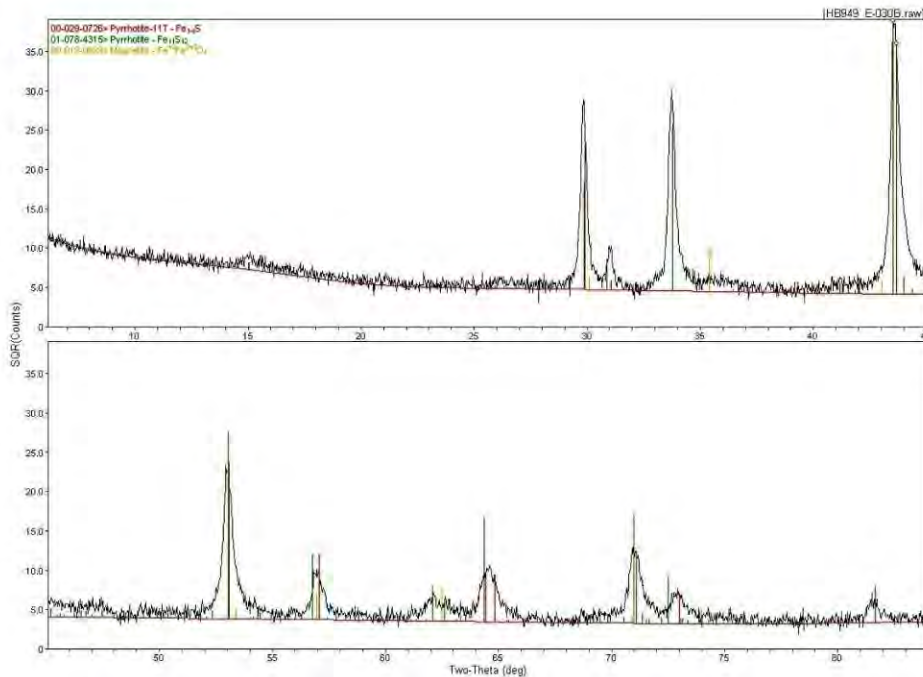
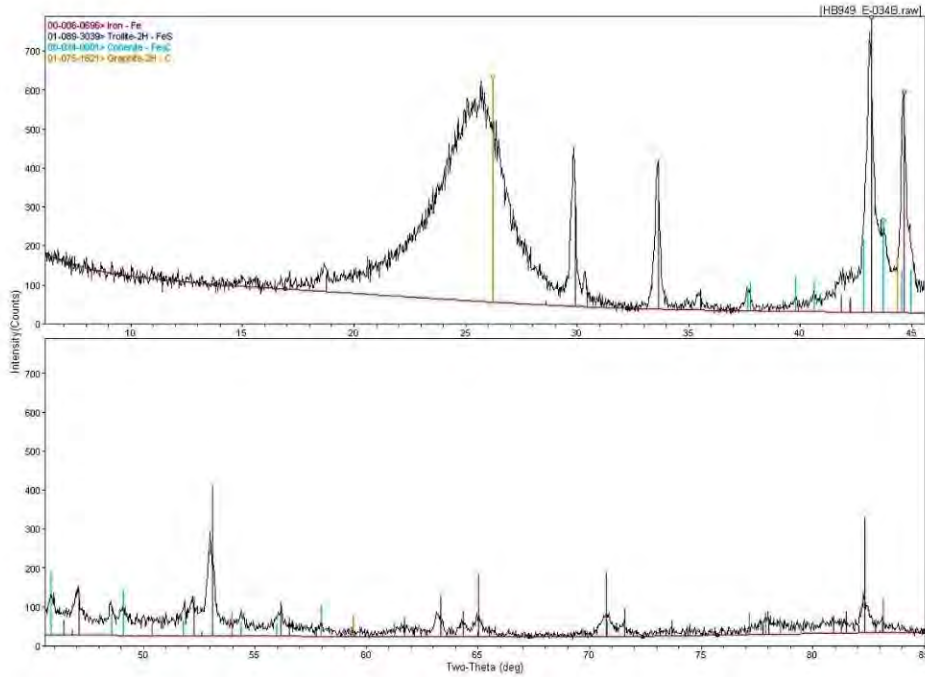
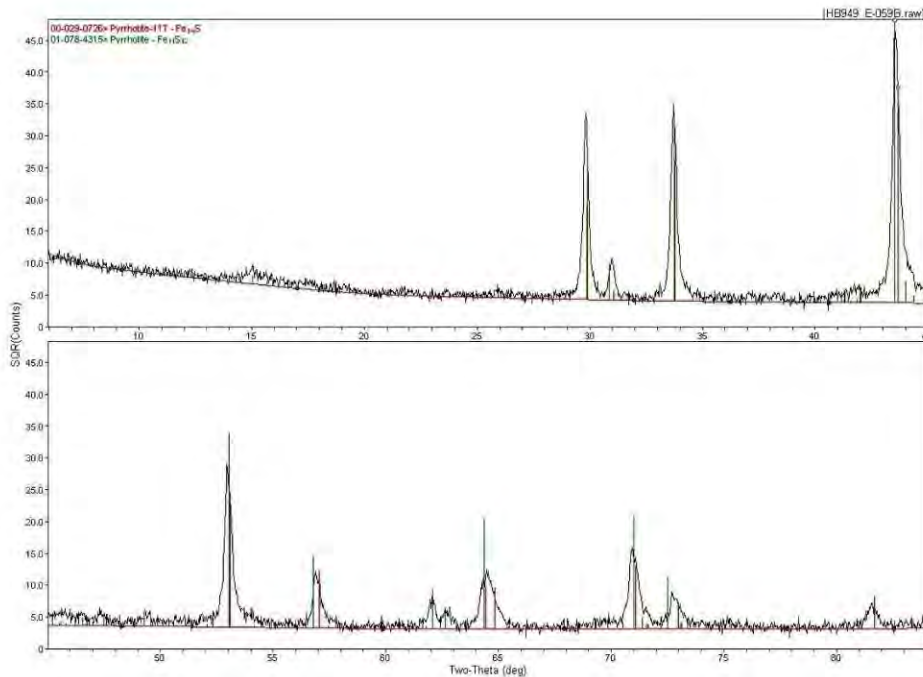
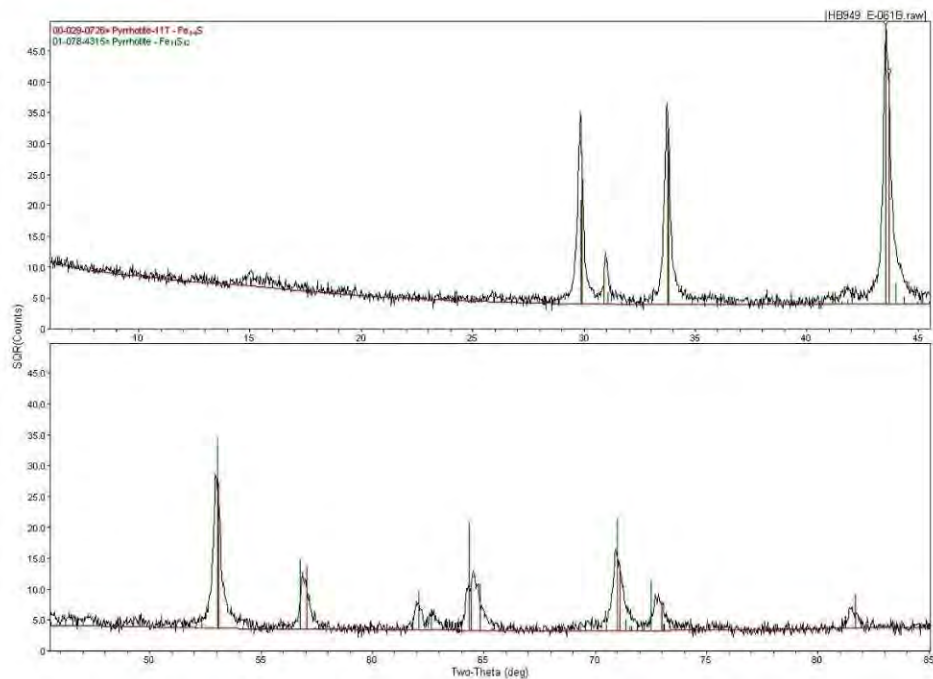
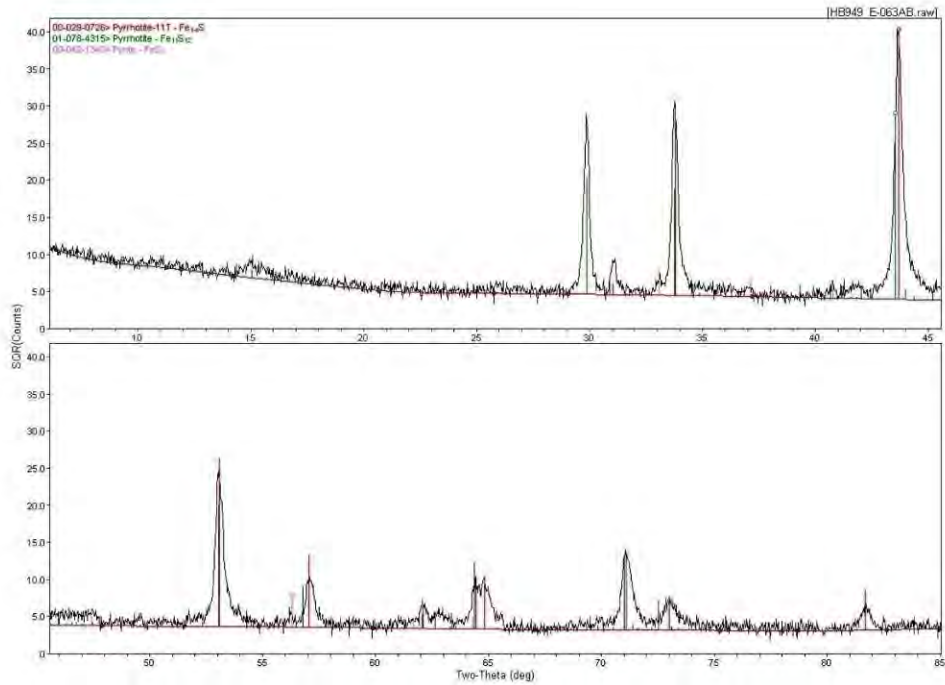
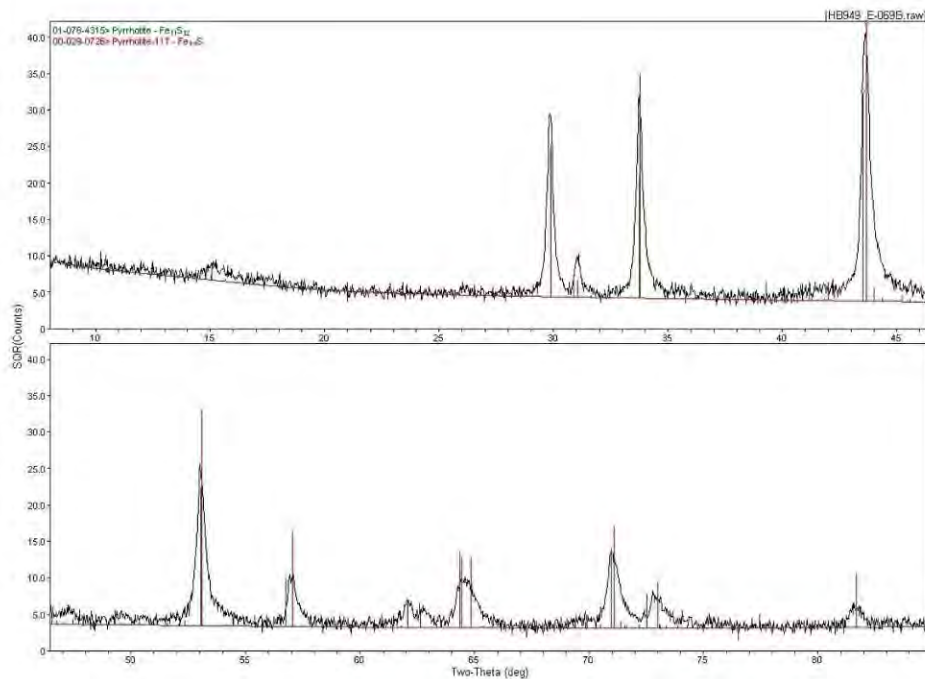
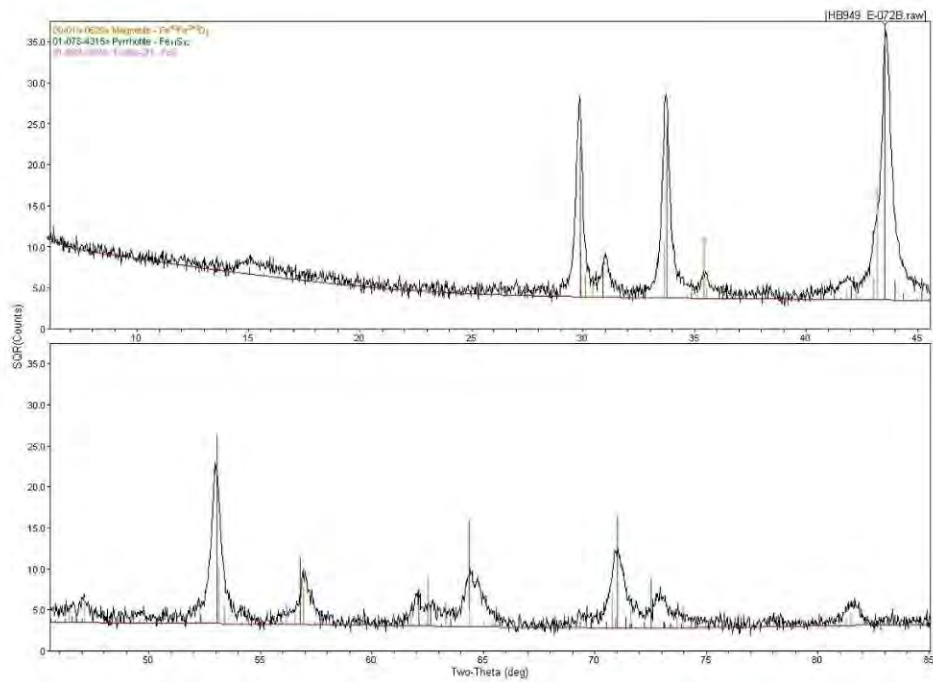
Figure 2 to Figure 11 show the best matches for all ten samples after comparing the background-subtracted experimental data to the ICDD/ICSD diffraction database. Most of the samples consist of a mixture of the monoclinic Pyrrhotite-6C and hexagonal Pyrrhotite-11T. The hexagonal Troilite-2H (FeS) was only observed in samples E-022B, E-034B and E-072B. Cohenite (Iron Carbide) and Iron was present as minor phases in sample E-034B. Note that the broad peak near 25 degrees two-theta in sample E-034B could be due to Graphite. However, this phase could not agree well with the reference pattern. It is more likely that this phase is an semi-amorphous phase similar to pyrolytic carbon. Trace amounts of Magnetite were detected in samples E-023B, E-030B and E-072B. Lepidocrocite and Pyrite trace phases were also matched in few samples, but these are considered speculative matches because they were based on only a few weak peaks.

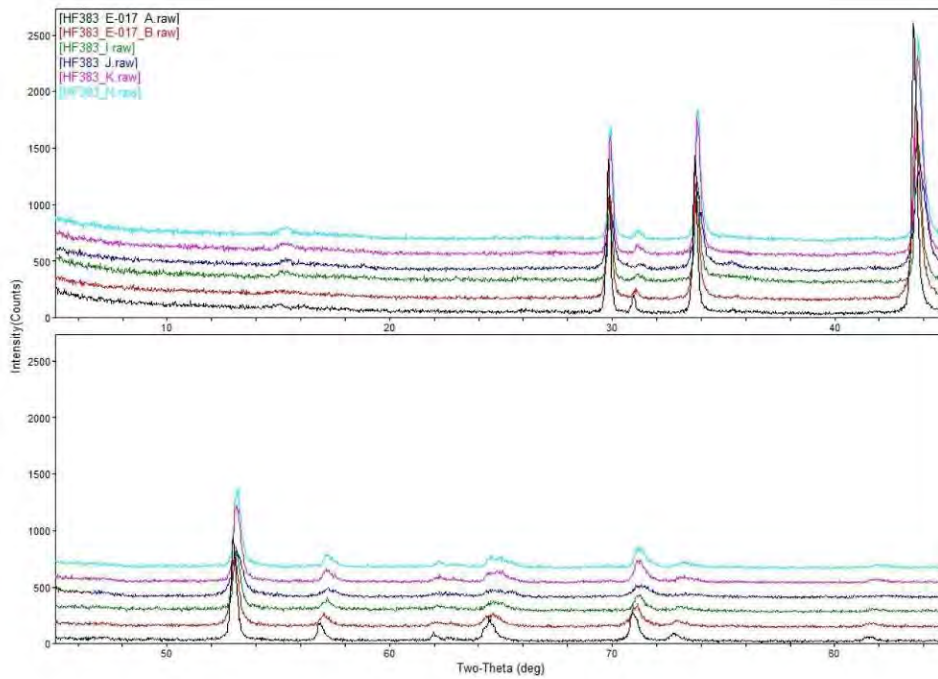
Figure 1 – Comparison of data from all six samples

Figure 1 compares the data from all six samples. While the samples are all quite similar, there are differences in peak positions and widths, especially at higher angle.

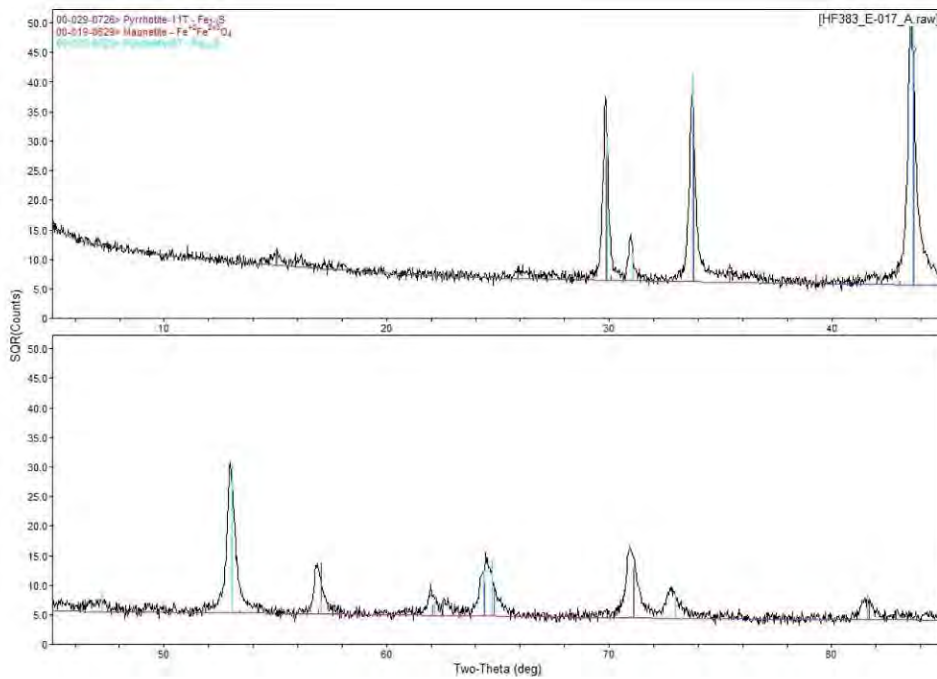
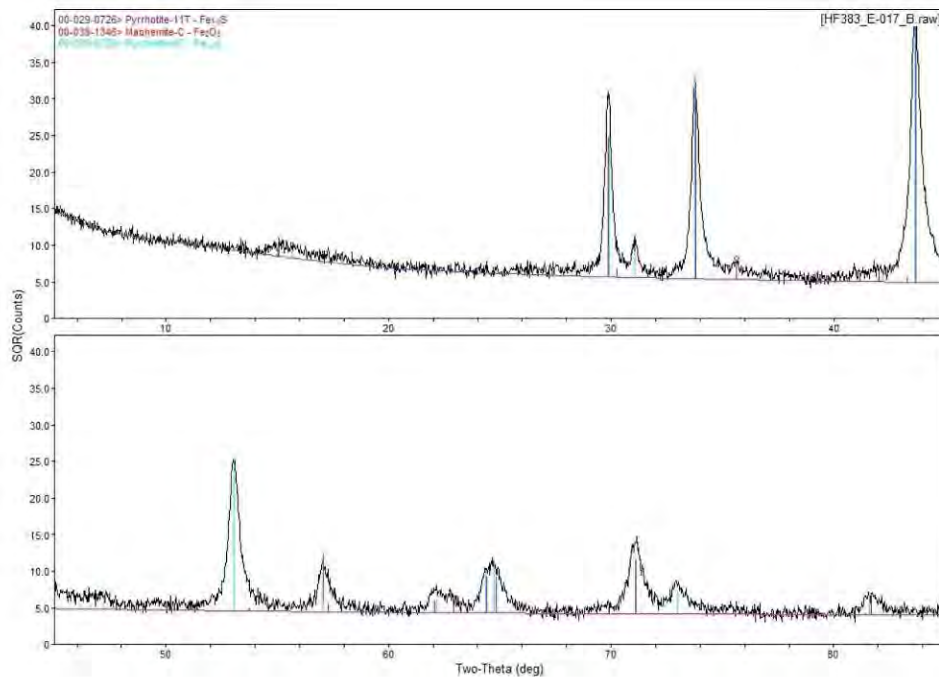
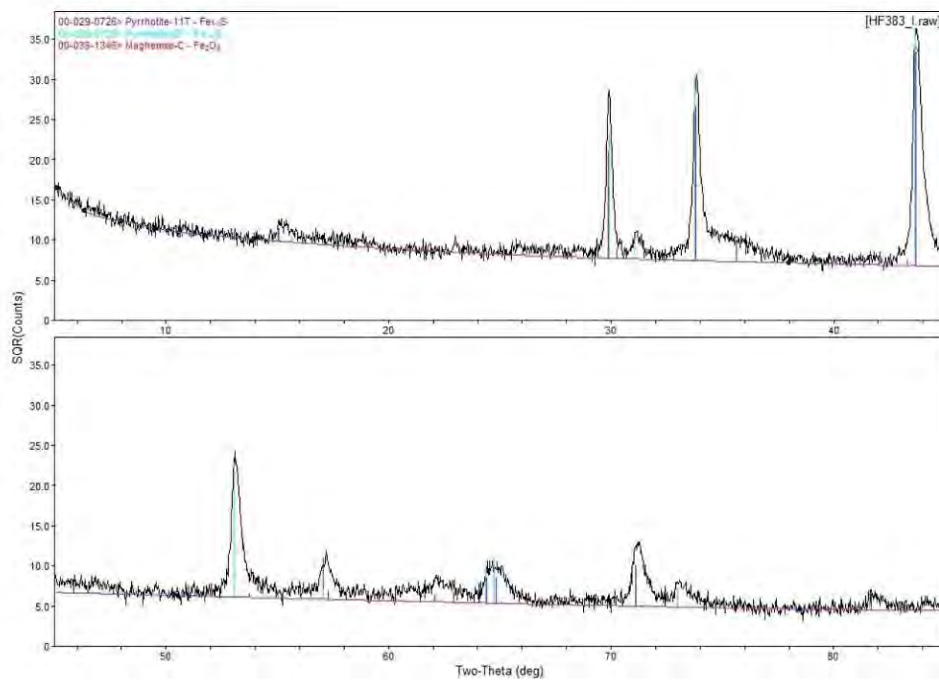
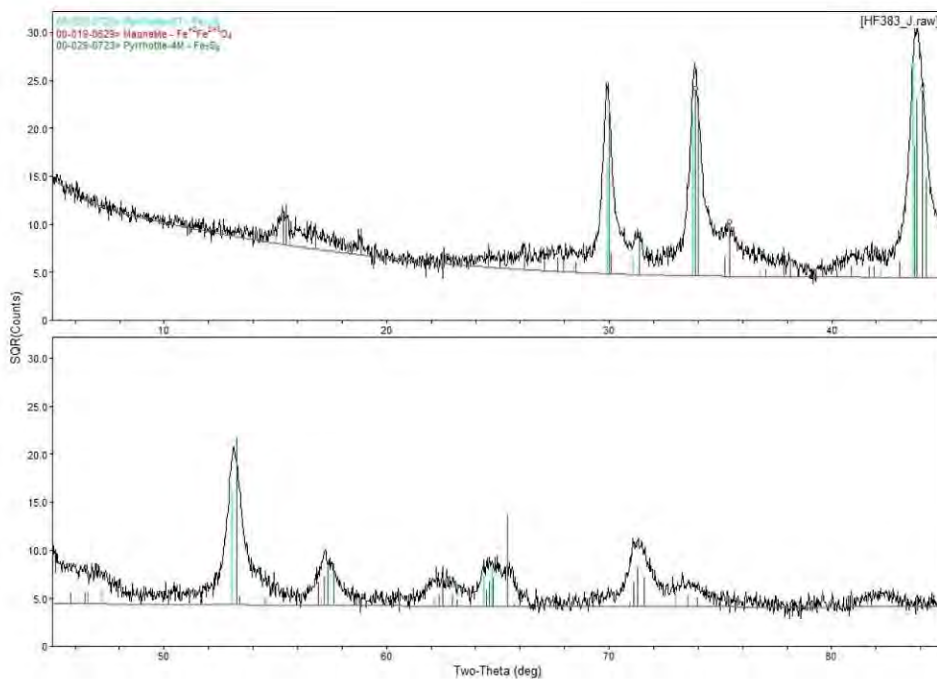
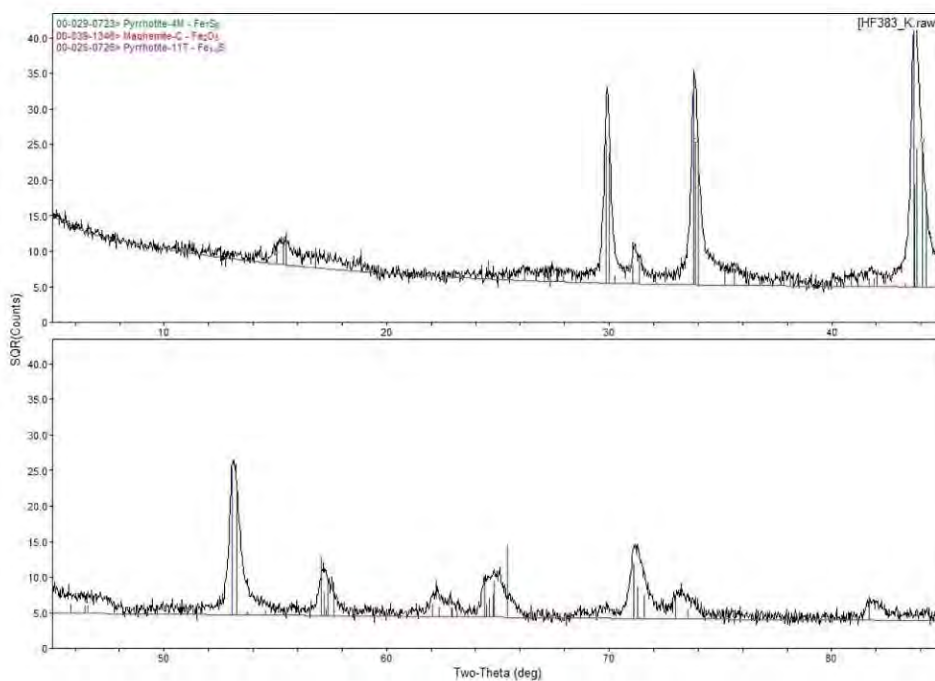
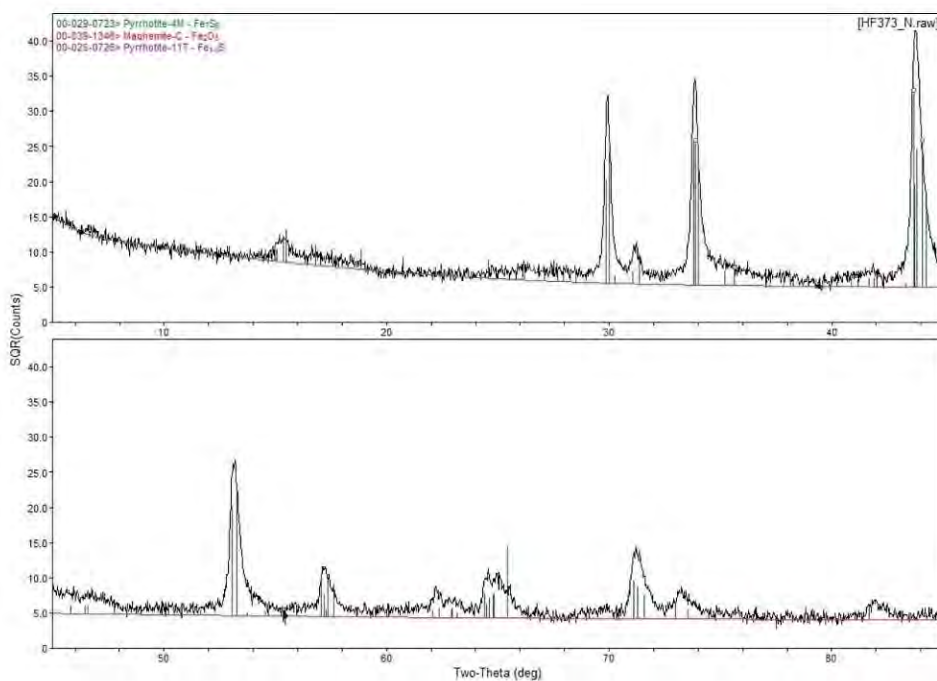
Figure 2 - Figure 7 shows the best matches obtained by comparing the background-subtracted raw data from each sample with the ICDD/ICSD powder diffraction database. Note that the data is plotted with a square-root intensity scale to emphasize the weaker peaks. All of the major phases are different polymorphs of the Iron Sulfide mineral Pyrrhotite. In addition, trace amounts of either Magnetite (Fe₃O₄) or Maghemite (Fe₂O₃) are detected in most of these samples. There are not enough diffraction peaks observed to differentiate these two similar trace phases so which phase was matched was based solely on the position of the strongest peak near 36 degrees 2-Theta. Note that XRD is sensitive to crystal structure, not to elemental composition so it is possible that the actual composition of each phase is somewhat different than listed in the table above. In particular, the experimental peaks do not exactly match the reference peak positions. This may be due to either the incorporation of Manganese into the Iron Sulfide lattice or to a difference in Fe:S ratio.
