**Silver Eagle Refinery
Explosion Investigation:
Metallurgical Analysis**

Dan Tillema, P.E.
Chemical Incident Investigator
U.S. Chemical Safety & Hazard Investigation Board

June 19, 2013

0907487.000 A0F0 0613 RPT1

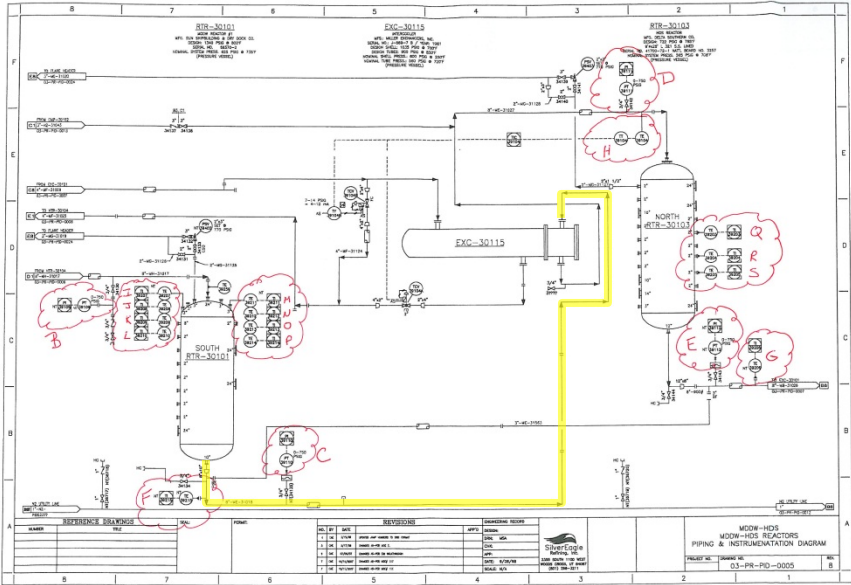
Figure 1. Process and instrumentation diagram (P&ID) of the MDDW reactors.

Following the sudden rupture of the R30101 exit pipe, high pressure gas was released from both ends of the ruptured pipe. These were a 10-inch diameter pipe connected to the bottom of R30101 (Figure 13) and a longer length of 10-inch diameter pipe connected by a flange to an eight-inch diameter stainless steel pipe that fed heat exchanger EXC 30115 (highlighted in Figure 1).

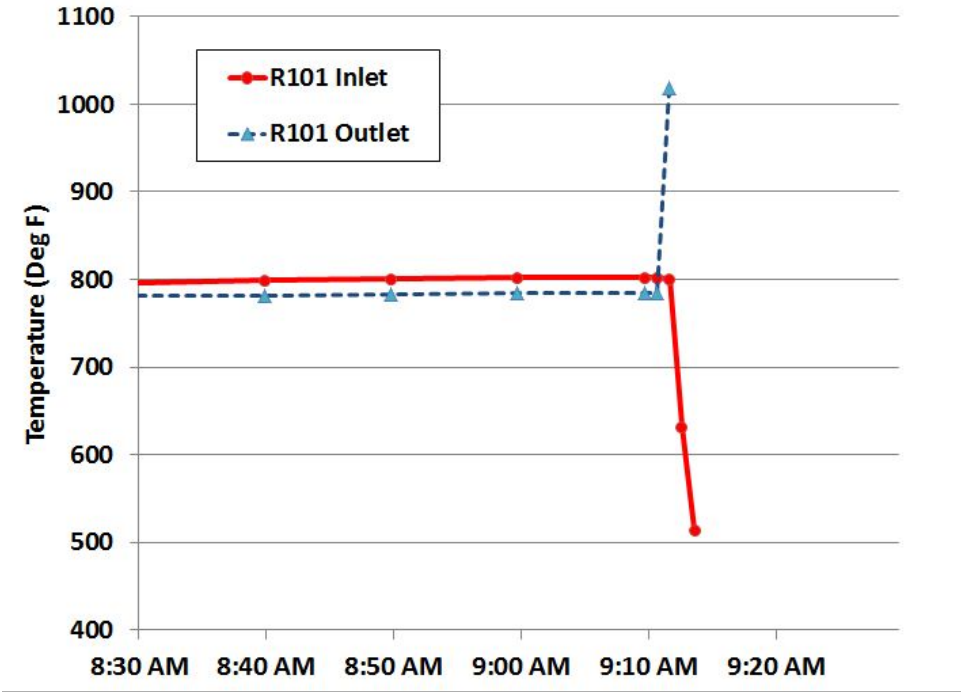
Figure 4. R30101 inlet and exit temperatures (detail).

The composition of the gases is listed in Table 1 below. The primary species was hydrogen (81% by volume), followed by C1 or methane (9.5%), and small amounts of other light hydrocarbons and nitrogen. Temperature (Figure 4) and pressure measurements in the MDDW unit (Figure 6) show conditions at the discharge of R30101 were 642 psig and 785°F.

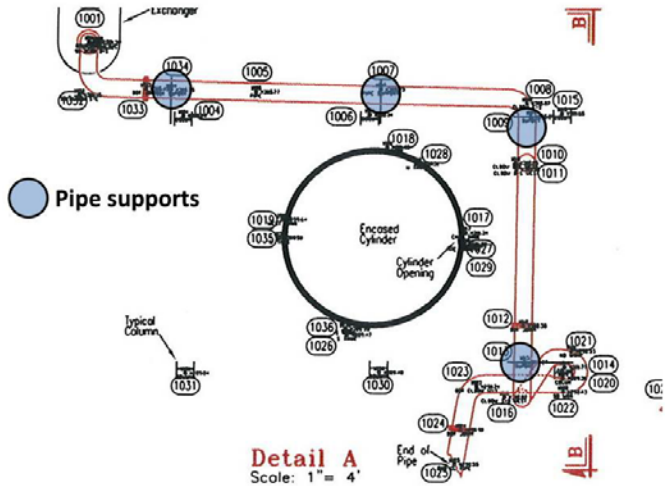
Figure 17. Plan view of surveyed pipe.

pipe ran through an opening in the skirt around the base of R30101, labeled as Point #1029. The rupture occurred under the skirt around R30101. A plan (overhead) view of the pipe is shown in Figure 17.

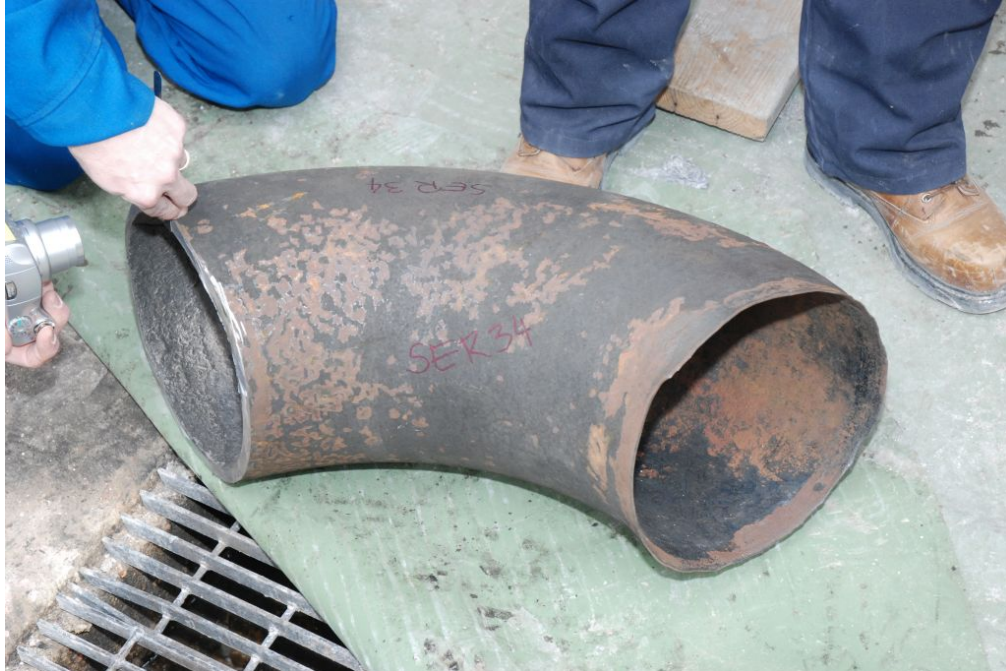
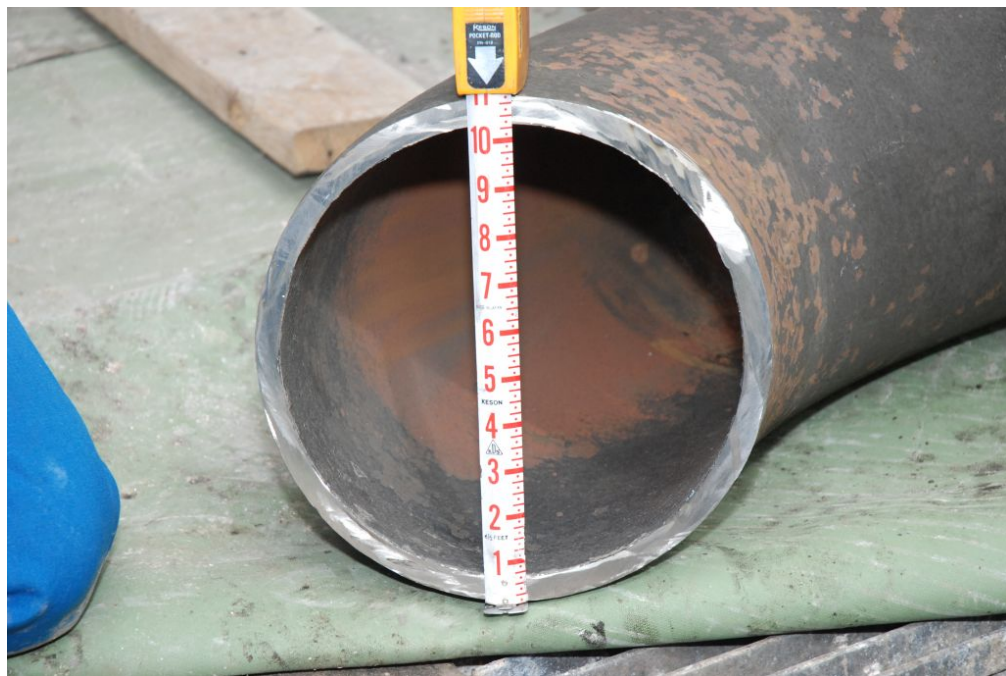
Figure 20. Images of the "SER 34" ruptured segment after sectioning and removal in March 2010.

The upstream end of the fractured segment still attached to the bottom of the reactor was labeled “SER 34” and sectioned for removal from the site, as shown in Figure 19 and Figure 20. The downstream end of the fractured segment that had wrapped around a reactor support beam was labeled “SER 35” and also sectioned for removal from the site, as shown in Figure 21 with the sectioning location through the eight-inch-diameter pipe indicated. Prior to sectioning, fluid remaining in the piping was drained through the valve designated “SER 36” and stored in a glass bottle (Figure 22).

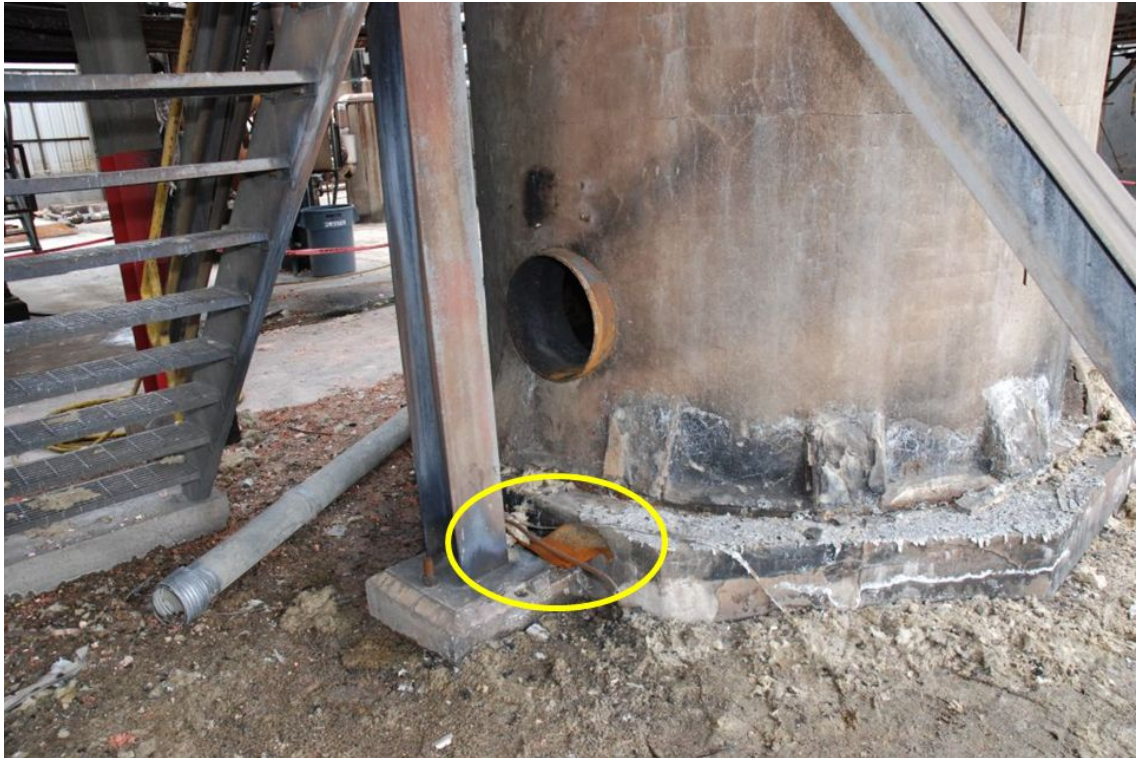
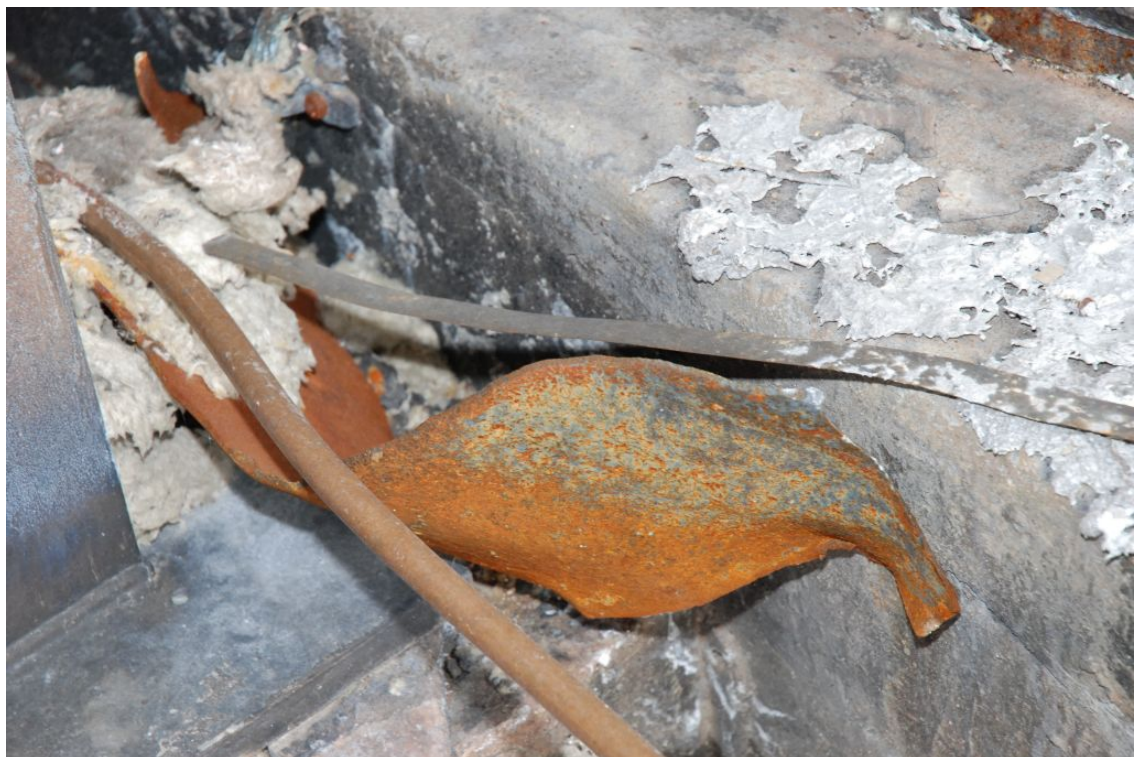
Figure 23. Images of the "SER 27" item as-observed outside of the reactor skirt in March 2010.

Two additional items were found near the fractured sections SER 34 and SER 35 that appeared to be pieces of the ruptured piping segment. Outside of the reactor skirt, a piece of steel approximately 20 inches in length was found (Figure 23). This item was labeled “SER 27” and retained for further examination and analysis (Figure 24). Inside of the reactor skirt, a piece of

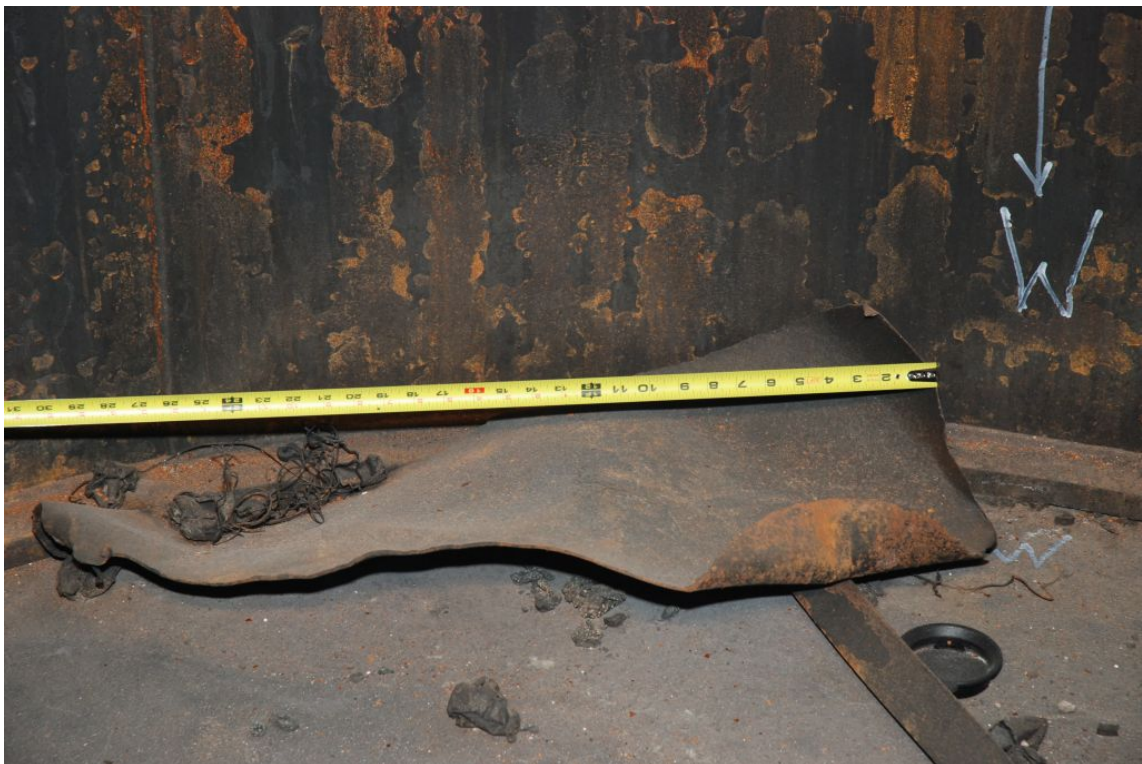
Figure 25. Image of the "SER 28" item as-observed inside the reactor skirt in March 2010.

steel approximately 32 inches in length was found (Figure 25). This item was labeled “SER 28” and also retained for further examination and analysis. Additional debris items found inside the reactor skirt were also collected and retained.

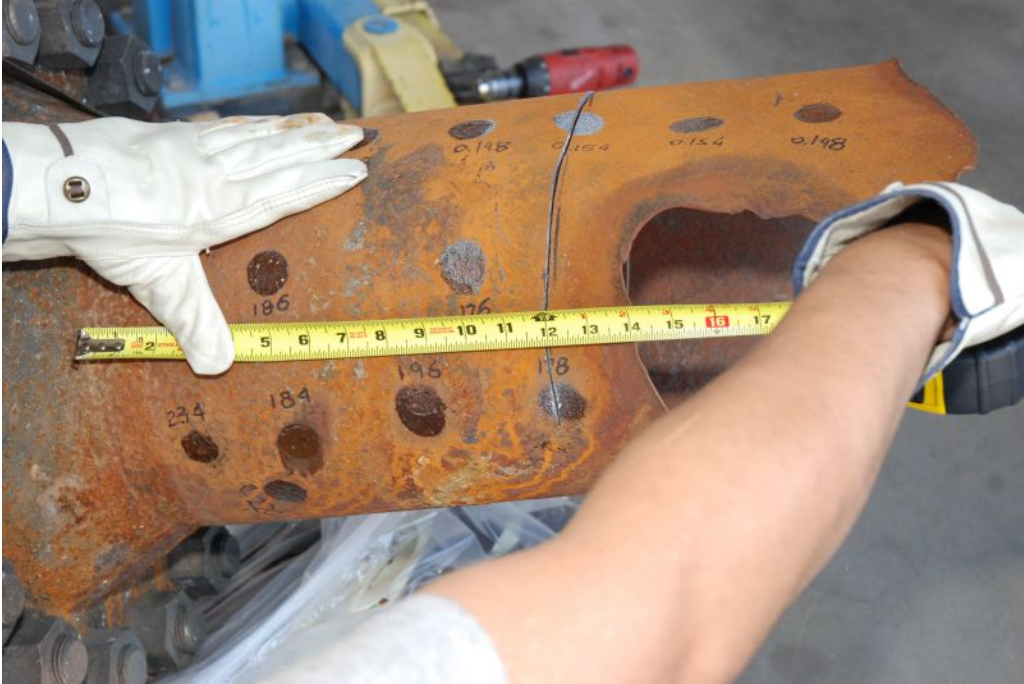
Figure 27. The fractured end of SER 35 during sectioning in August 2010.

Ultrasonic thickness (UT) testing on the fractured end of the SER 35 segment was conducted at locations along the length and around the circumference of the ruptured pipe. Thickness measurements ranged from 0.120 to 0.244 inches (Figure 26). The fractured end was then sectioned from the remaining segment approximately 12 inches upstream of the flange shoulder with a handheld reciprocating saw (Figure 27).

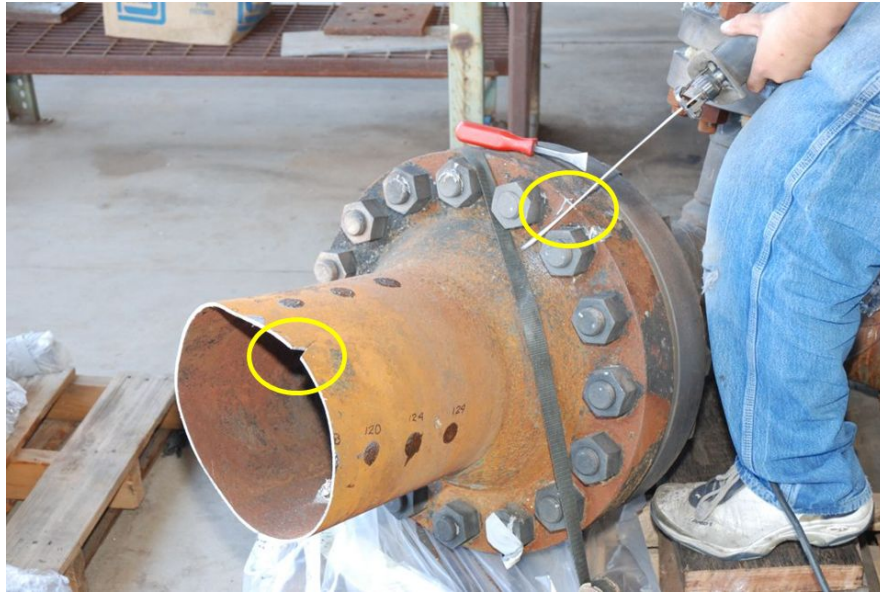
Figure 29. Image showing quantitative chemical analysis samples being sectioned from the 10-inch pipe and flange on SER 35 (circled) in August 2010.

Samples for quantitative chemical analysis were sectioned from the upstream field-cut end of the SER 34 segment, the lab-cut end of the SER 35 segment, the SER 35 segment flange, and the downstream eight-inch-diameter field-cut end of the SER 35 segment. All four samples were removed using a handheld reciprocating saw (Figure 29).

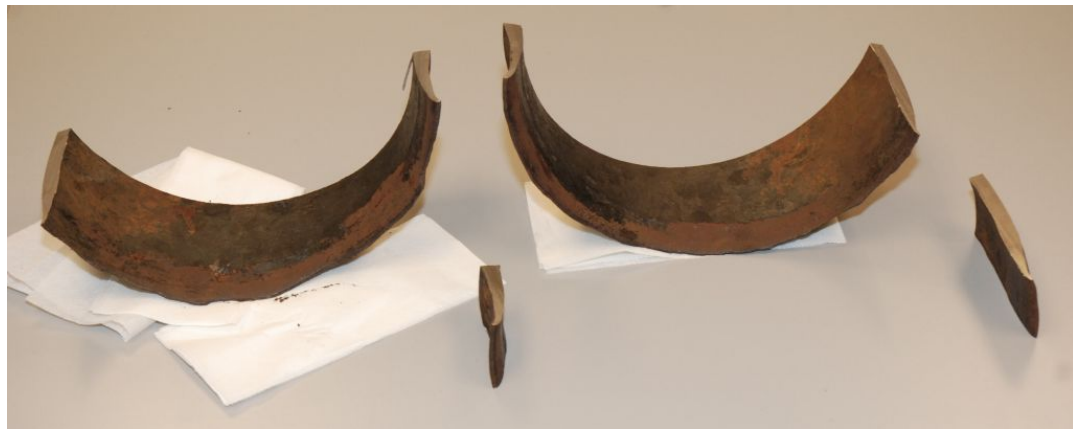
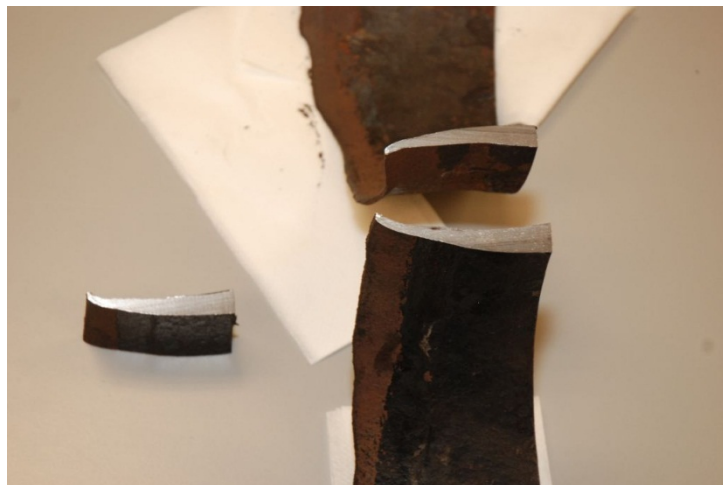
Figure 30. Images showing sectioning of the SER 34 fracture surface for metallographic and quantitative chemical analyses in August 2010.

Examination of the SER 34 fracture area revealed that the fracture occurred just downstream of the circumferential weld between the elbow and the straight segment. Cross-sectional specimens containing the weld and the fracture surface were then cut for metallographic and quantitative chemical analysis (Figure 30). The chemical analysis samples were sectioned from the 6 o'clock location and labeled "6-1" (the upstream elbow segment), "6-2" (the
