# Investigation Report

Published: December 2022

## SAFETY ISSUES:

On November 27, 2019, a series of explosions occurred at the TPC Group (TPC) Port Neches Operations (PNO) facility, located in Port Neches, Texas, after highly flammable butadiene released from the process unit. The explosions caused a process tower to propel through the air and land within the facility, other process towers to fall within the unit, extensive facility damage, and fires that burned for more than a month within the facility. The butadiene unit was destroyed, forcing the facility to cease butadiene production operations indefinitely. As of the date of this report, the butadiene production operations remain shut down. Two TPC PNO employees and a contractor reported minor injuries, and according to media reports, at least five local residents reported injuries. Officials in Jefferson County, Texas declared the county to be in a state of disaster and issued a mandatory four-mile radius evacuation order that affected people in the cities of Port Neches, Groves, Nederland, and a portion of Port Arthur. The explosion also led to reduced usage of the Sabine-Neches Waterway, the nation's third largest waterw

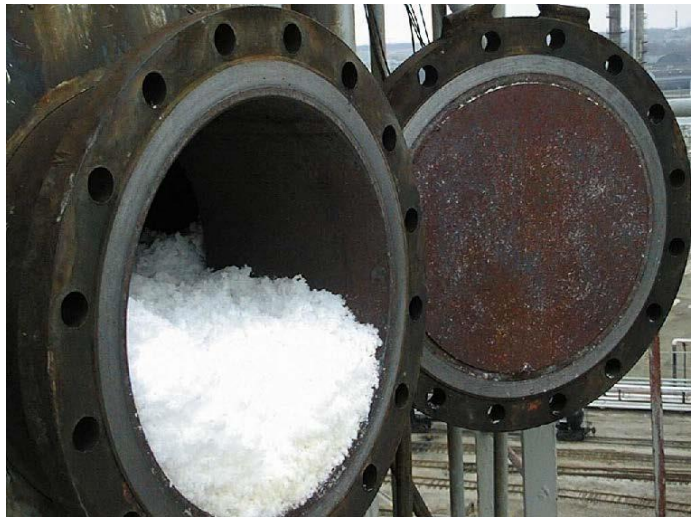
Equipment that handles high-purity butadiene (typically > 80% purity) is highly susceptible to the development of a potentially hazardous substance called “popcorn polymer” [4, p. 32].<sup>a</sup> Popcorn polymer can be hazardous because when popcorn polymer accumulates inside equipment, its continued growth and expansion can generate high pressures that may ultimately rupture equipment [4, p. 32]. The physical appearance of popcorn polymer resembles “cauliflower or popcorn [7, p. 32].” Popcorn polymer can also “take the form of glassy, friable crystals; fluffy, needle-like crystals; or hard, clear gel [4, p. 32].” **Figure 4** shows an example of popcorn polymer from an undisclosed facility.<sup>b</sup>

**Figure 4.** Popcorn polymer in a manway from an undisclosed facility (Credit: International Institute of Synthetic Rubber Producers Inc. [8, p. 261])

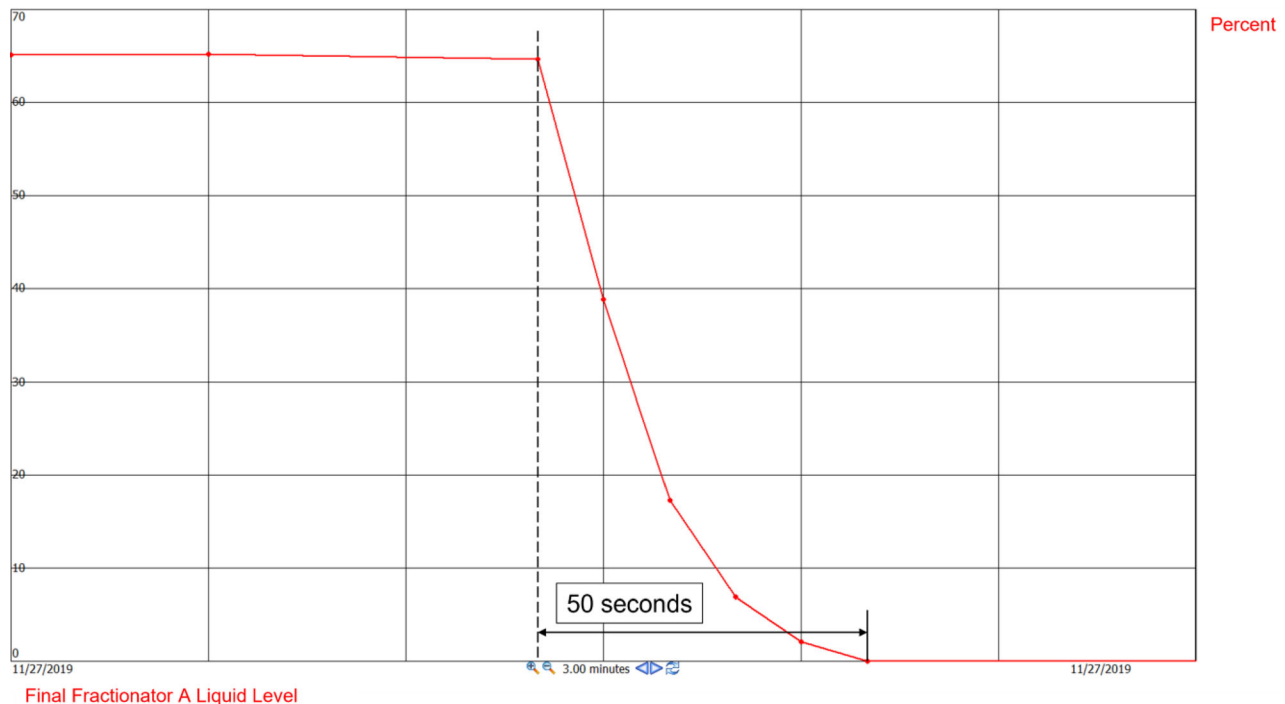
A loss of containment event then occurred as a result of the rupture, causing the liquid level in the Final Fractionator A to drop rapidly from its operating level. The CSB calculated the Final Fractionator A liquid volume at the time of the initial level drop to be approximately 6,000 gallons.<sup>d</sup> Process data indicate that the liquid, which was primarily butadiene, fully emptied from the Final Fractionator A in less than a minute (**Figure 10**). The liquid butadiene vaporized upon release<sup>e</sup> and formed a flammable vapor cloud.

**Figure 10.** Process data trend showing the liquid level (in percent) in the Final Fractionator A at the time of the incident. (Credit: CSB)

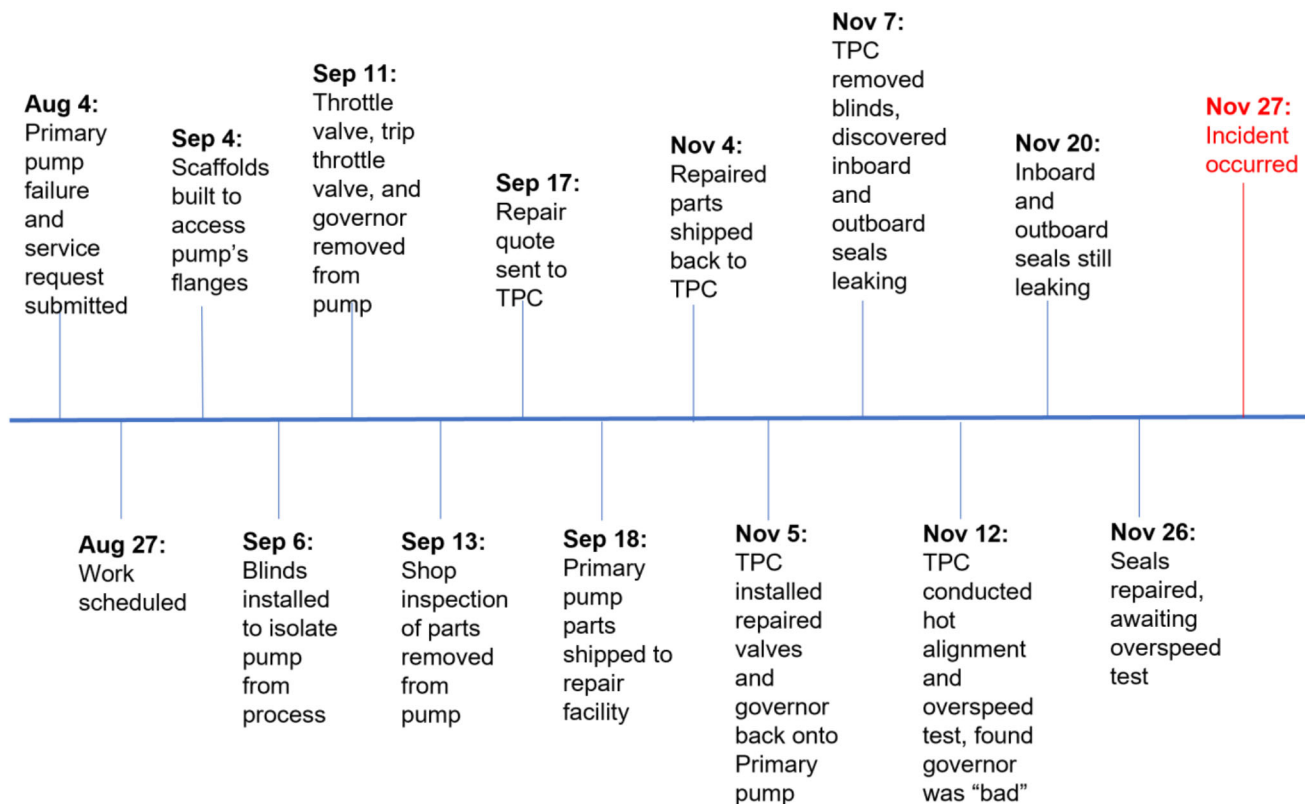
The CSB found that although TPC PNO originally established the maintenance priority for the out-of-service Primary Pump as “urgent,” on August 5, 2019, TPC PNO changed the priority of the pump repair to “routine.” TPC PNO indicated to CSB investigators that the Primary Pump repair was not classified as “emergency” or “urgent” due to the existence of the Spare Pump. One TPC PNO employee stated that the repair urgency was not elevated because TPC PNO did not “have the...parts to repair it.” The employee also stated the following about the operation of the spare pump while the primary pump was out of service: “If you lost the common spare [i.e., the Final Fractionator A/B Spare Pump, which was also a spare for an adjacent absorber column], then the whole unit’s down. Then your production’s down. Then you know, every...everything is down.” The timeline of the Final Fractionator A/B Primary Pump maintenance activities is depicted below in **Figure 21**.

**Figure 21.** Primary Pump repair timeline. (Credit: CSB)

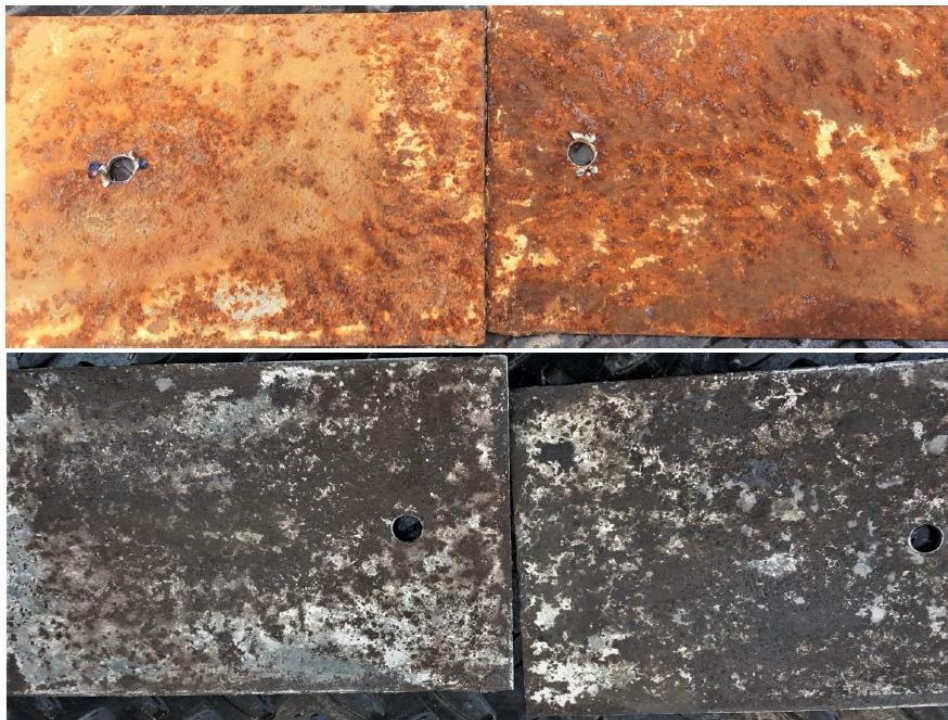
TPC PNO told the CSB that the TPC PNO facility began passivating equipment called butadiene finish tanks in May 2019. TPC PNO also completed passivating the overhead condensers for Final Fractionator A in June 2019. However, other equipment within the unit were not yet passivated, including both the Final Fractionator A and B columns and the Final Fractionator A overhead accumulator, which were scheduled to be passivated during the next outage. **Figure 25** shows photos of the Final Fractionator A, and **Figure 26** shows photos of the Final Fractionator A overhead accumulator, both taken during TPC PNO’s 2017 turnaround. Both figures show rust formed on the steel equipment walls, which is known to contribute to the formation of popcorn polymer. **Figure 27** shows photos of passivation coupons that were used to determine the efficacy of the passivation operation for the Final Fractionator A overhead condensers. This figure also illustrates how effective passivation can be for neutralizing rust.

**Figure 27.** Photos showing passivation coupons that were used to determine the efficacy of the passivation operation for the Final Fractionator A overhead condensers. Before passivation (top) and 19 hours after passivation (bottom). (Credit: TPC)

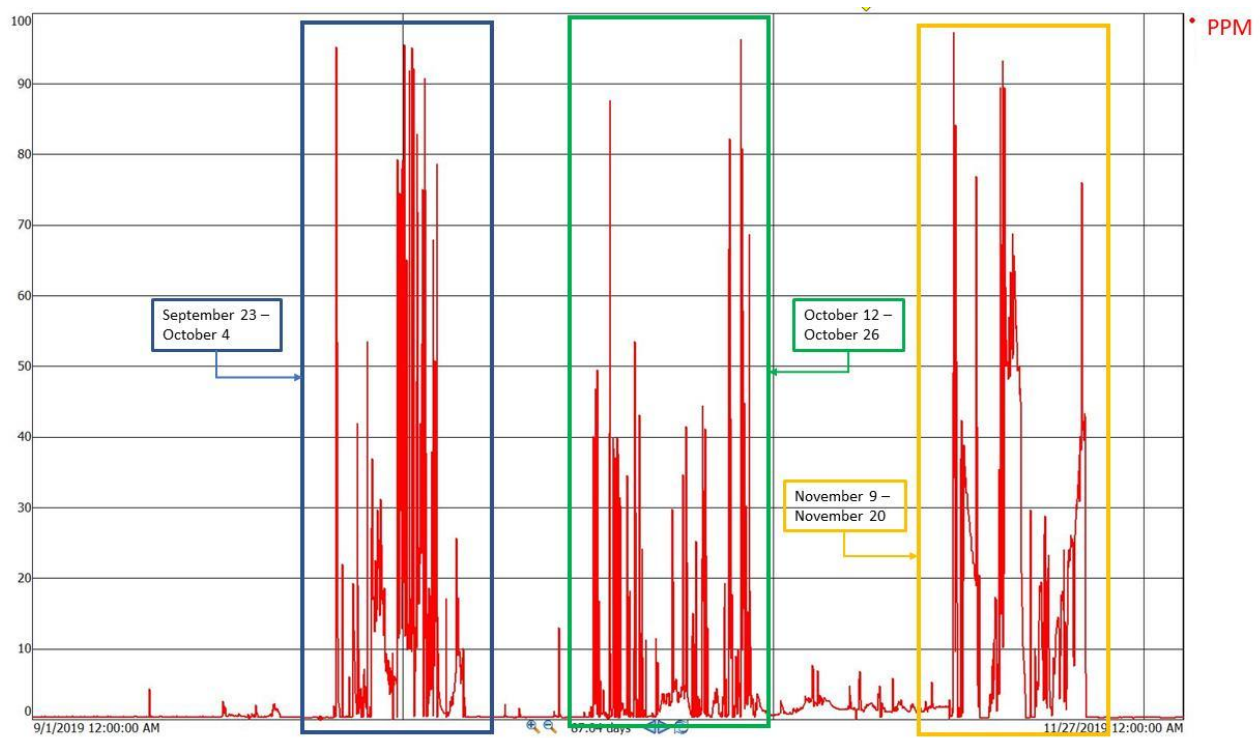
TPC PNO measured the oxygen concentration in the Final Fractionator using an analyzer attached to the vapor space of its reflux accumulator (**Figure 28**). The TPC PNO Tower Profile procedure specified a maximum oxygen concentration of 5 ppm.<sup>a</sup> This procedure further stated that manually venting the reflux accumulator “can be used if [oxygen] content is high in the overhead [accumulator],” though TPC PNO relied on continuous condenser venting to ensure oxygen removal. Between September 1, 2019, and the time of the incident, this analyzer indicated elevated oxygen concentration levels greatly exceeding the 5 ppm maximum, at some points reaching over 90 ppm, during three separate long-term periods (**Figure 29**).

**Figure 29.** Process trend data graph showing the oxygen concentration levels (in ppm) in the Final Fractionator reflux accumulator from September 1, 2019, until the time of the incident. (Credit: CSB)

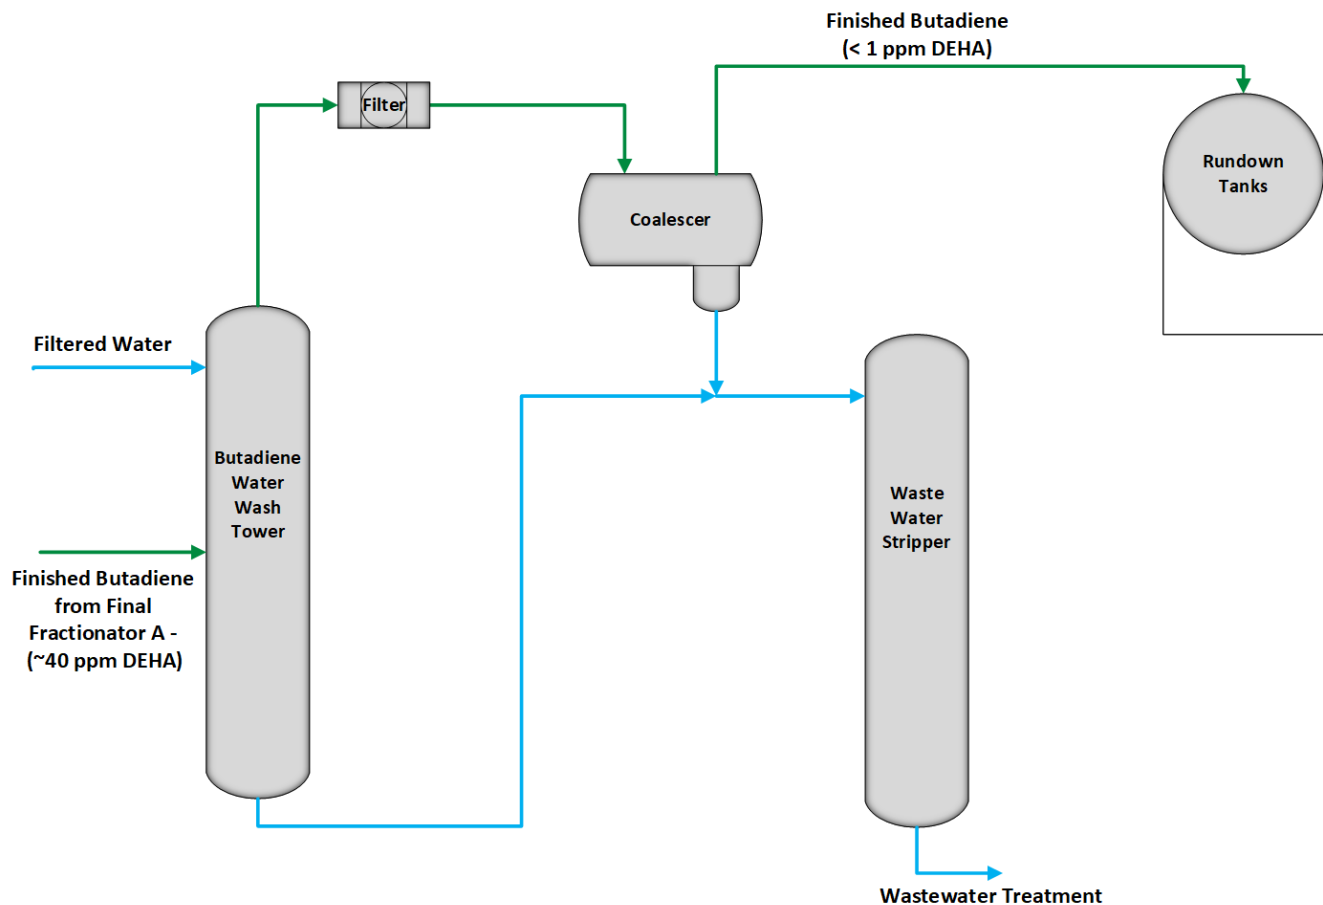
The TPC PNO site has historically experienced popcorn polymer formation at its facility. With some rare exception,<sup>a</sup> the bulk of the facility's popcorn polymer was removed from the equipment depicted in **Figure 31**, which included the butadiene water wash tower and its associated equipment (filter and coalescer), the waste

water stripper, and the finished butadiene storage tanks (also called “rundown” tanks). Since 2011, 95.6%<sup>a</sup> of all disposed popcorn polymer, nearly 20 tons annually, came from the areas shown in **Figure 31**.

**Figure 31.** Flow diagram depicting the butadiene process flow through the butadiene water wash tower to the rundown tanks (until April 2019). (Credit: CSB)

In May 2019, TPC PNO noted an increase in strainer cleanings in the rundown tanks just downstream of the bypassed butadiene water wash tower (**Figure 31**). In a document titled “Current Fouling Threats,” an employee wrote:

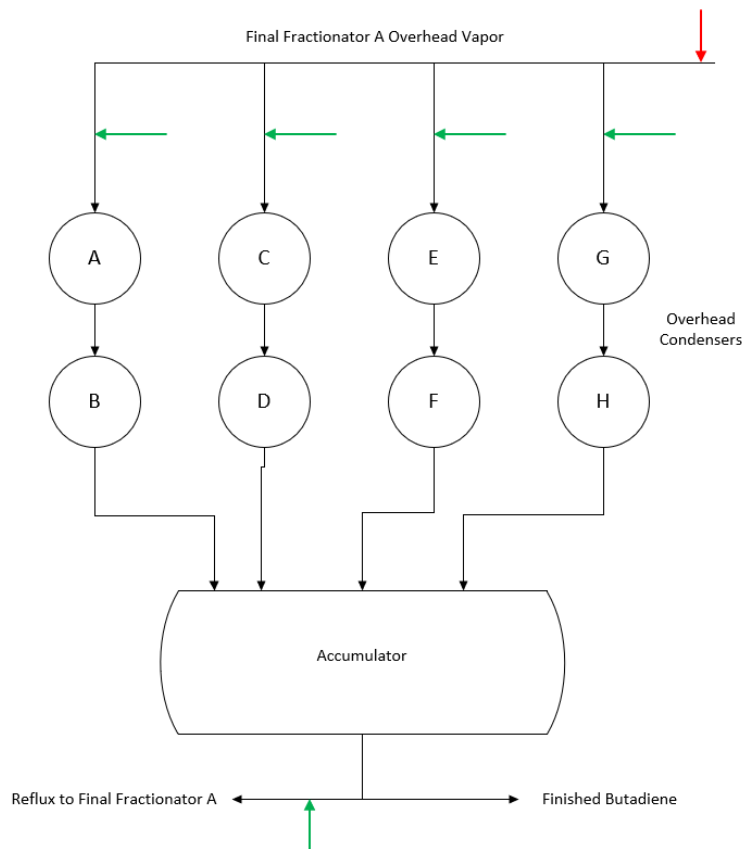
theoretically allowing TPC PNO to use less DEHA and eliminating the need for the water wash tower.<sup>a</sup> In consultation with its contracted butadiene process chemistry expert,<sup>b</sup> TPC PNO decreased its overall DEHA usage from 83 gallons per day (GPD) to 23 GPD. TPC PNO also changed its DEHA injection configuration. Prior to the quill installation, DEHA was injected into the Final Fractionator overhead condensers as depicted in green in **Figure 32**. Once the quill was operational, TPC PNO stopped the injections to the individual condensers, instead injecting DEHA at the location indicated by the red arrow. To monitor how the TPC PNO unit responded to these changes, the trial included “[Final Fractionator] tower/exchanger performance and fouling” as a key performance indicator. TPC PNO also worked with its process chemistry expert on these changes.

**Figure 32.** Final Fractionator DEHA injection locations prior to (green) and following quill installation (red). (Credit: CSB)

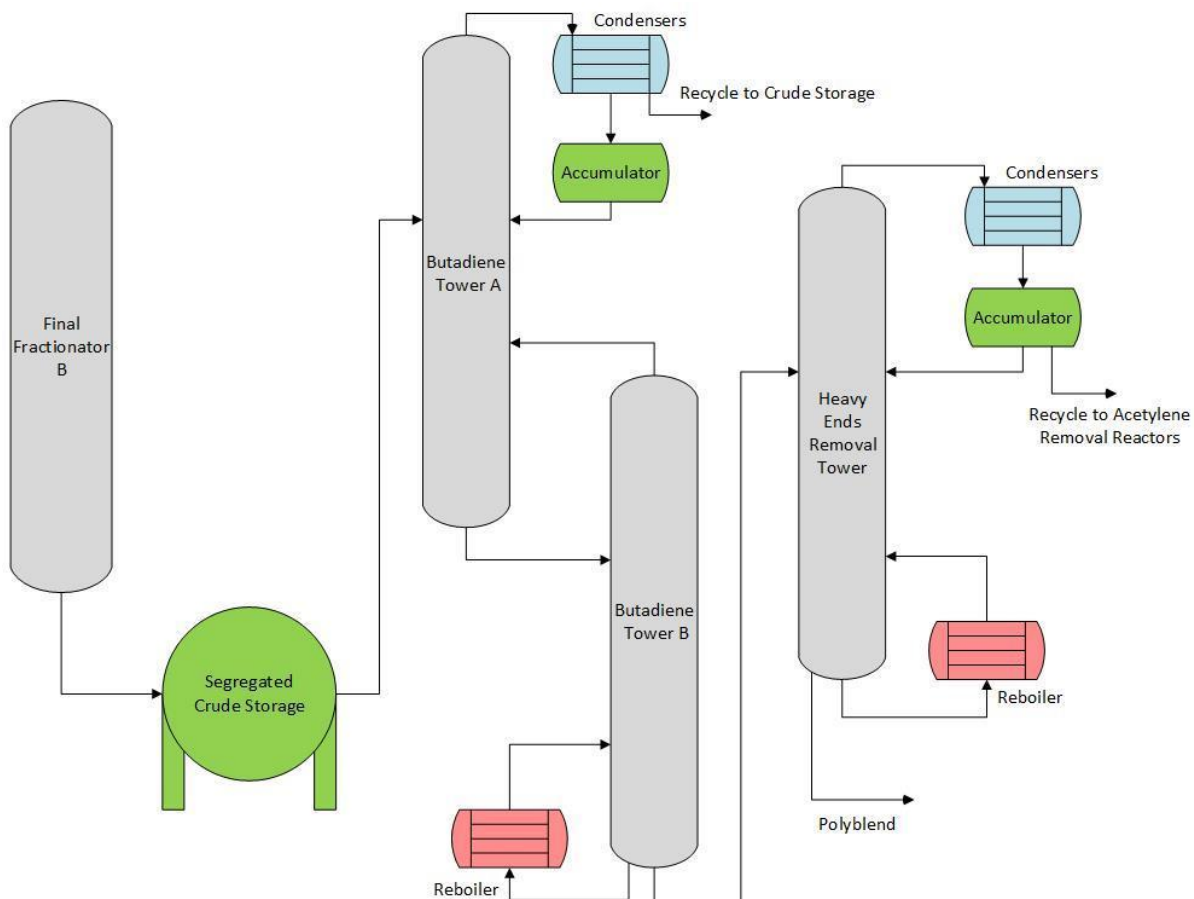
At the end of June 2019,<sup>a</sup> still during the trial in which the water wash tower was permanently bypassed and the amount of DEHA used in the unit was reduced, TPC PNO began to observe popcorn polymer plugging downstream of the Final Fractionator B bottoms, in the segregated crude pumps and the Butadiene Tower A (see **Figure 33**). TPC PNO also experienced popcorn polymer plugging in the bottom of the heavy ends removal tower (see **Figure 33**). The shift handover logs showed multiple popcorn polymer plugging incidents involving the Butadiene Tower B and the heavy ends removal tower throughout the months of July and August.

**Figure 33.** TPC PNO segregated crude unit. (Credit: CSB)

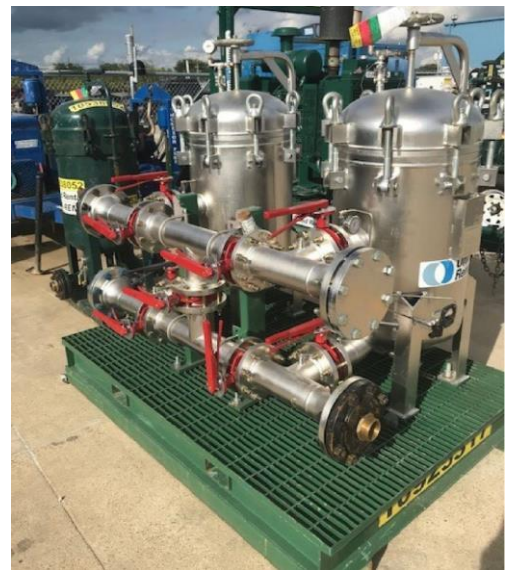
We were able to get the [Final Fractionator B bottoms] filters freed up this morning and have the line moving again. However, the filters fill with popcorn within 30 seconds of putting them online. As it stands, [we are] constantly changing filters as they plug. We’re going to need to make sure that the warehouse is stocked with plenty of filters.

**Figure 35.** Temporary filter skid – exemplar. (Credit: TPC)

<sup>b</sup> This filter skid was previously installed on the same line further downstream.

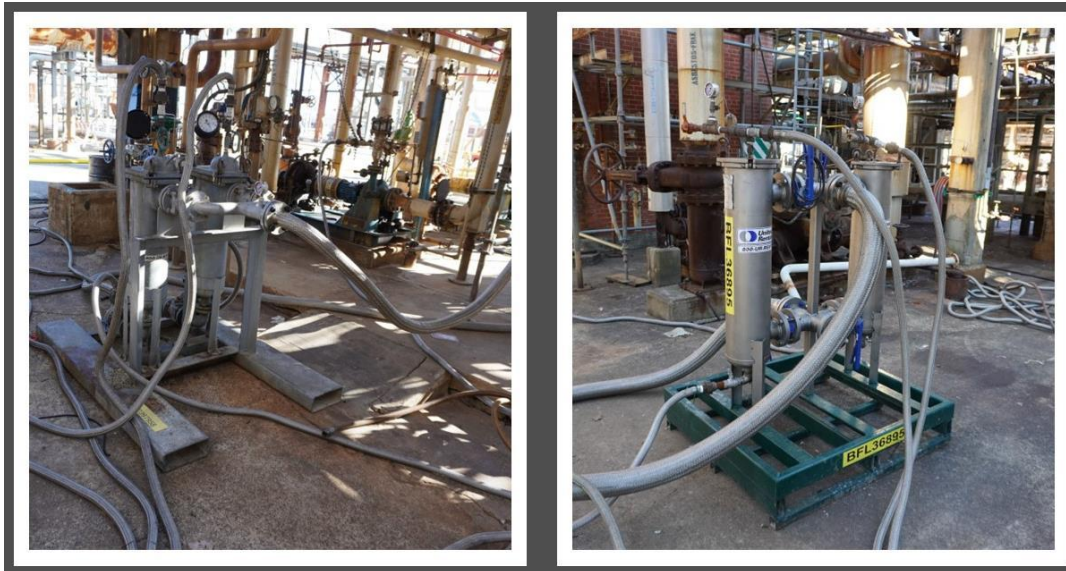
**Figure 36.** Photos of filter skids located elsewhere on the TPC PNO facility. (Credit: CSB)
