Introduction

At approximately 11:00 PM on May 31, 2017, explosion(s)¹ at the Didion Milling (Didion) facility in Cambria, Wisconsin, resulted in 5 worker deaths and an additional 14 workers injured. Because the event occurred at night, only 19 employees were working within the facility at the time of the incident.²

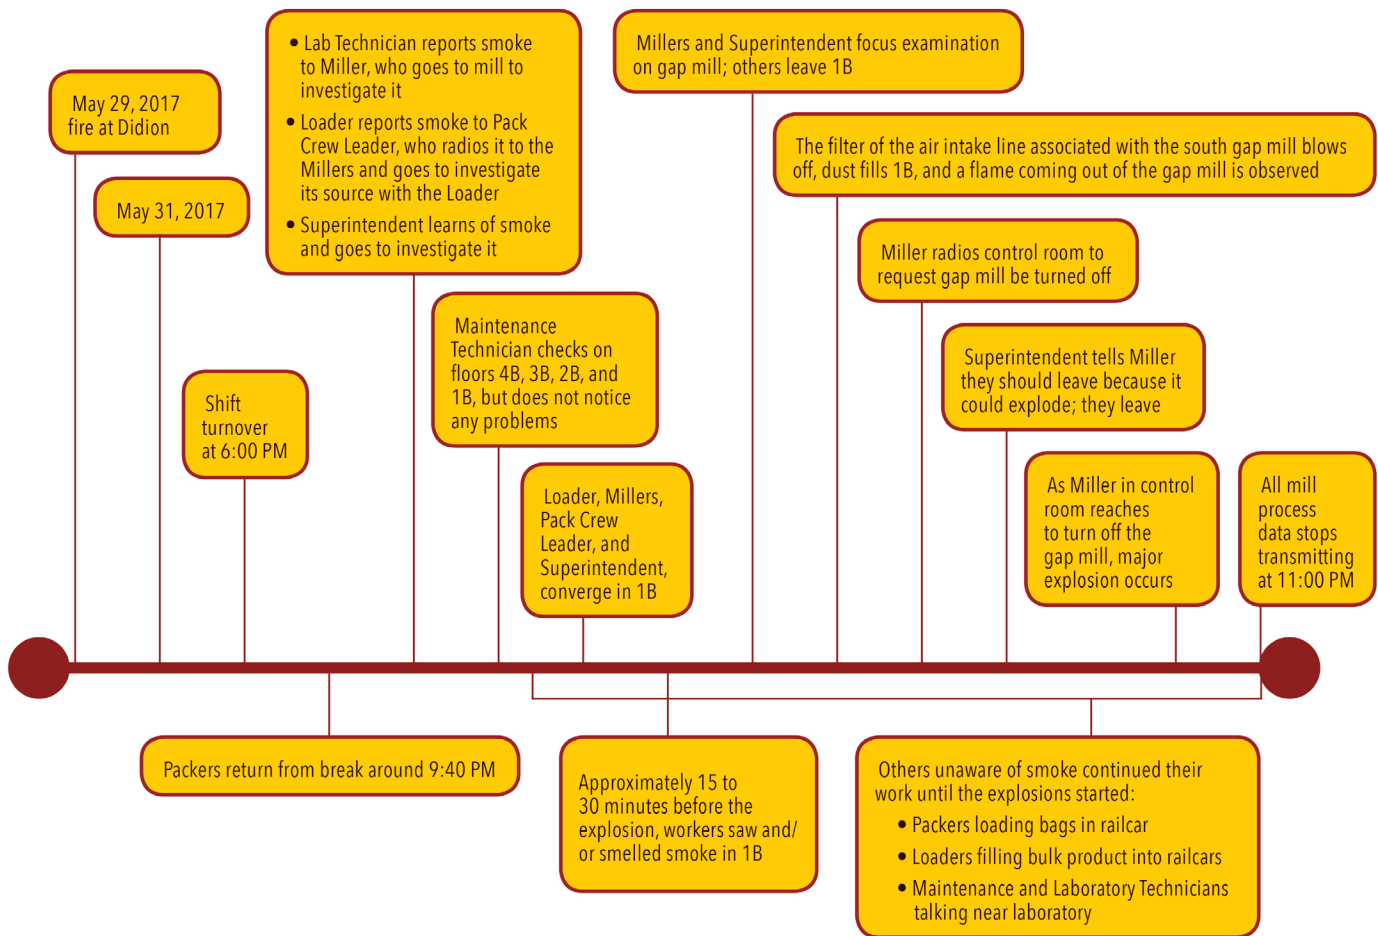
1. Workers believed the conditions at the mill on the night of the incident were “normal,” and up until just moments before the explosion(s), workers either were unaware of any problems or assumed their troubleshooting efforts would reveal a typical and manageable situation.

2. Approximately 15 to 30 minutes before the explosion, workers saw and/or smelled smoke in 1B.
3. Just before the incident, individuals were walking around various levels in A and B Mills, and no one observed any other problems beyond the smell of smoke.

Figure 7. Timeline of select pre-incident activities. Computer data from the night of the incident indicates that the Packers' break likely ended ~9:40 PM and that the explosion occurred at 11:00 PM when data transmissions in the mill ended. It was not possible to attach timestamps to the various activities, so they are depicted chronologically here.
