TESORO ANACORTES REFINERY

EXCHANGER E6600B

June 24, 2010 Inspection Report

**TESORO ANACORTES REFINERY
HEAT EXCHANGER E-6600E
Unit: NHT**

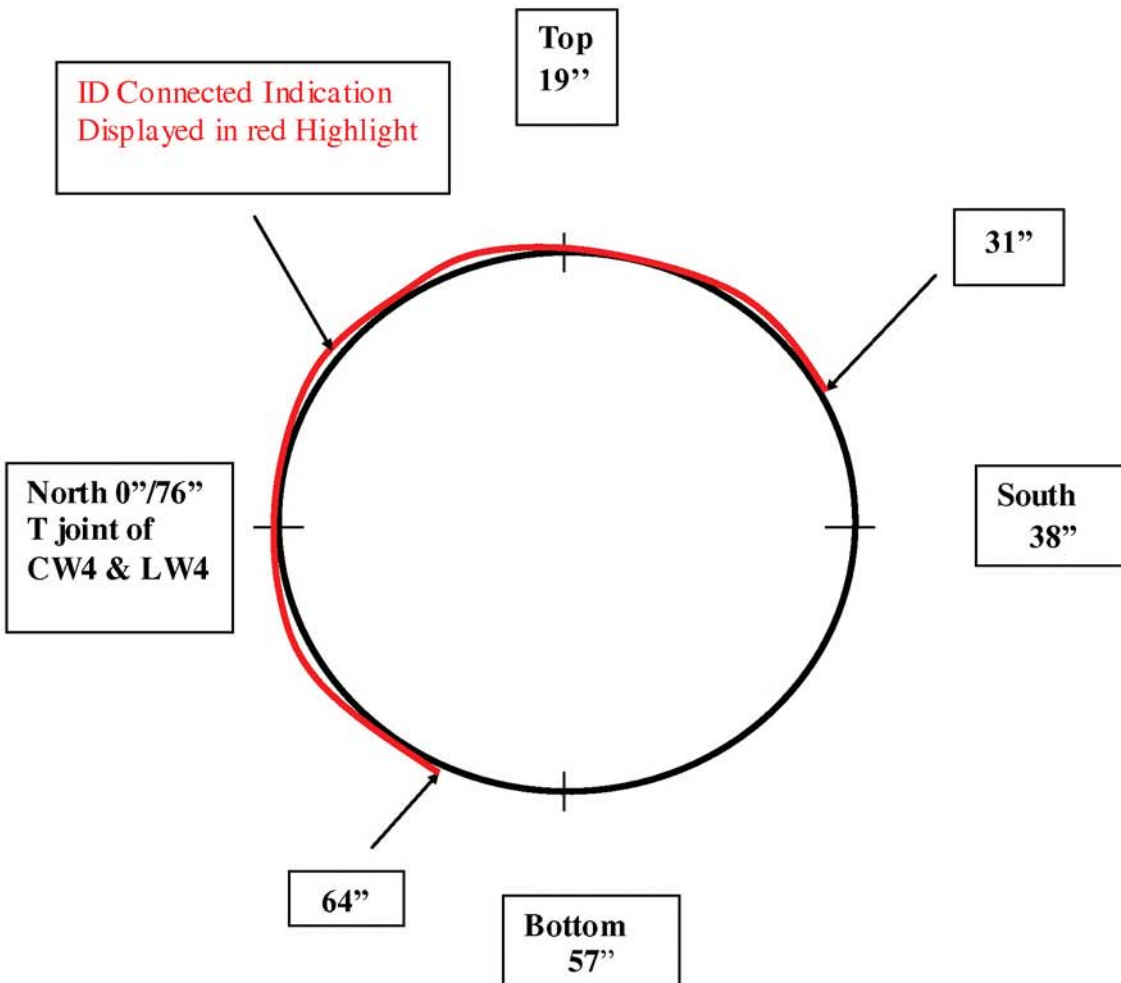
1. Phased Array inspection found ID connected Lack of fusion (0.3" deep from ID) or crack (since it is ID connected) at the edge of stainless cladding on circumferential weld CW4. Internal visual and internal WFMT confirmed the Phased Array finding and found it cover at least 50% of the weld. (48" long linear indication on ID surface).

WFMT with Linear ID indication in CW-4.

Total circumference of CW4 was 76". ID connected indication ran from 0"- 31". It was also present from 64"-76".

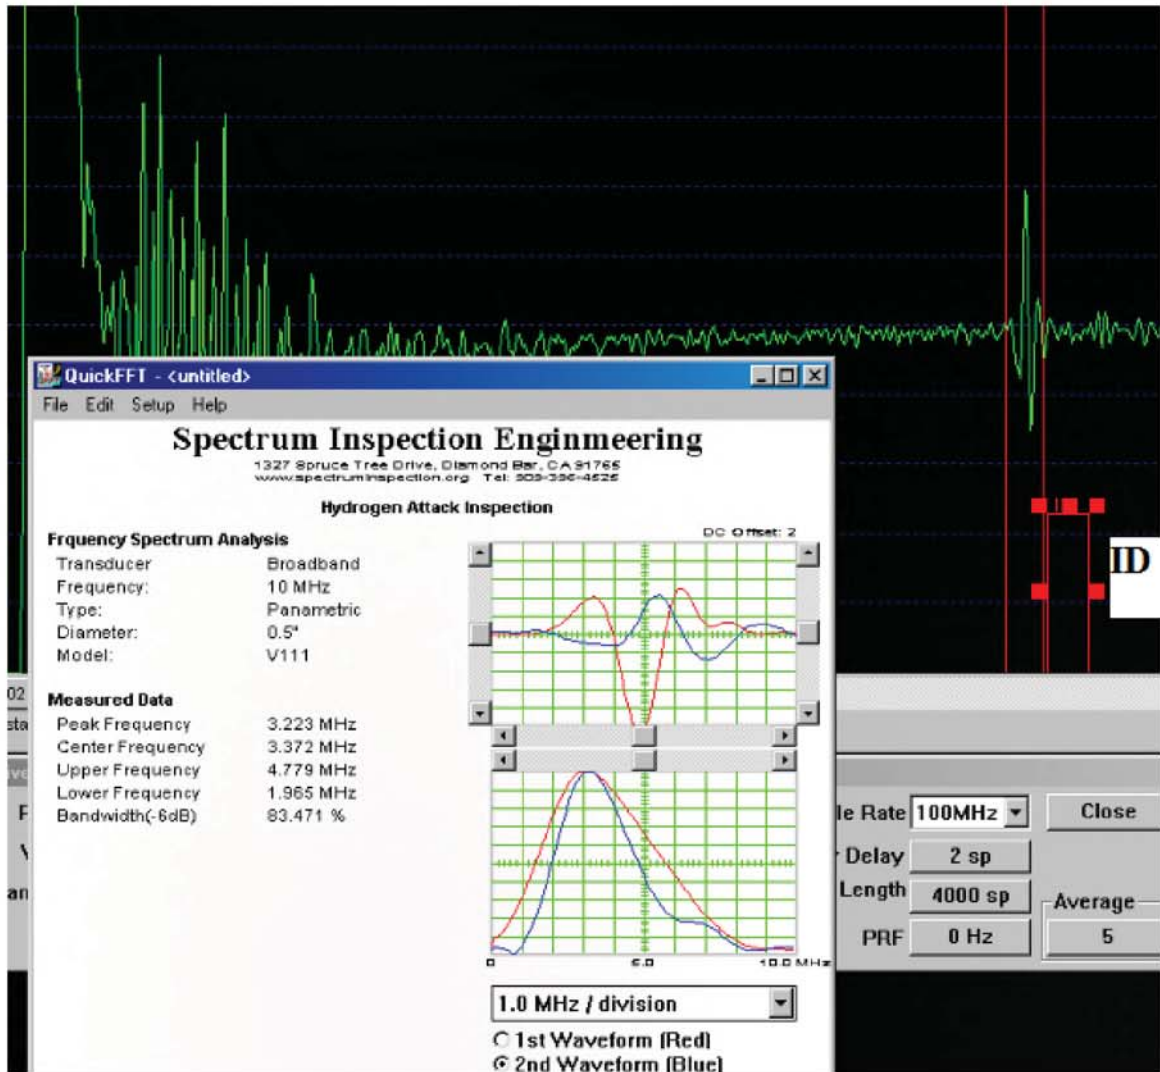
AUBT did not find hydrogen attack fissures in weld and HAZ.

All indications are confirmed that small Hydrogen attack fissures were not found by frequency Spectrum Analysis. (Red curve is reference back wall frequency spectrum and blue curve is frequency spectrum of indication found in the weld). These large indications are welding defects or large macro-cracking but not small fissures along grain boundary.

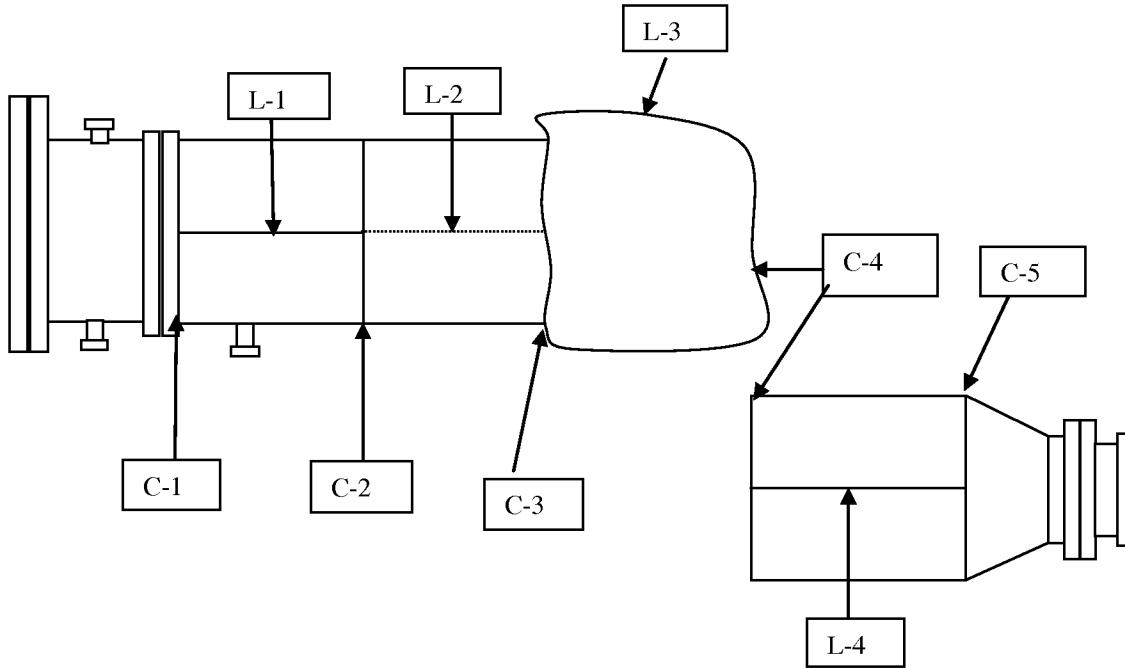
Exchanger Drawing:

Inspection Area covers: Circumferential weld C-3, C-4 and Longitudinal weld L-3

Longitudinal Weld: L-1, L-2, L-3 and L-4
