VOLUME: 2

DATE: MARCH 12, 2025

# INCIDENT REPORTS

EVENTS REPORTED TO THE CSB UNDER THE ACCIDENTAL RELEASE REPORTING RULE

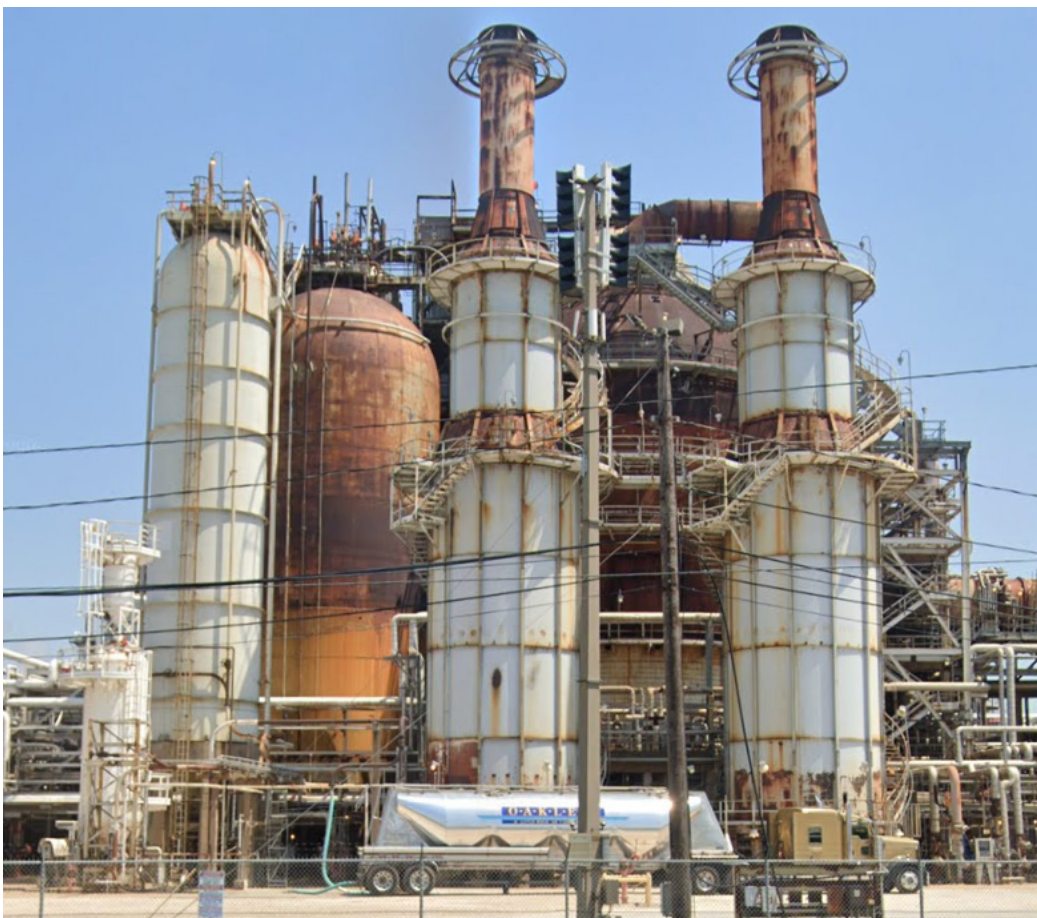
At the time of the incident, employees noticed flames coming from the head of a reactor in the fluidized catalytic cracking unit (“FCCU”) (**Figure 1**). The flammable vapor released from the reactor likely caught fire from autoignition because the reactor operated at 960 degrees Fahrenheit (°F), which is above the autoignition temperature for most of the hydrocarbons released. Unit operators put out the flames with a fire extinguisher. LyondellBasell reported that over 400 pounds of flammable vapors were released during this incident.

**Figure 1:** The FCCU at LyondellBasell. (Credit: Google Earth)
