## Investigation Report

Published: March 2025

On November 19, 2023, at 12:21 a.m., a metal tube ruptured within a fired heater during the initial startup of a renewable diesel hydroprocessing unit at the Marathon Martinez Renewables (“Marathon Martinez”) facility in Martinez, California.<sup>a</sup> The ruptured tube released renewable diesel and hydrogen, resulting in a fire that seriously injured one Marathon Martinez employee. The incident occurred while the unit was starting up for the first time as a renewable diesel hydroprocessing unit.

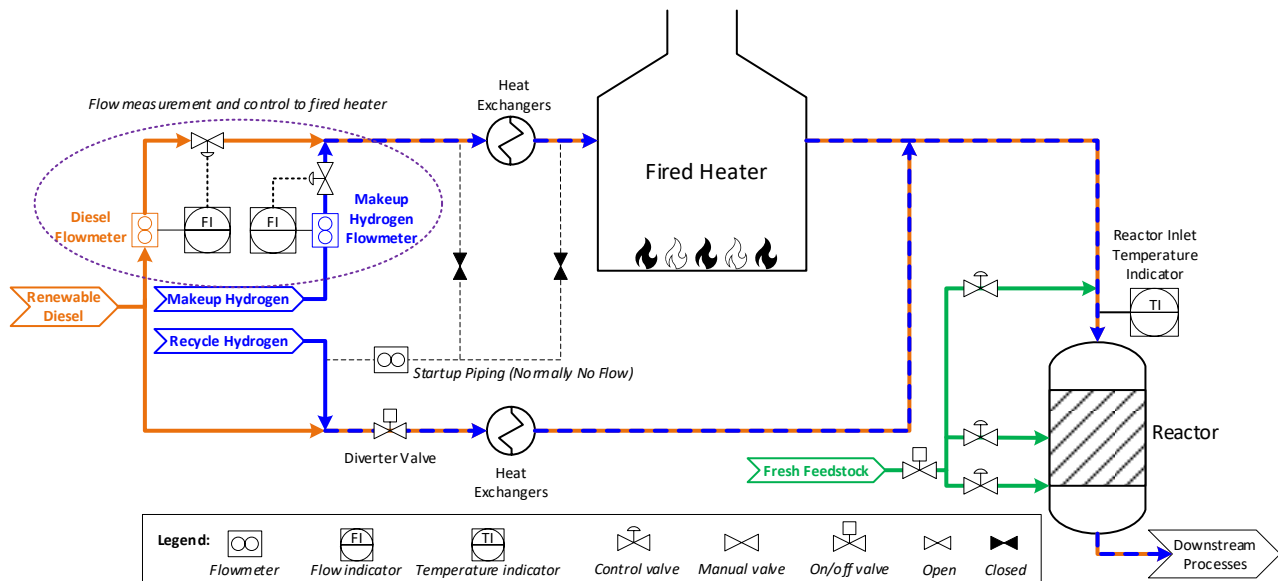
**Figure 1.** Reactor preheat section simplified process flow diagram, normal operation. (Credit: CSB)

A reactor inlet temperature of 500 °F to 700 °F was required for the hydroprocessing reaction to take place. For the reactor inlet to reach those elevated temperatures, Marathon Martinez designed the unit to heat a portion of the recycled renewable diesel and makeup hydrogen using the fired heater involved in the November 19, 2023, incident. The rest of the process flow was to bypass the heater and feed directly into the reactor. This process flow was able to be routed to the reactor when the Diverter Valve was in the open position (**Figure 1**, bottom).

Flow instrumentation was installed to monitor and control the renewable diesel and makeup hydrogen flows individually before the materials mixed together and entered the fired heater. The diesel flow meter measured the liquid renewable diesel flow rate, and the makeup hydrogen flow meter measured the gaseous hydrogen flow rate to the fired heater. Control valves were installed to control the measured flow rates to the heater (**Figure 1**, circled).

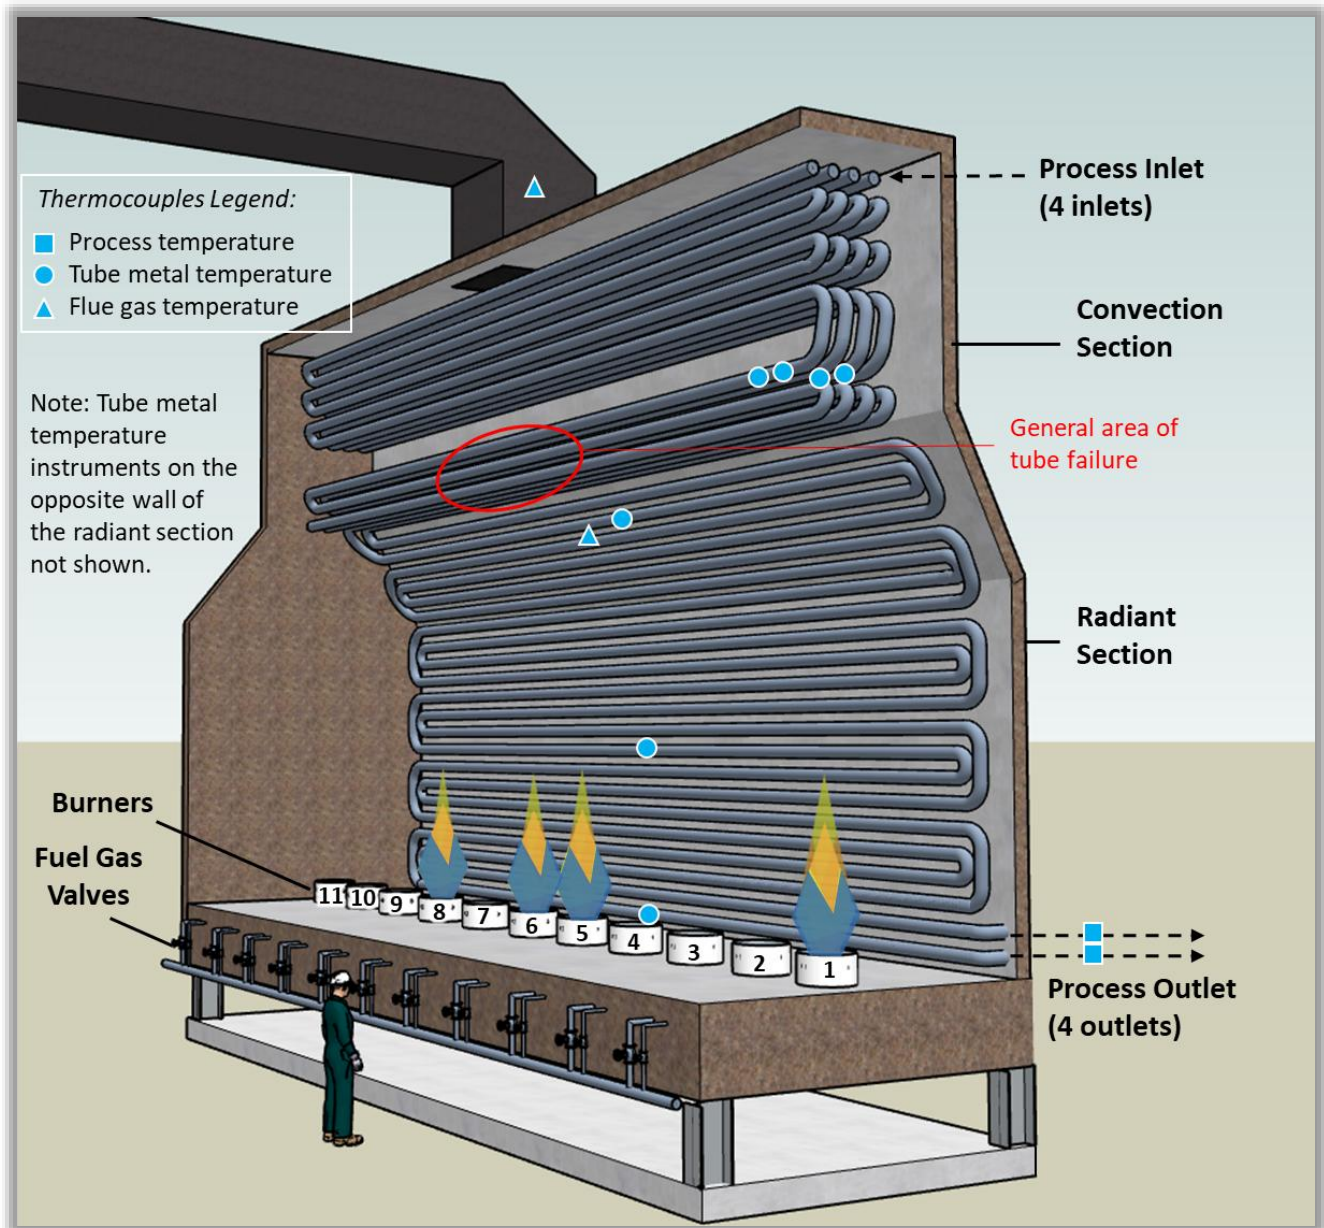
**Figure 3** depicts the interior of the fired heater. The heater had 11 floor fired burners, which burned fuel gas to generate the flames and heat the material in the tubes. The fired heater operation was monitored, in part, by measuring temperatures at three location types: (1) process fluid flowing through the heater tubes, (2) tube metal walls,<sup>a</sup> and (3) the flue gas (**Figure 4**). The locations of the thermocouples that measured these temperatures are shown in **Figure 3**.<sup>b</sup>

**Figure 3.** Interior of the fired heater. Note: The lit burners in the illustration do not necessarily depict their actual state at the time of the incident. (Credit: CSB)

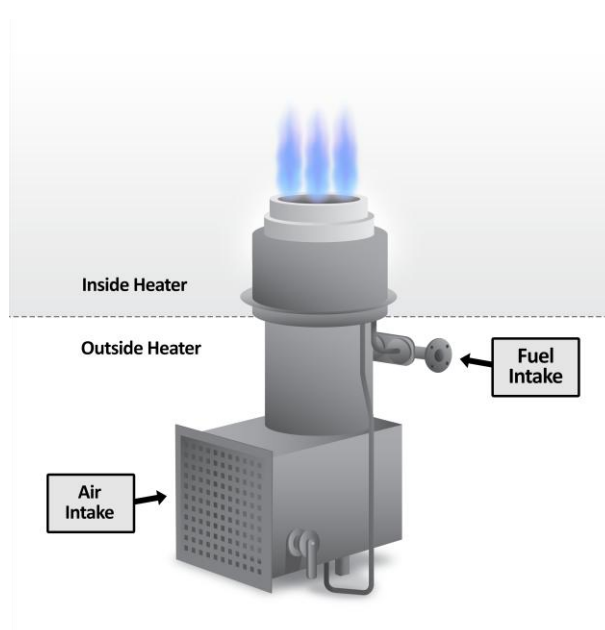
Fuel gas entered each burner through piping, and air entered each burner through combustion air intake openings (**Figure 5**). The proper air-fuel ratio at each burner is important for the heater to operate safely and efficiently. Too little air can lead to lack of proper mixing of air and fuel and result in incomplete combustion of the fuel gas inside the heater, and too much air can increase nitrogen oxide (NO<sub>x</sub>) emissions, an environmental pollutant [26, p. 907]. Cover plates are often used to cover the air intakes of out-of-service burners to prevent excess air from entering the fired heater [23, p. 16].

**Figure 5.** Generic diagram of a fired heater burner. (Credit: CSB)

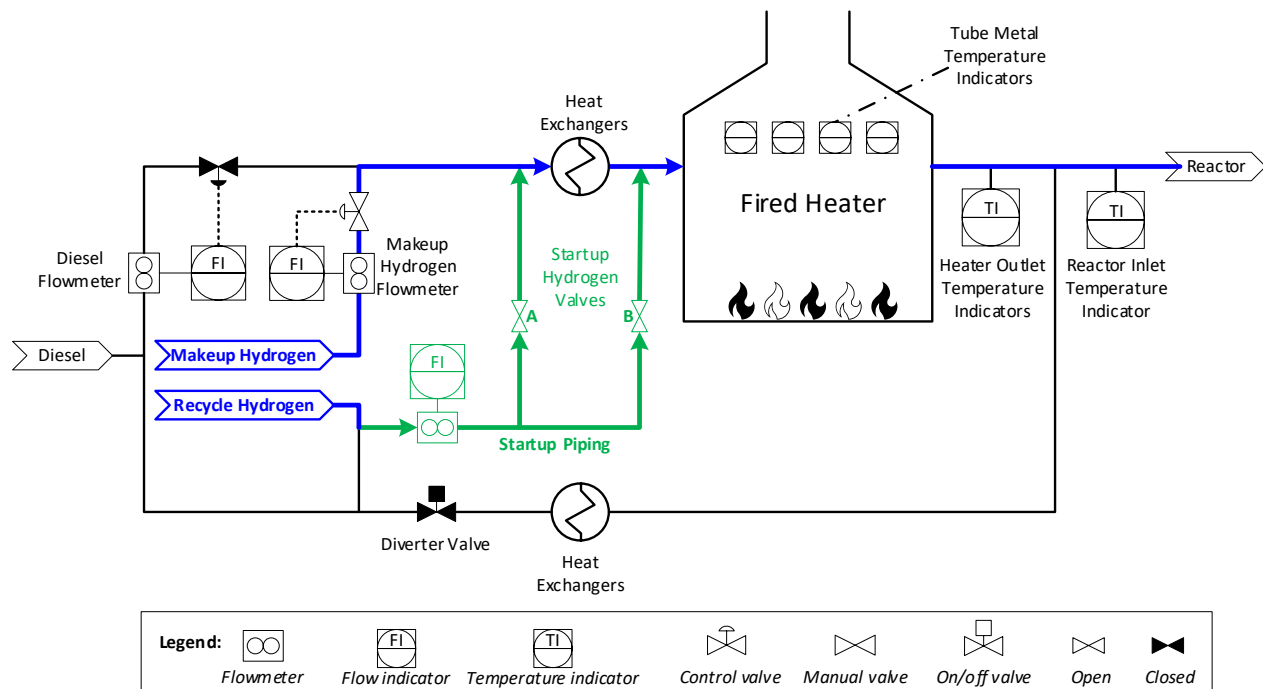
Unit startup required first heating the unit with hydrogen only (no diesel), which was achieved by flowing both makeup and recycle hydrogen to the fired heater (**Figure 7**). To achieve this, the startup procedure called for closing the Diverter Valve and opening one of the startup hydrogen valves to direct hydrogen into the fired heater. As will be discussed in *Section 4.5*, the startup procedure did not clearly indicate which startup piping valve was to be opened, but historically (when the unit was a petroleum refinery), only Valve A would be opened at this step. At some point during the initial startup sequence, both Valves A and B were opened.<sup>a</sup>

**Figure 7.** Unit heat-up through startup piping with both startup hydrogen valves open. (Credit: CSB)

Neither of the startup valves was equipped with a position indicator that could be monitored from the control room screen. Both valves being open did not adversely impact the process during the initial heat-up step. However, Valve B remained open through subsequent startup steps, and key Marathon Martinez engineering and operations personnel were not aware that Valve B was open until after the November 19, 2023, incident.

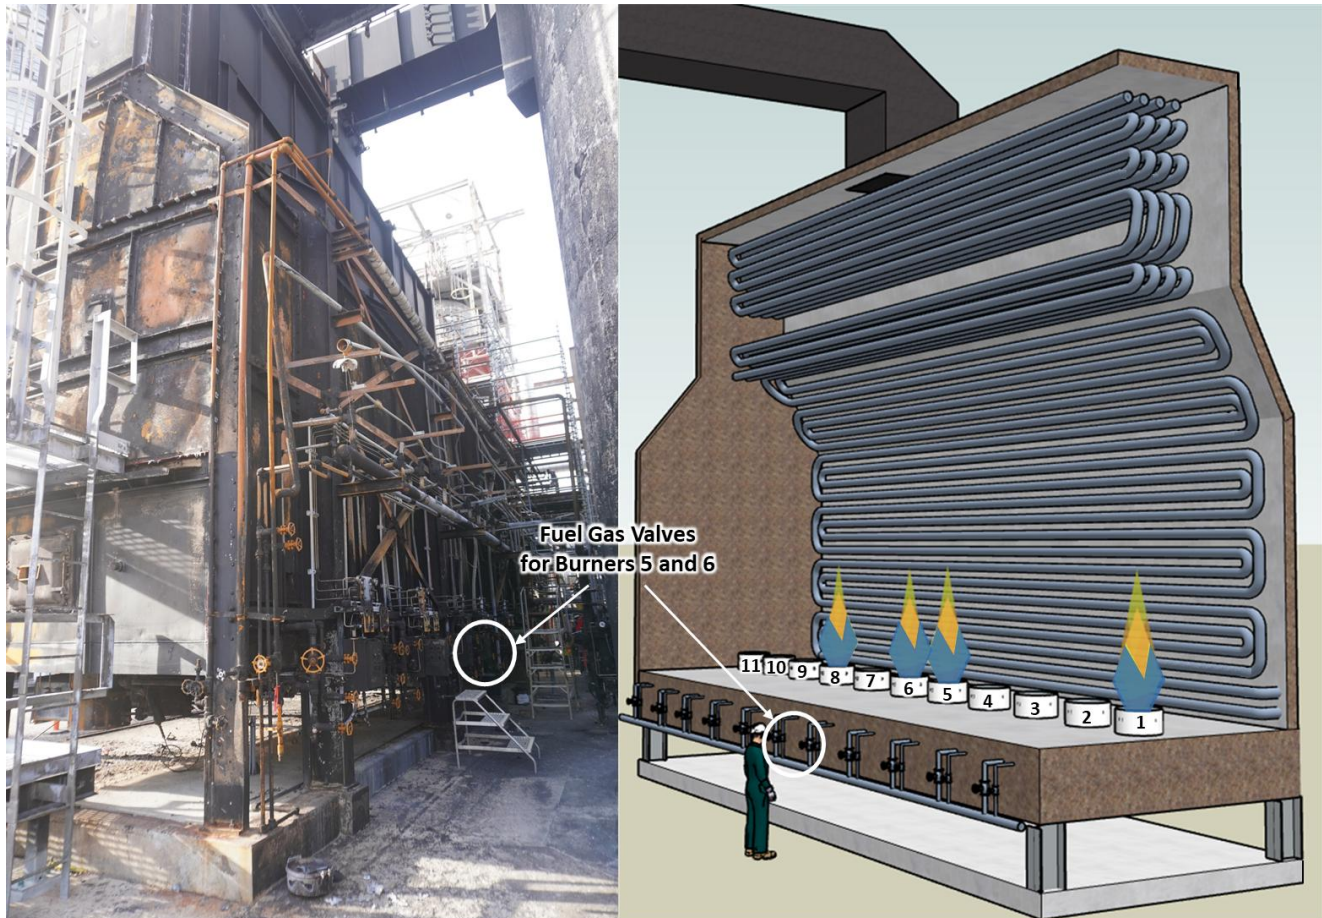
As a final troubleshooting step, Marathon Martinez personnel radioed the field operators to shut down some of the fired heater's burners. Shutting down an individual burner involved closing the manual fuel gas valve physically located at the burner.<sup>a</sup> One of the field operators responded to the call and approached the manual fuel gas valves to burners 5 and 6, located immediately next to the fired heater, to close them (**Figure 14**). The field operator shut down burner 5, and at the request of the board operator, he shut down a second burner (burner 6).

**Figure 14.** Location of manual fuel gas valves. The lit burners in the figure do not necessarily depict their actual state at the time of the incident. (Credit: CSB)

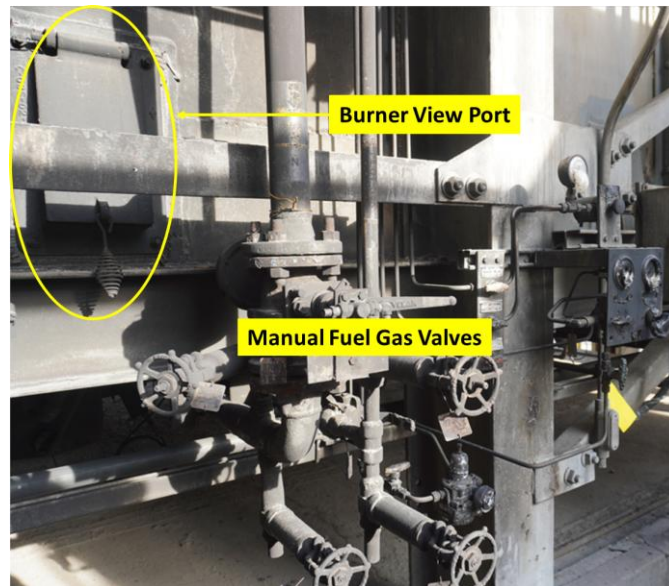
**Figure 17.** Location of burner view ports in relation to the manual fuel gas valves at the burners. (Credit: CSB)

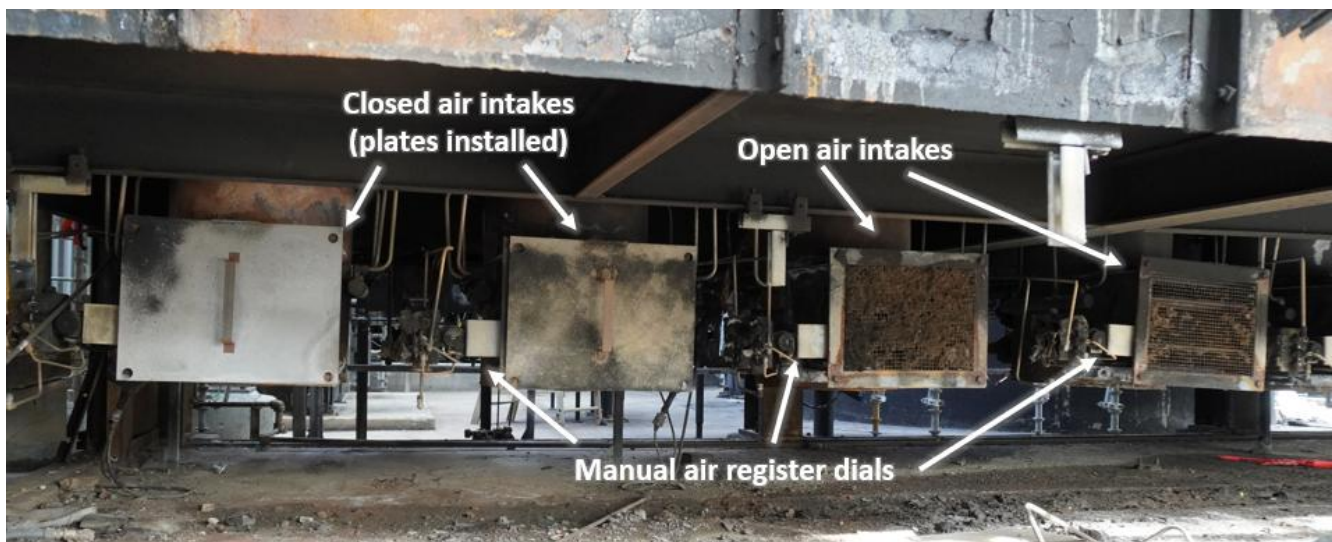
At the heater involved in the incident, each burner was equipped with air registers (or dampers) that could automatically open and close to control the air intake through the burner.<sup>a</sup> The air registers drew in some air even when they were closed. Because “tramp air” (air leakage into fired heaters through the air registers of out-of-service burners) can lead to excess oxygen in the heater and the formation of undesirable environmental emissions such as NO<sub>x</sub> [29, pp. 345-347], the burners could be covered by cover plates when not in use (**Figure 24**).<sup>b</sup> The Marathon Martinez facility’s hydroprocessing unit training workbook explained:

**Figure 24.** Burner air intakes, cover plates, and air register dials at each burner. (Credit: CSB)

As described in *Section 3.3*, the CSB found that two of the four operating burners’ air intakes were blocked by cover plates, which led to afterburning in the fired heater and contributed to the tube rupture on the day of the incident. The CSB found that neither the operating procedures nor the operating training for the unit involved in the incident adequately instructed operators to remove these cover plates prior to lighting the burners:

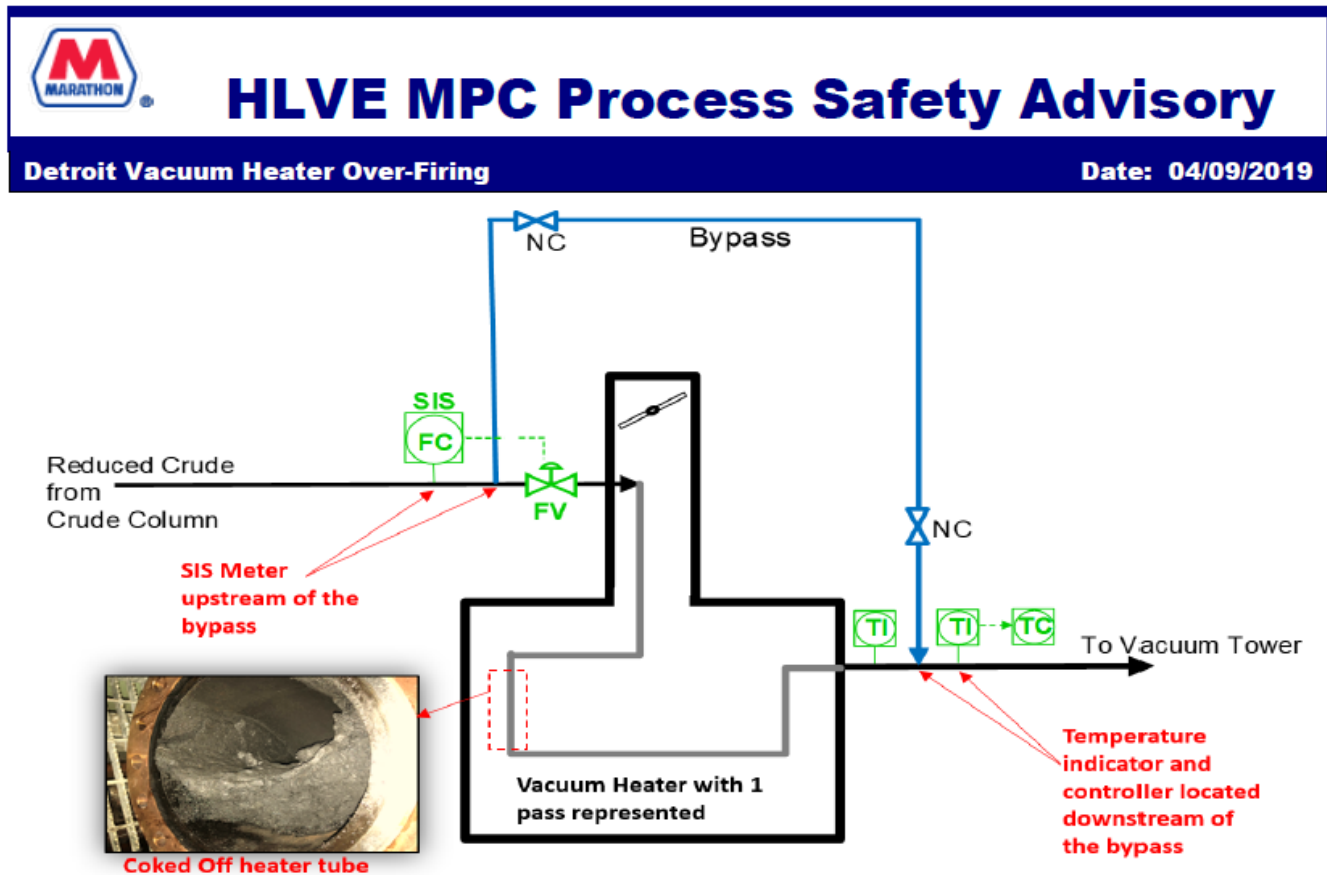
Figure 1: Simplified Schematic of Vacuum Heater Showing SIS and TI location relative to the bypass

The heater was equipped with a safety instrumented system (SIS) to protect against low flow through the heater tubes, however the low-flow condition was not detected because the bypass line was installed downstream of the SIS flow meter (Figure 1), essentially defeating the safety system. Ideally, this condition would have been identified during the unit Process Hazard Analysis, but it was not.

As startup progressed, the true heater outlet temperature was higher than intended. Because the inputs to the temperature controller are located downstream of where the bypass line ties in to the heater outlet (Figure 1), the temperature being controlled was much lower than the true heater outlet temperature. The result was over-firing of the heater. A high heater outlet temperature alarm on the temperature indicators upstream of the bypass was not received, as this alarm point had not been loaded after the alarm rationalization effort.
