Investigation Report

Published: October 11, 2022

U.S. Chemical Safety and Hazard Investigation Board

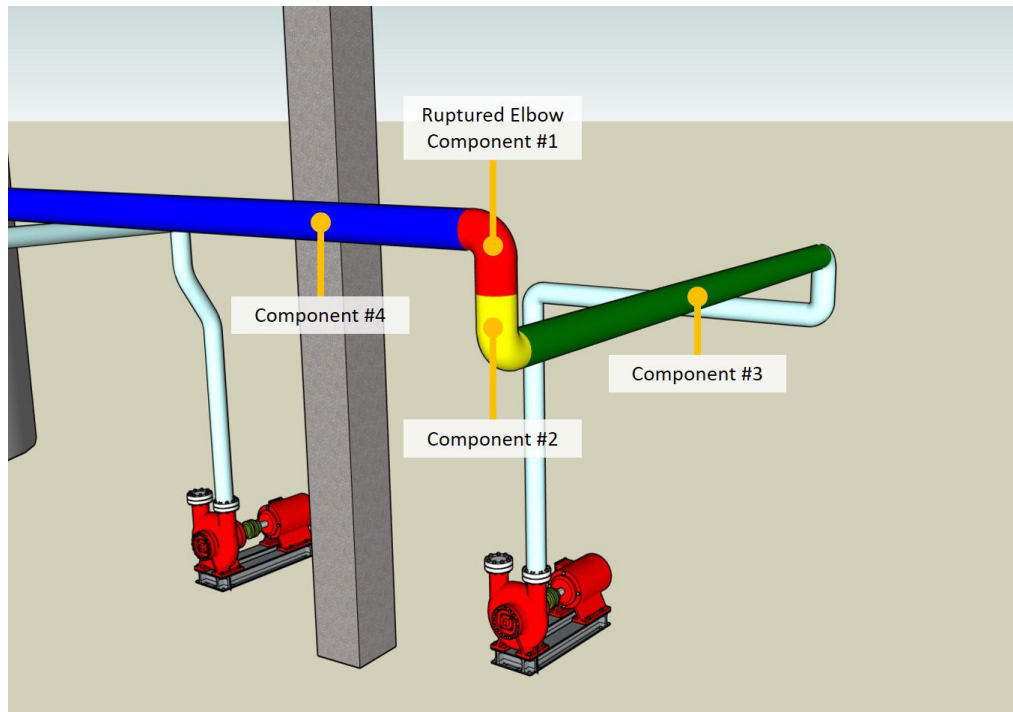
As shown in **Table 3** below, post-incident testing found that the ruptured elbow contained nickel and copper content that far exceeded the 2003 NACE technical paper's recommended composition limits, while adjacent piping components did meet these recommended limits and were not thin. The piping locations relative to the ruptured elbow are shown in **Figure 23**.

Figure 23. Depiction of the location of the four piping segments discussed in this report. (Credit: CSB).

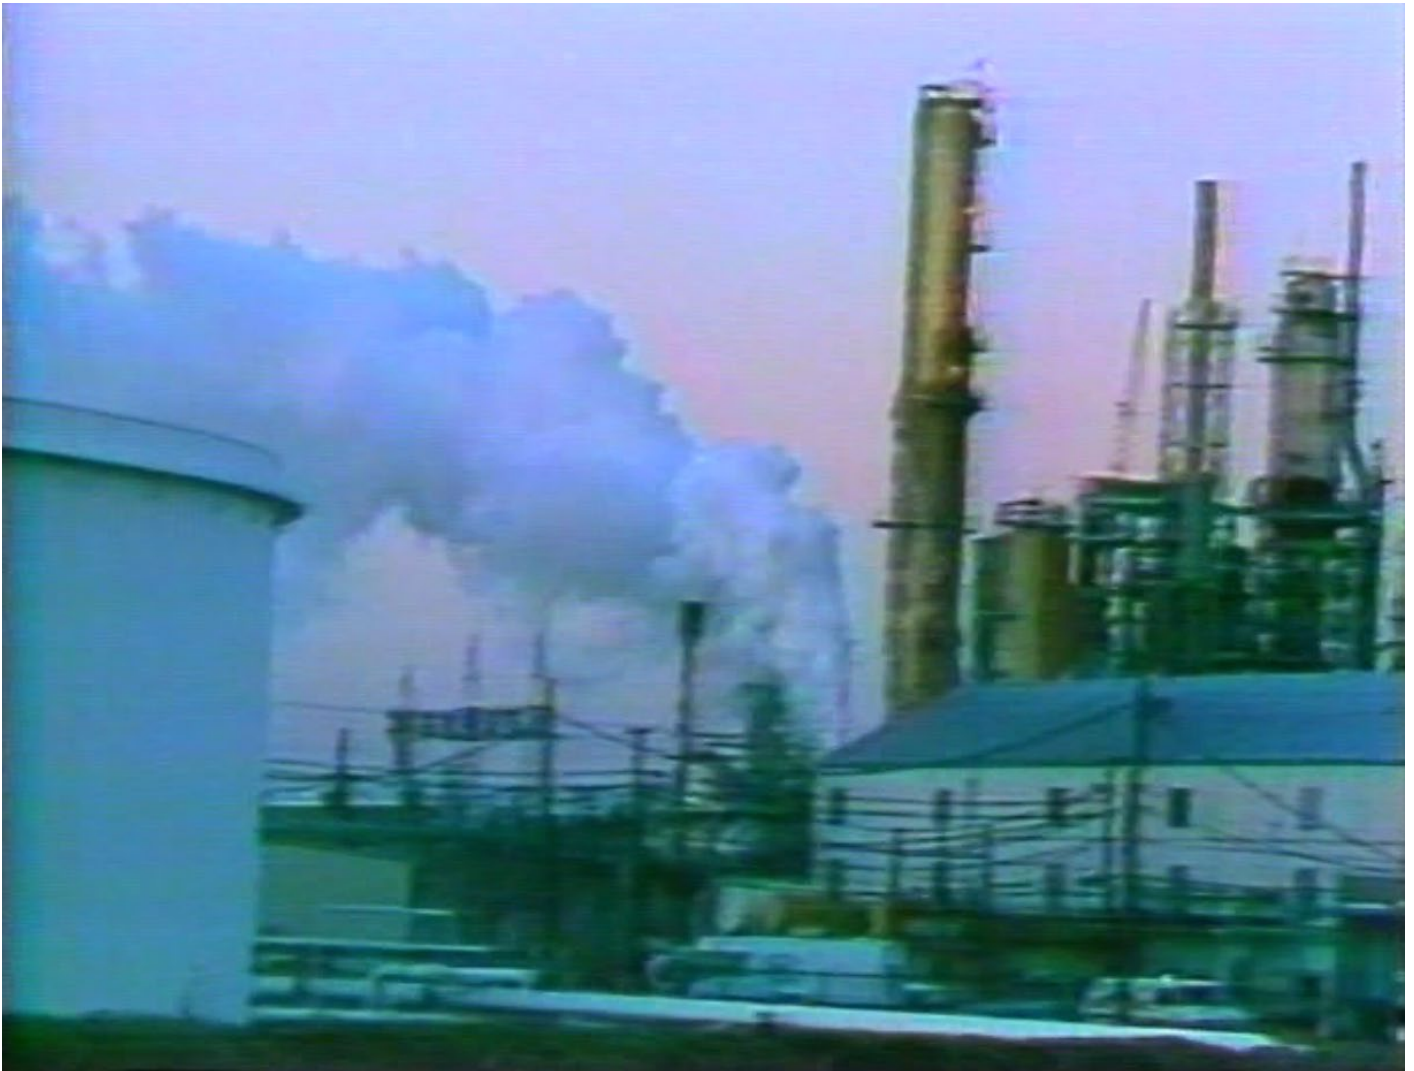
On October 30, 1987, hydrofluoric acid was released from the Texas City, Texas Marathon oil refinery (**Figure 30**). During a unit turnaround, a crane was used to lift heavy equipment over a vessel containing hydrofluoric acid. Marathon miscalculated the weight of the equipment and overloaded the crane, causing the crane to tip over. The heavy equipment dropped from the crane and fell onto the HF vessel, severing a 4-inch HF acid loading line and a 2-inch pressure relief line. About 30,000 to 53,000 pounds of HF were released [38, p. 113]. About 4,000 people were evacuated as a result of the hydrofluoric acid release [39]. Over 1,000 residents in the

A sprinkler designed to control a hydrofluoric acid release was damaged by the crane. A siren intended to sound during the emergency was also rendered inoperable when the event knocked out the power for the siren. About 600 people sued Marathon for long-term damage to their health [40]. This incident drew nationwide attention to the use and safety of HF in refineries [38, p. 113].

Figure 30. Video capture of the October 30, 1987, hydrofluoric acid release at the Marathon oil refinery in Texas City, Texas. (Credit: ABC News, 20/20 [40])

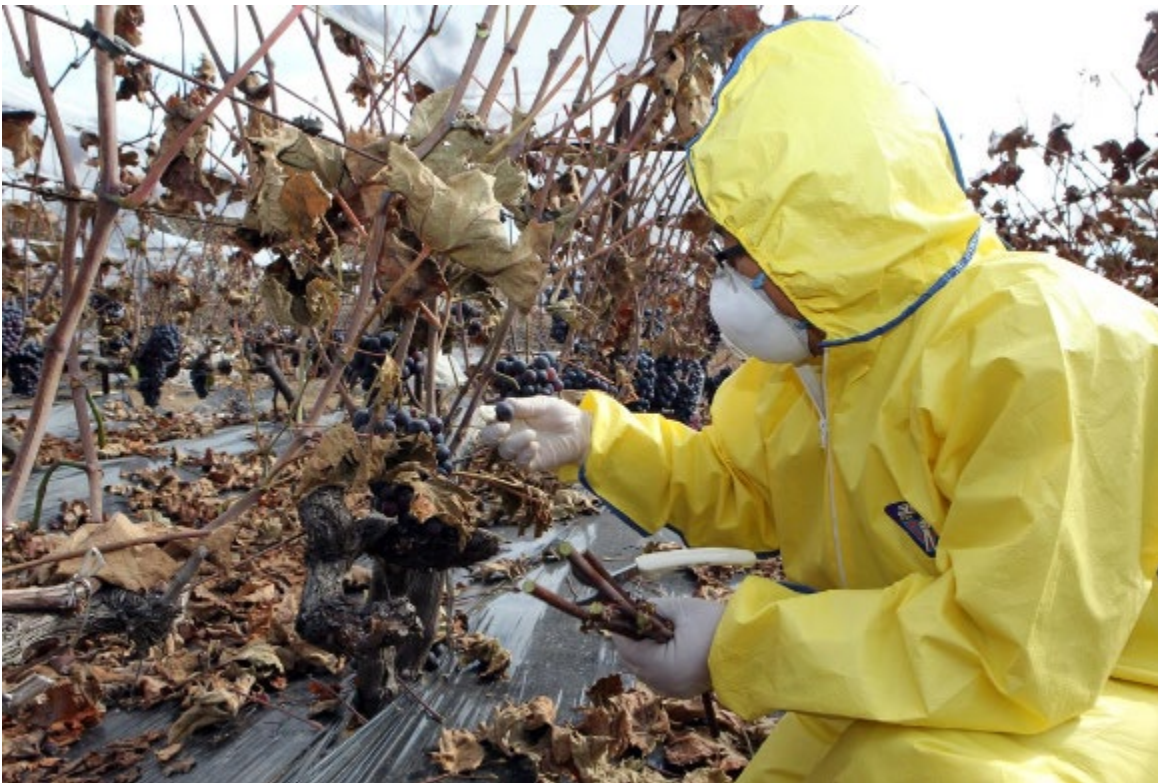
On September 27, 2012, over 17,000 pounds of hydrogen fluoride gas released from a chemical plant in South Korea. Five workers were killed, 18 workers were injured, and over 12,000 people from the surrounding area reported injuries. The South Korean government reported that it would pay \$33.4 million in compensation to citizens and local businesses [45]. The HF release damaged more than 500 acres of farmland (**Figure 31**) and affected 3,200 livestock animals. The South Korean government designated the area affected by the release as a “special disaster zone” [46].

Figure 31. Photo of damaged crops following September 27, 2012, hydrogen fluoride release in South Korea. (Credit: Yonhap News Agency [47])

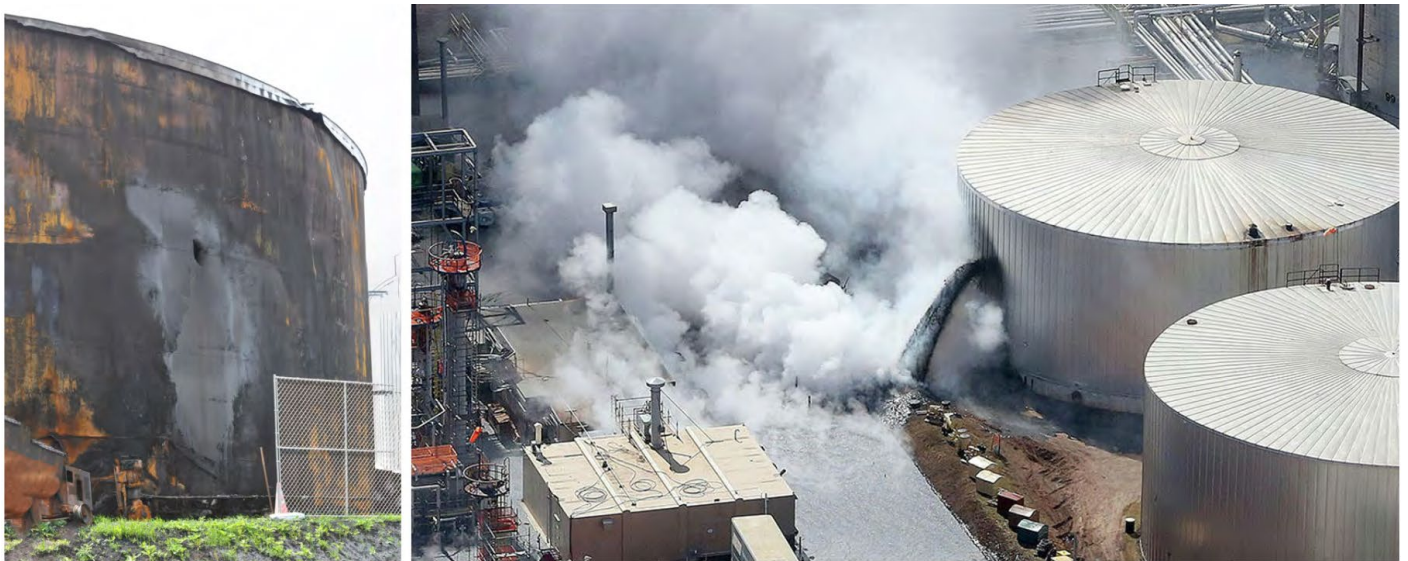
On April 26, 2018, an explosion occurred at the Superior Refinery Company LLC refinery in Superior, Wisconsin (“Husky Superior Refinery”) in the refinery’s fluid catalytic cracking unit. Debris from the explosion flew about 200 feet, and impacted a large, nearby, aboveground storage tank containing about 50,000 barrels of asphalt, puncturing the side of the steel tank and spilling more than 15,000 barrels of hot asphalt into the refinery (**Figure 33**). This released asphalt ignited about two hours after the explosion, creating a large fire [50].

Figure 33. Post-incident photographs of the leaking asphalt storage tank at the Husky Superior Refinery. (Left photo credit: CSB. Right photo credit: Duluth News Tribune [50])
