DATE: JANUARY 14, 2025

INCIDENT REPORTS

EVENTS REPORTED TO THE CSB UNDER THE ACCIDENTAL RELEASE REPORTING RULE

U.S. Chemical Safety and
Hazard Investigation Board

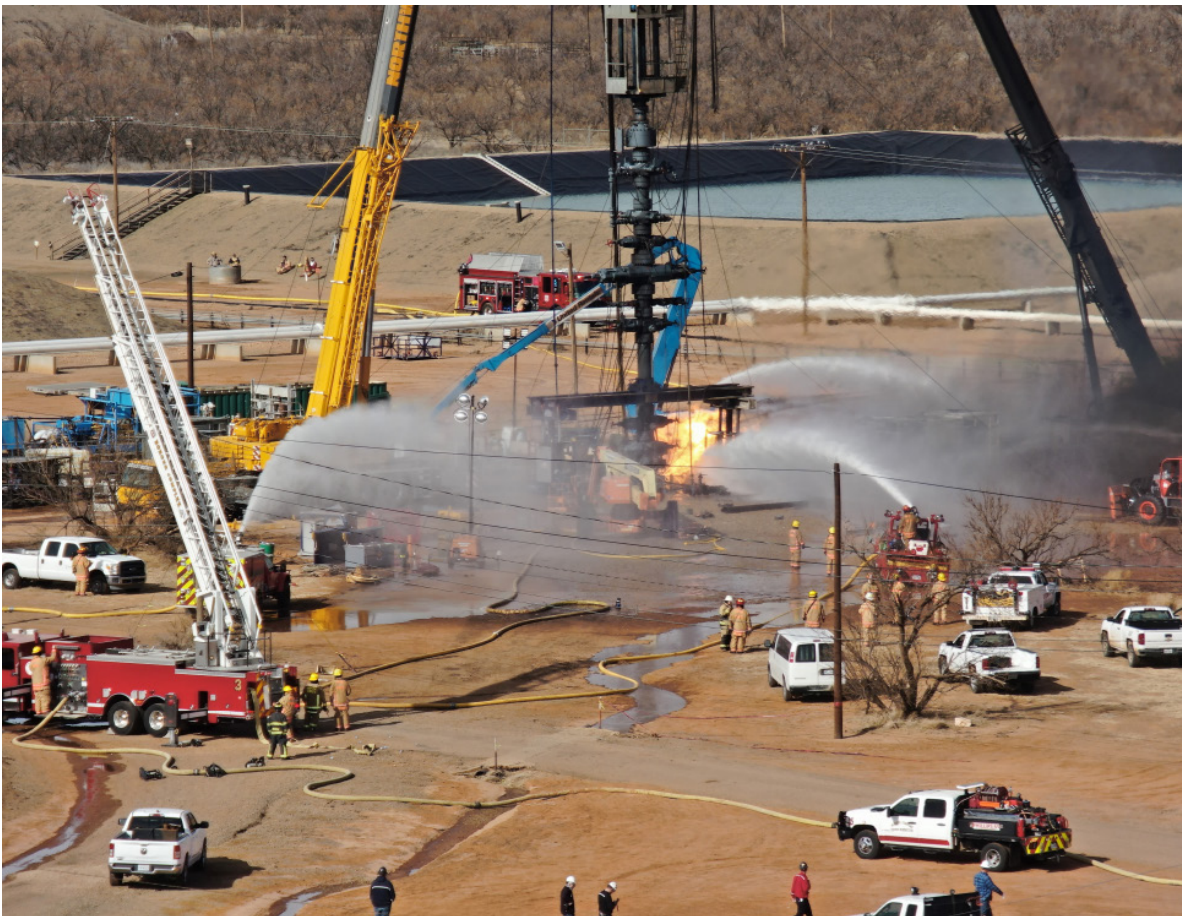
On January 17, 2023, natural gas liquid was accidentally released during maintenance of a natural gas liquid storage cavern at the Phillips 66 Borger Refinery (“Phillips 66”) tank farm near Borger, Texas. The released natural gas liquid formed a vapor cloud and ignited, causing a large fire (**Figure 1**). The fire fatally injured one contract worker and seriously injured another. Phillips 66 estimated the property damage from the incident to be \$3.1 million.

Figure 1. Local emergency response to the incident. (Credit: Phillips 66)

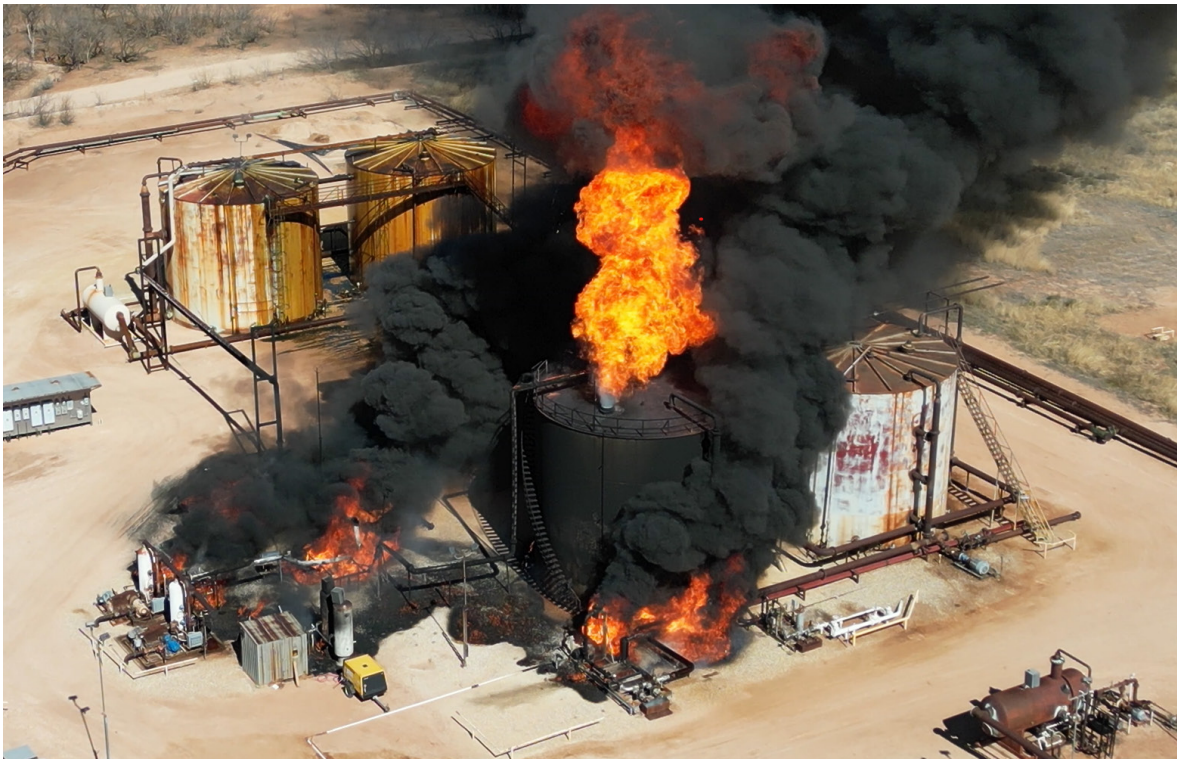
Figure 1. Aerial view of the fire and equipment involved in the incident. (Credit: Kinder Morgan)

Kinder Morgan's investigation found excessive wear and tear on the pump, which led to its failure. The company also found that the pump's bearing lock nut, which holds the bearings in place, was loose. Kinder Morgan concluded that this loose lock nut allowed the pump shaft to move and contact pump components, which caused pump damage that resulted in crude oil being released from the pump into the atmosphere. The company also concluded that heat from metal-to-metal contact in the pump seal area may have provided the ignition source.

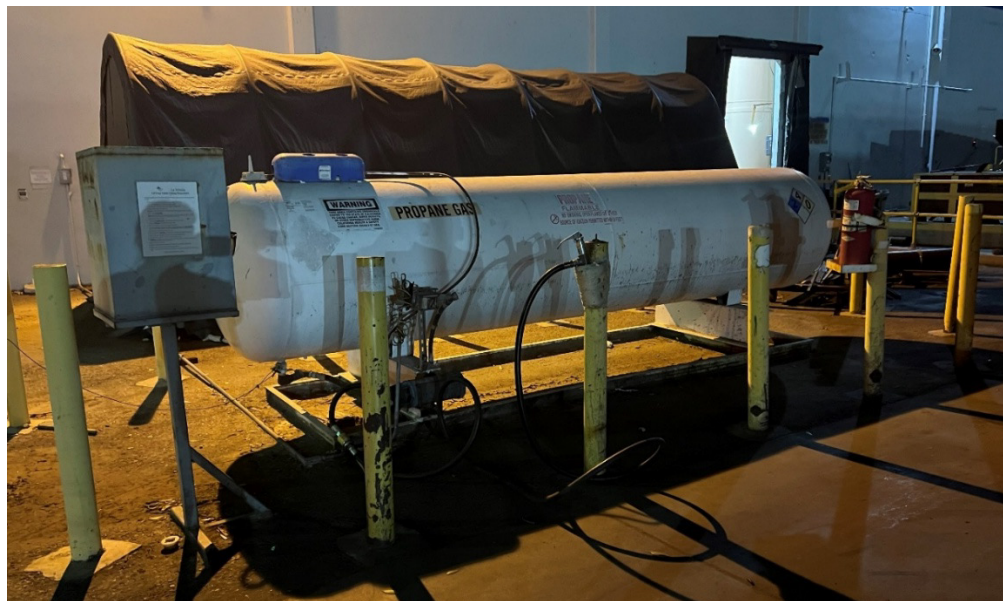
The temporary employee had moved a propane-fueled forklift to the facility’s filling station (**Figure 1**) to refuel its tank. He connected the filling station’s hose to the forklift’s tank and opened the valve to start the propane flow. The hose connection was not secure, and propane immediately discharged into the atmosphere. The employee tried to either tighten or remove the hose during the release. As a result, the cold propane sprayed and cryogenically burned him. The temporary employee was not wearing personal protective equipment (PPE) that could have protected the employee from being exposed to cold propane.

Figure 1. Propane Filling Station. (Credit: Georgia-Pacific Corrugated, LLC)

There was no documentation that the temporary employee had been trained on safely filling propane tanks, although another employee stated that the temporary employee had been trained. Georgia-Pacific’s investigation found that site training on refilling propane fuel tanks did not include information on items to inspect before beginning the filling operation.

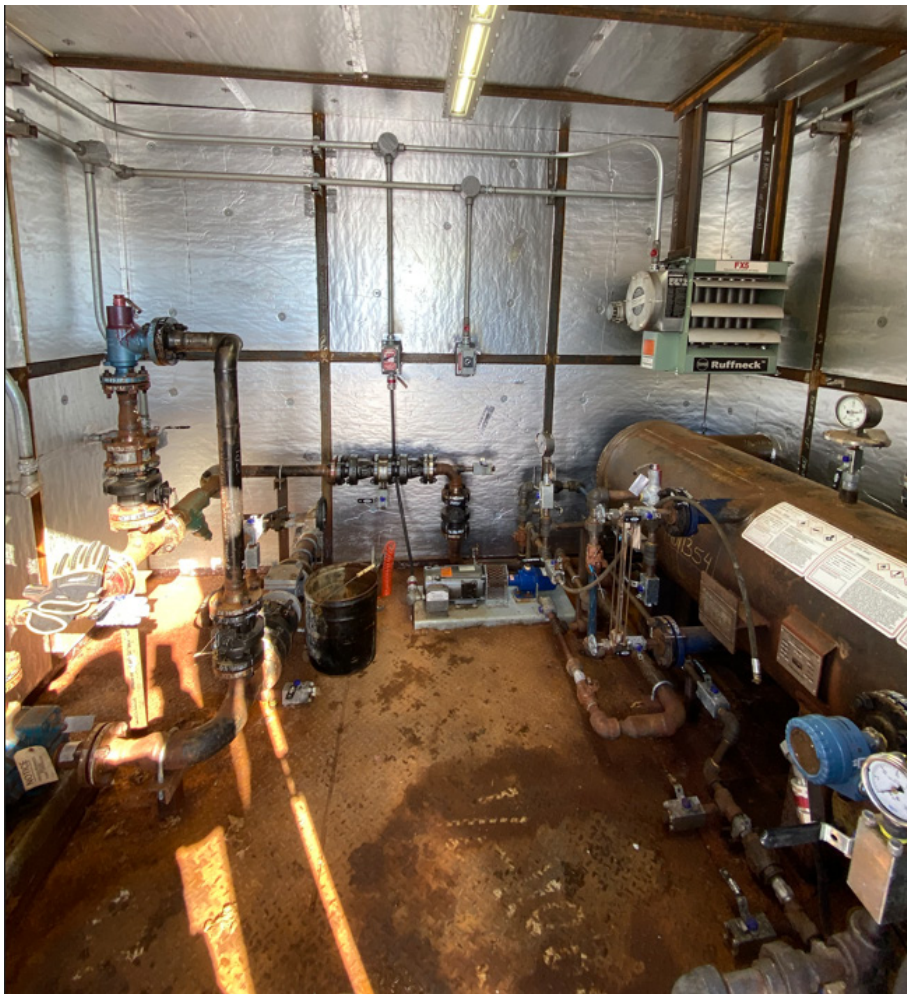
During the morning of February 24, 2023, an unknown amount of hydrocarbons and hydrogen sulfide were accidentally released, fatally injuring an employee inside an enclosed building (**Figure 1**) at a ConocoPhillips oil and gas facility in Watford City, North Dakota. The hydrocarbons and hydrogen sulfide displaced the oxygen in the building, and the employee asphyxiated in the oxygen-deficient atmosphere.

Figure 1. The Enclosed Building. (Credit: ConocoPhillips)
