## Investigation Update

February 2025

This document provides an update on the CSB’s investigation of the November 12, 2024, incident at the Givaudan Sense Colour (“Givaudan”) facility in Louisville, Kentucky.

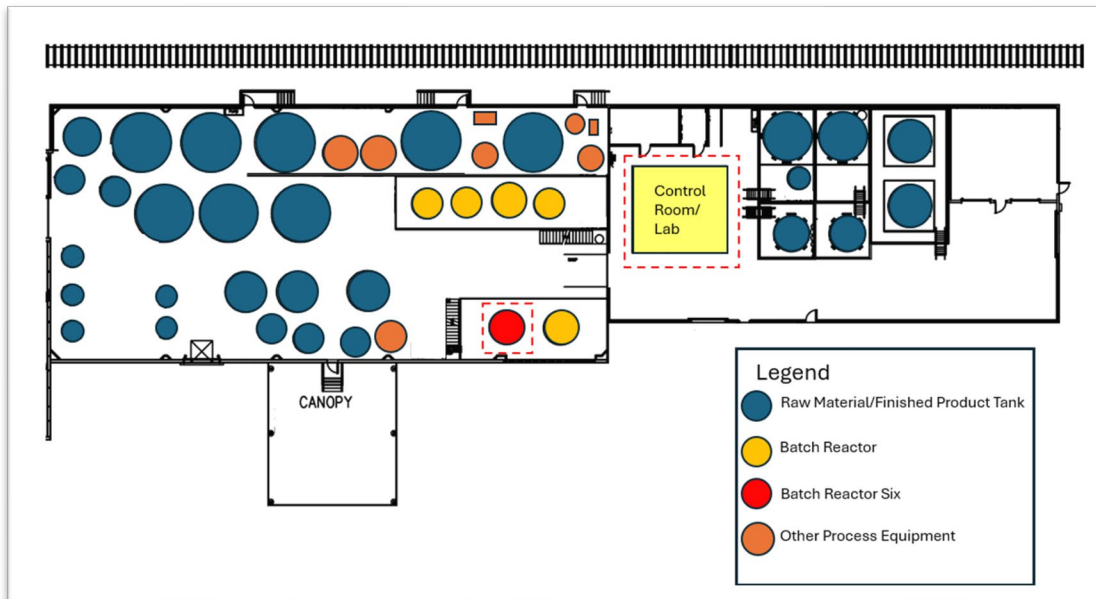
- As a result of the explosion, two employees were fatally injured, and three employees were seriously injured. The two fatally injured employees, along with four additional employees, were inside the control room at the time of the incident (**Figure 4**).

**Figure 4.** Simplified map of Givaudan manufacturing facility in Louisville, Kentucky. (Credit: Givaudan with annotations by CSB)
