INVESTIGATION REPORT

REFINERY FIRE INCIDENT

TOSCO AVON REFINERY

REPORT No. 99-014-I-CA
ISSUE DATE: MARCH 2001

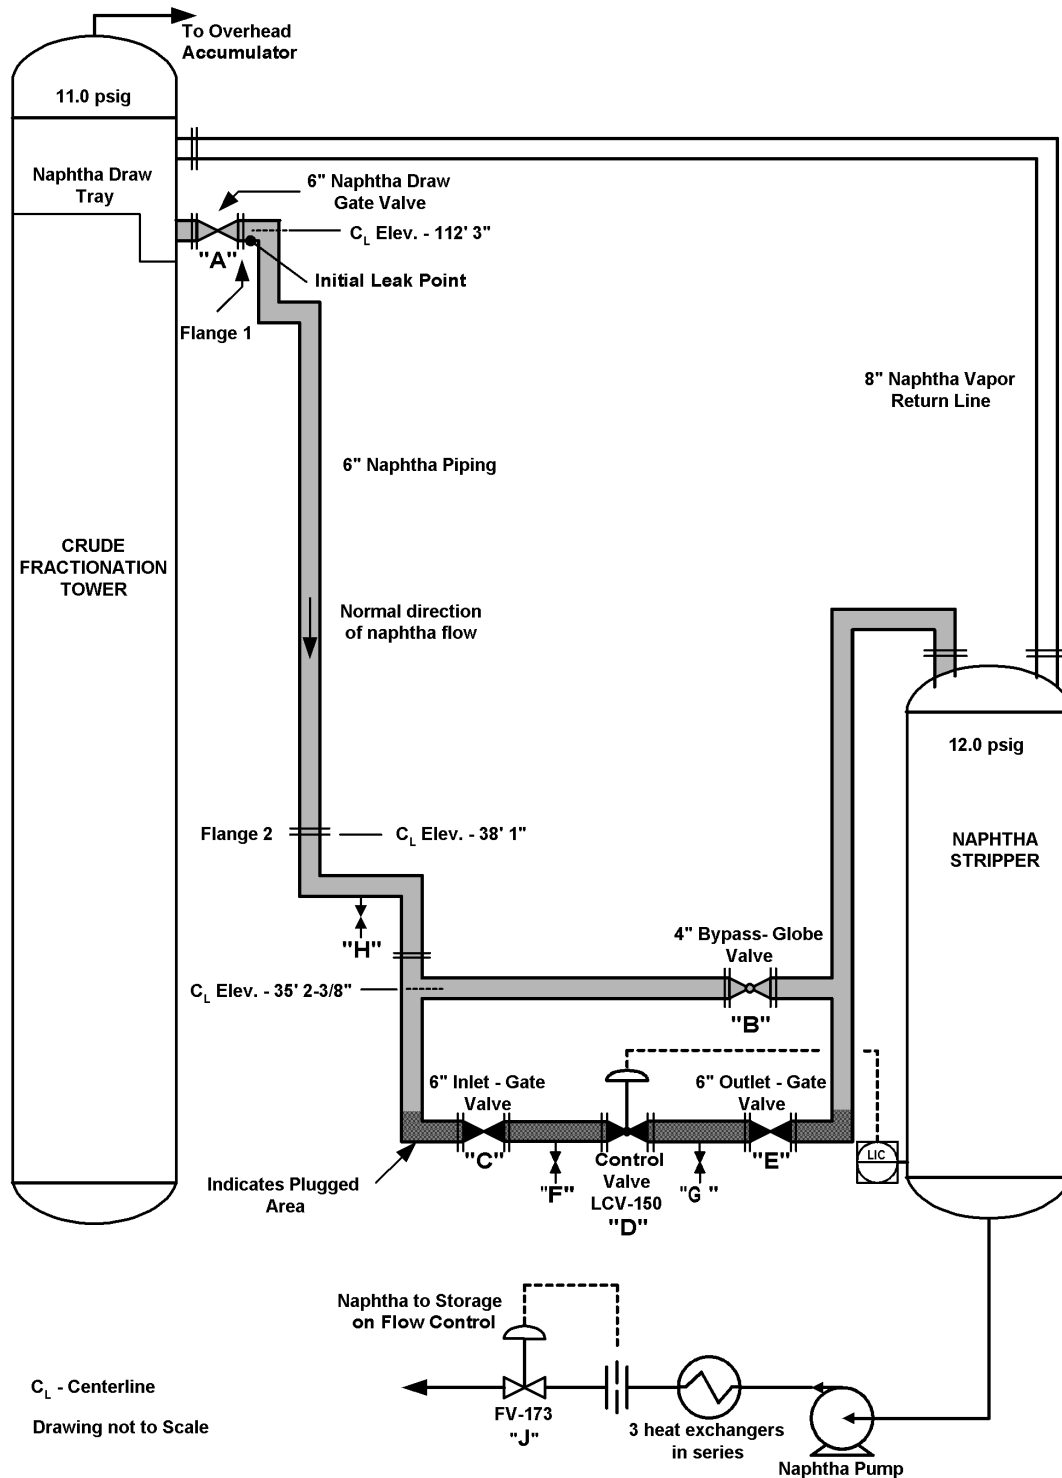
Figure 2. Fractionator and naphtha draw, simplified diagram at time of initial leak.

- a. 1:20 pm: A leak was detected in the 50 Unit at the first elbow of the naphtha piping leaving the crude fractionator tower (just downstream of valve A; Figure 2).

- g. 9:40 pm: The liquid in the naphtha stripper vessel rose to a high level. Operations personnel lowered the liquid level by opening the naphtha to storage flow control valve (valve J; Figure 2), downstream of the naphtha stripper.

¹ Valves A, B, C, and E (Figure 2) are also referred to as the isolation valves.

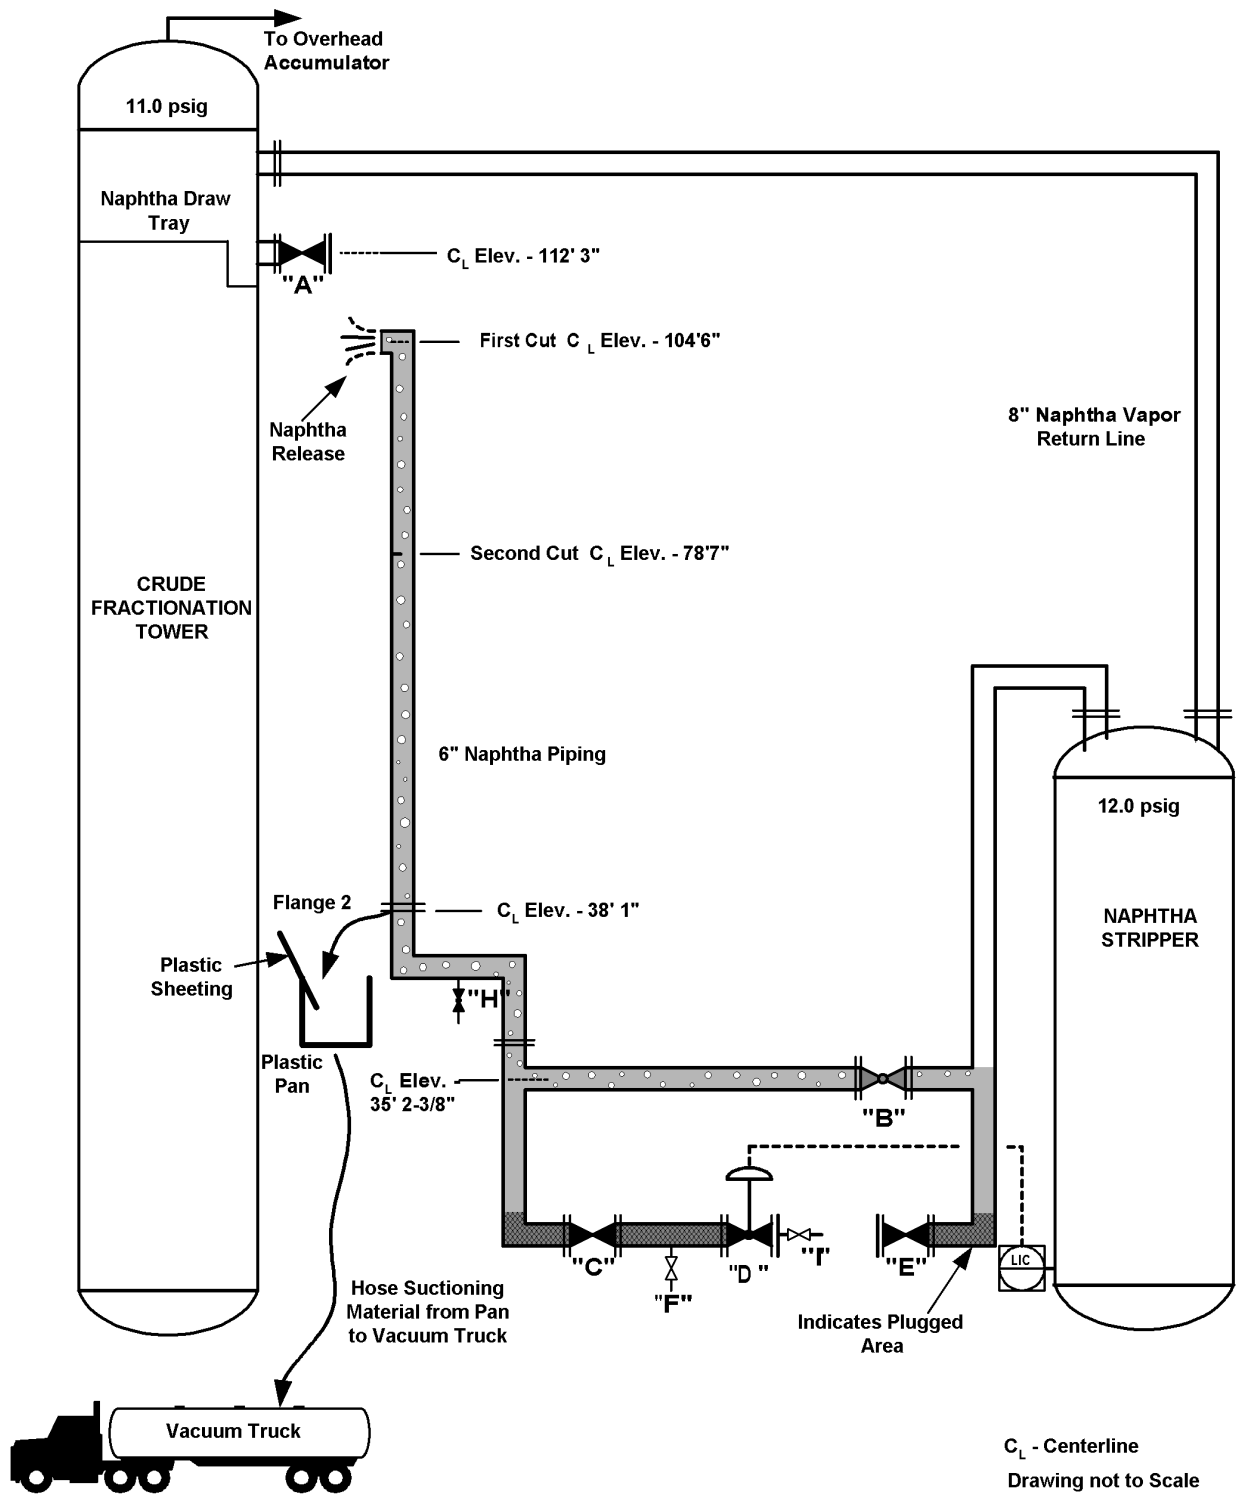
Figure 4. Fractionator and naphtha draw, simplified diagram, draining at lower flange at time of release.

In preparation for draining the line, the vacuum truck was placed into position approximately 20 feet from the base of the fractionator. A metal half-barrel was placed under the flange, with the attached drain valve (valve I; Figure 4) downstream of the naphtha stripper level control valve (valve D). A hose was extended from the truck and placed in the barrel. An operator incrementally opened valve D from the control room to assist with draining the line from valve I. Under the direction of their supervisor, the maintenance workers then attempted to open a flange upstream of the control valve. Both efforts to drain the line were unsuccessful.

The maintenance supervisor decided to again attempt to drain the line by opening flange 2, located upstream of the naphtha stripper level control valve (valve D) and within 3 feet of the fractionator (Figure 4). Workers loosened the bolts on flange 2, which allowed liquid to flow. Plastic sheeting was hung to deflect the draining liquid away from the hot fractionator and into an open plastic pan, from which it was suctioned to the vacuum truck.

- g. 8:50 am: A maintenance worker signed the work authorization permit.
- h. 9:19-9:26 am: Maintenance personnel initially attempted to remove naphtha from a drain valve (valve I; Figure 4) in the

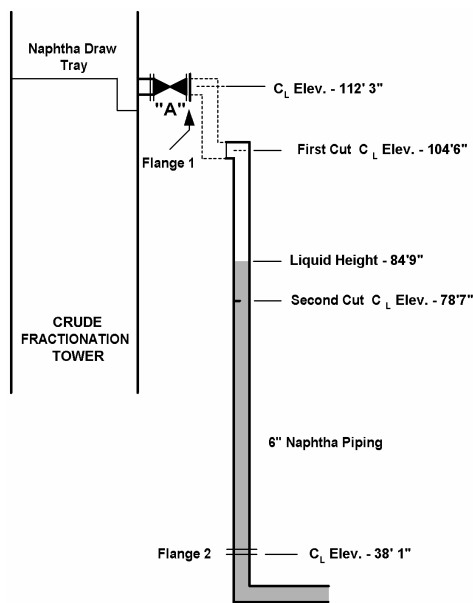
Figure 6. Fractionator and naphtha draw, simplified diagram, first cut and second cut.

valve A. A blind flange was bolted to valve A. The remaining piping was open at the point of the cut and faced the fractionator (Figure 6).

For the second cut, the maintenance supervisor directed workers to start 26 feet below the location of the first cut (Figure 6). When the saw pierced the inside diameter of the pipe wall, a small amount of liquid began to leak from the line. The worker operating the saw ceased cutting and was sent to obtain a pipe clamp to seal the leak.

- m. The first cut was completed at an approximate elevation of 104 feet above grade (Figure 6). The crane was used to remove the top 9-foot section of the piping.
