INVESTIGATION REPORT

COMBUSTIBLE DUST FIRE AND EXPLOSIONS

CTA ACOUSTICS, INC.

REPORT NO. 2003-09-I-KY

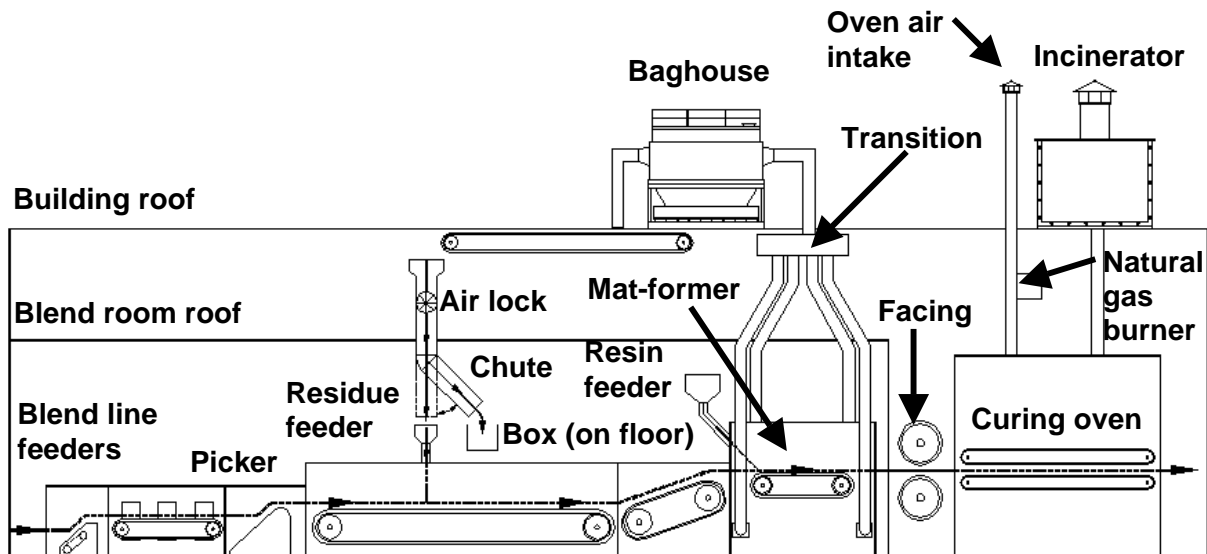
Figure 3. Line 405 process flow.

Lines 401, 402, and 403 generally operated in a manner similar to 405 (Figure 3). However, the process at line 405 is significant because CSB determined that it most likely was the origin of the initial ignition and explosion (Section 7.1.1.1). Line 416 only applied additional coatings to the industrial insulation products produced in Lines 401 and 402 and used no powdered phenolic resins.

CTA purchased and used two types of phenolic resin powder. The powders—referred to as “natural” and “black”—have similar chemical compositions and properties (Section 8.1). The natural resin, Borden Chemical Durite SD-110A, was used on lines 401 and 402 to make duct liner; while the black resin, Borden Chemical Durite SD-52SS, was used on lines 403 and 405 to make automotive acoustic insulation products. The black resin contained approximately 2 percent carbon black to produce the desired color. Substantial quantities of phenolic resins, often several hundred thousand pounds per month, were used. The quantity of black resin greatly exceeded the quantity of natural resin used in the plant’s production lines.

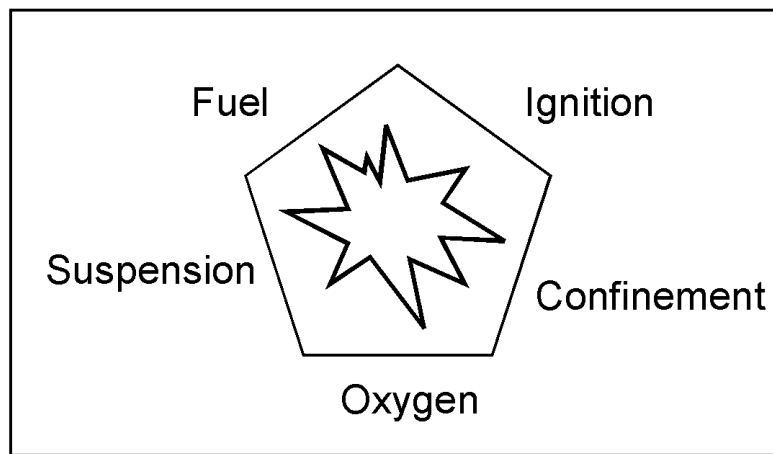
Figure 10. Dust explosion pentagon.

Fuel, ignition, oxygen, suspension, and confinement form the five sides of the dust explosion pentagon (Figure 10). Removing either the suspension or confinement elements prevents an explosion, though a fire may still occur.

Confinement is one of the requirements for a dust explosion. (Figure 10 [Section 6.2] shows the dust explosion pentagon.) Review of the CTA facility design and assessment of facility damage indicate that the processing area had many confined areas.

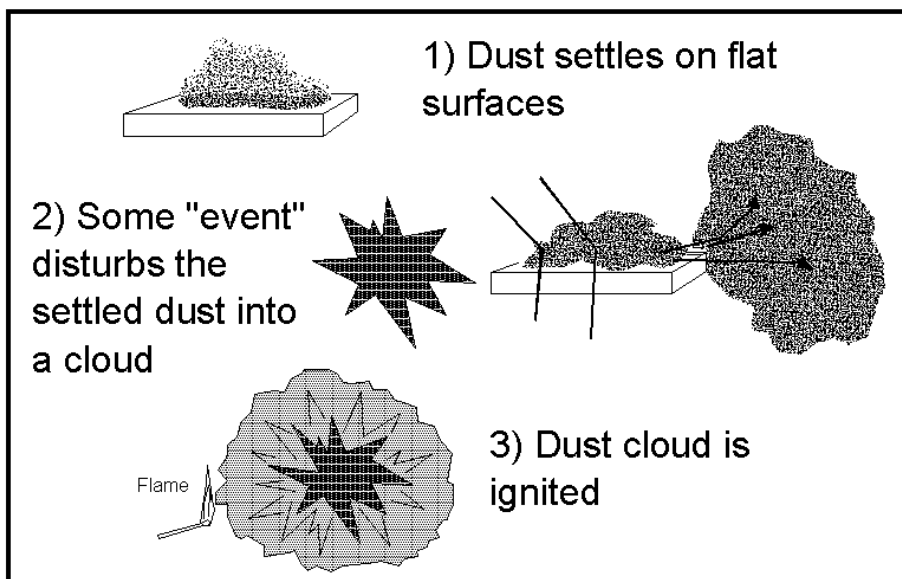
Figure 12. Mechanism for a dust fire or explosion.

Typically, dust explosions occur when a small primary explosion—not necessarily a dust explosion itself—lifts dust deposits from floors, walls, overhead beams, or equipment. As illustrated in Figure 12, the suspended dust is then ignited, causing a secondary dust explosion. The blast wave from the secondary explosion causes accumulated dust in other areas to become suspended in air. This effect, in turn, may generate additional dust explosions. Depending on the extent of the dust deposits, a weak primary explosion may cause very powerful secondary dust explosions. At CTA, the initial explosion occurred at line 405, but secondary dust explosions caused severe destruction as far as 300 feet away, near line 401.

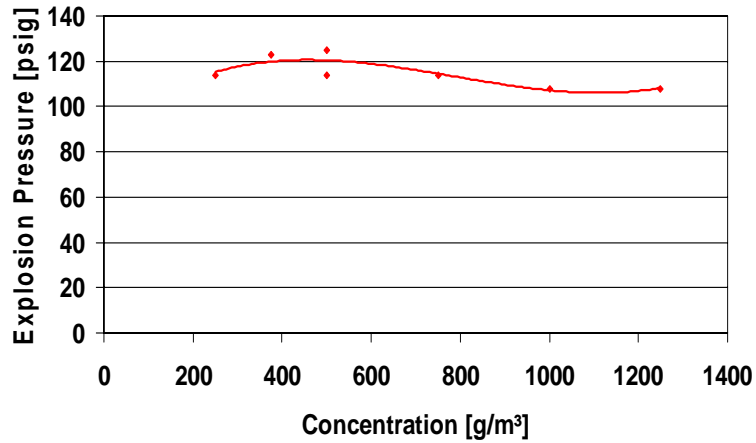
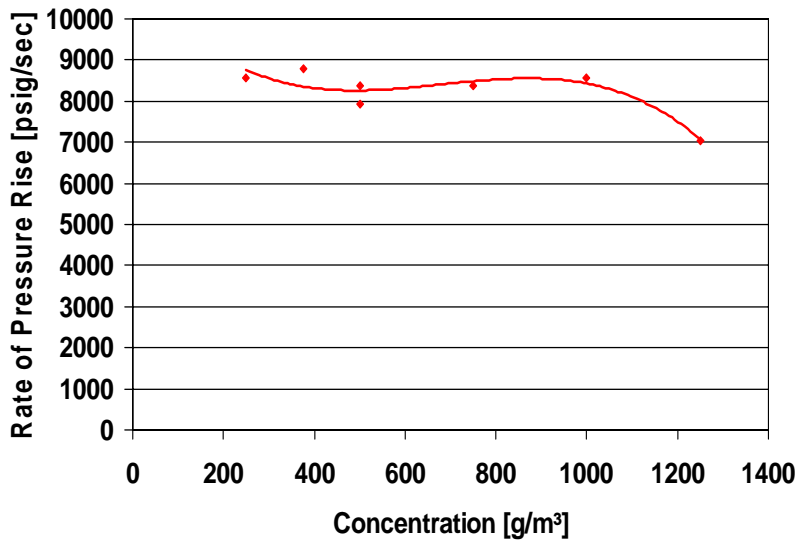
Figures B-1 and B-2 show test overpressures and rates of pressure rise as a function of concentration, respectively. The highest values of each over the entire concentration range determined P_{\max} and $(dP/dt)_{\max}$. For comparison, Figure 14 (Section 7.2) shows explosion severity data for polyethylene, Pittsburgh coal dust, and cornstarch.

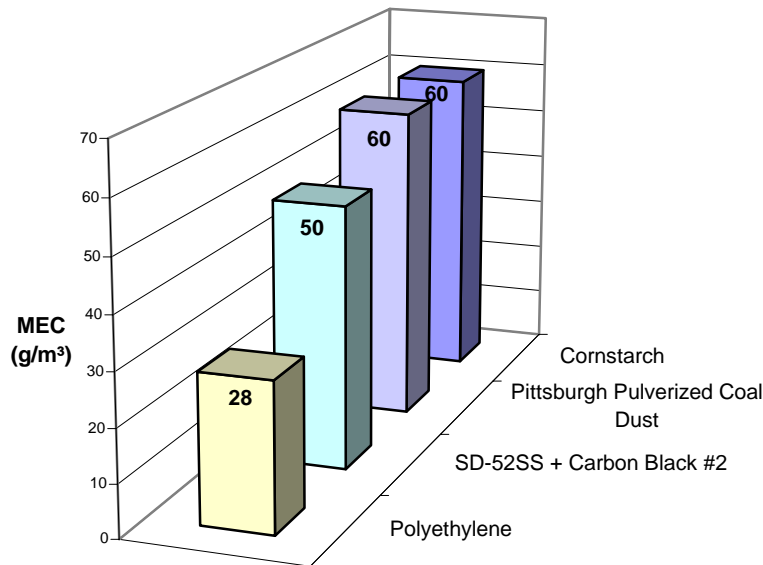
Figure B-3. Minimum explosive concentration of Durite SD-52SS compared with other common combustible dusts.

Figure B-3 compares MECs for the Borden Chemical SD-52SS phenolic resin, Pittsburgh coal dust, polyethylene dust, and cornstarch.
