**U.S. CHEMICAL SAFETY AND HAZARD INVESTIGATION BOARD**

# **INVESTIGATION REPORT**

## **CATASTROPHIC VESSEL OVERPRESSURIZATION (4 DEATHS)**

Sonat Exploration Company  
Temple 22-1 Common Point Separation Facility  
Pitkin, Louisiana  
March 4, 1998

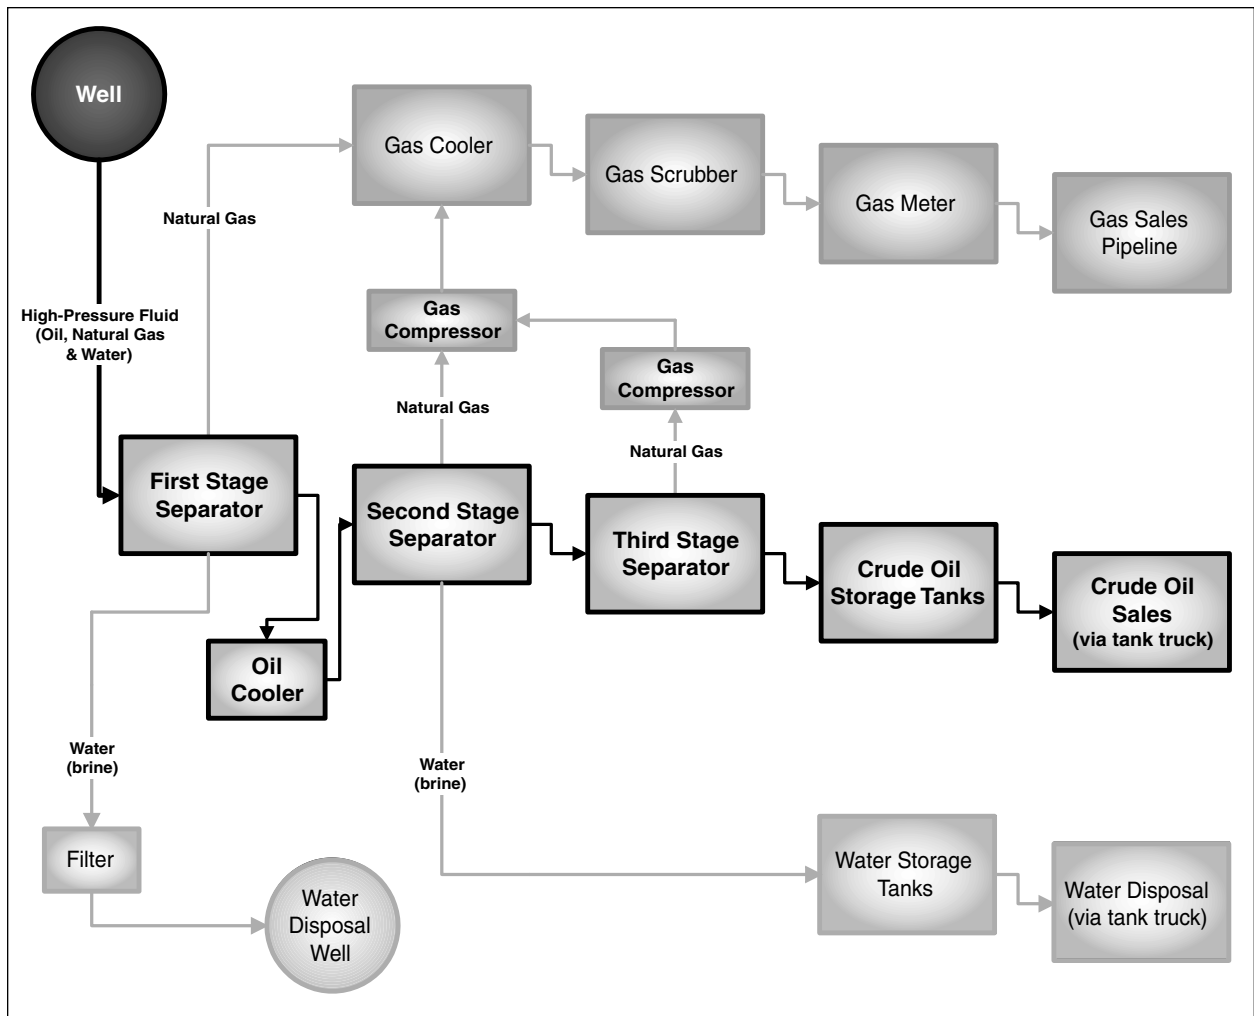
**Figure 2. Block Flow Diagram of the Separation Process**

on each separator. Actual operating pressures were considerably lower, around 900 psig for the first-stage separator and 225 psig for the second-stage separator. The third-stage separator<sup>16</sup> had an MAWP of 0 psig (atmospheric pressure) and would have operated around this pressure during normal operation. As the pressure of the well fluid was decreased through the series of separators, the solubility of natural gas in the fluid decreased and an increasing fraction of the gas would distill off for collection.

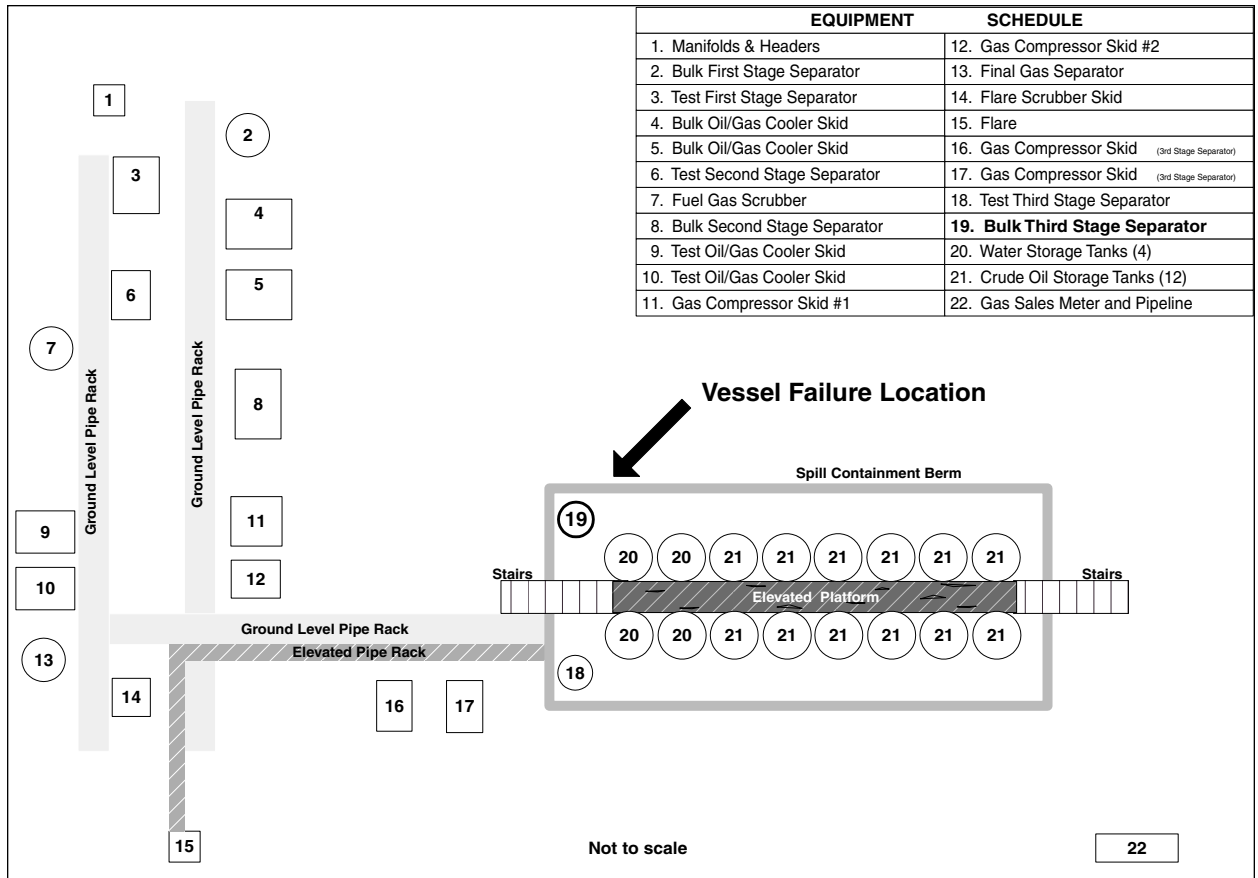
Figure 3. Plot Plan of the Temple 22-1 Common Point Separation Facility

The first two separators were designed for three-phase (gas/oil/water) separation, while the third-stage separator was designed for two-phase (gas/oil) separation. Residence time of the fluid in the first two separators was sufficient for the gravity-based separation of the oil and water phases. Natural gas from the separators was directed to the gas sales pipeline, while separated brine was either directly injected into the ground or impounded in storage tanks. The oil phase was transferred from one separator to the next, and eventually to the storage tanks for shipment by truck to a refinery. Natural gas was compressed and transported by pipeline to a gas processing plant. Figure 3 shows the overall layout of the facility.

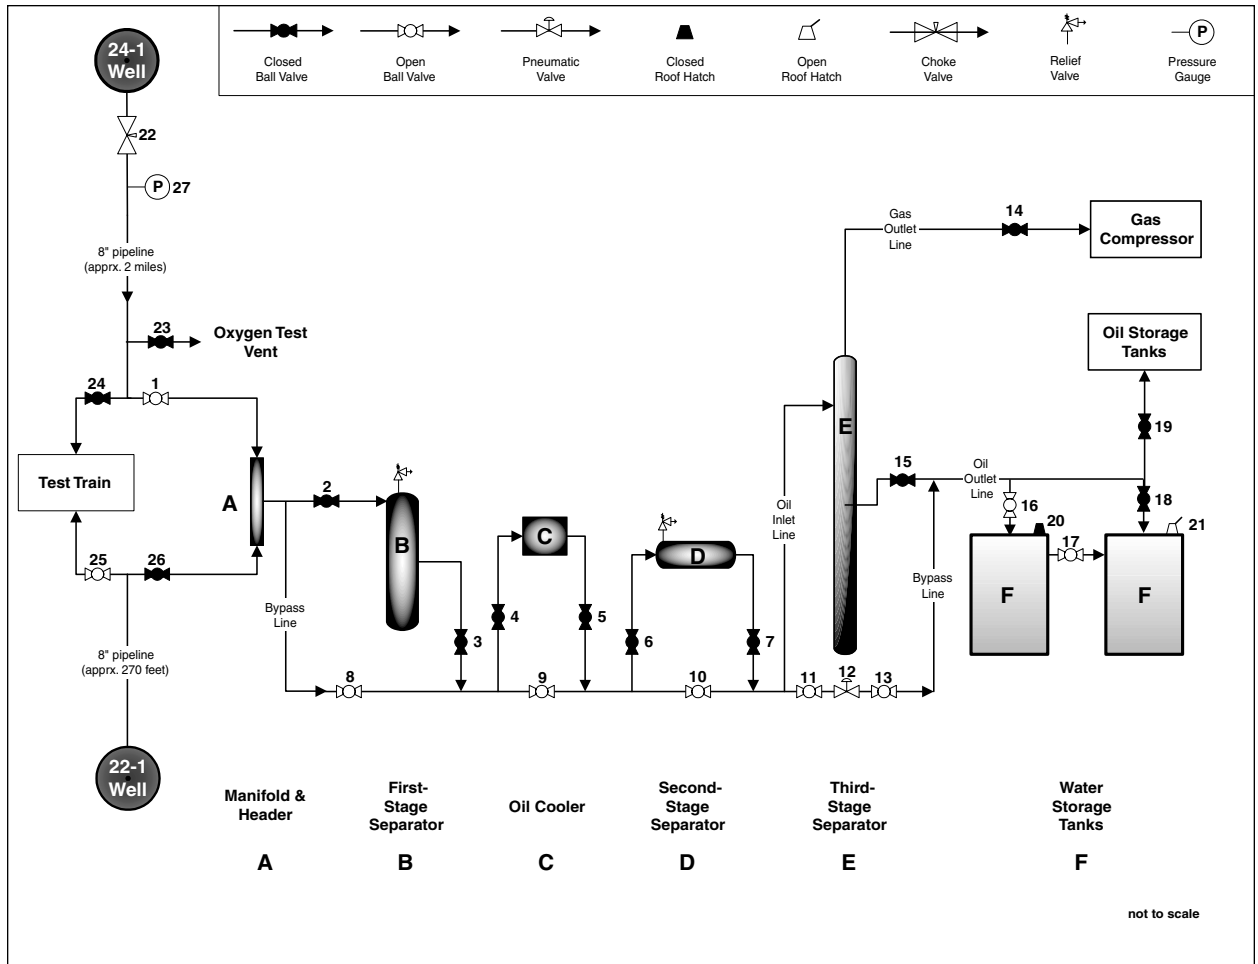
Figure 5. Intended Valve Positions after the Final Alignment

With the purging of the Bulk Train separation equipment completed, preparations were made for the purging of the two-mile pipeline leading from the 24-1 well. The Sonat construction supervisor and the assigned operator realigned the valves as shown in Figure 5.<sup>20</sup> According to their plan, they would direct well fluid as follows:

<sup>20</sup> Figure 5 assigns numbers to valves, hatches, and gauges that are referred to in the remainder of the report. The numbers were assigned arbitrarily for the purpose of this report and were not used at the facility. Figure 5 is not intended to be a complete schematic diagram.

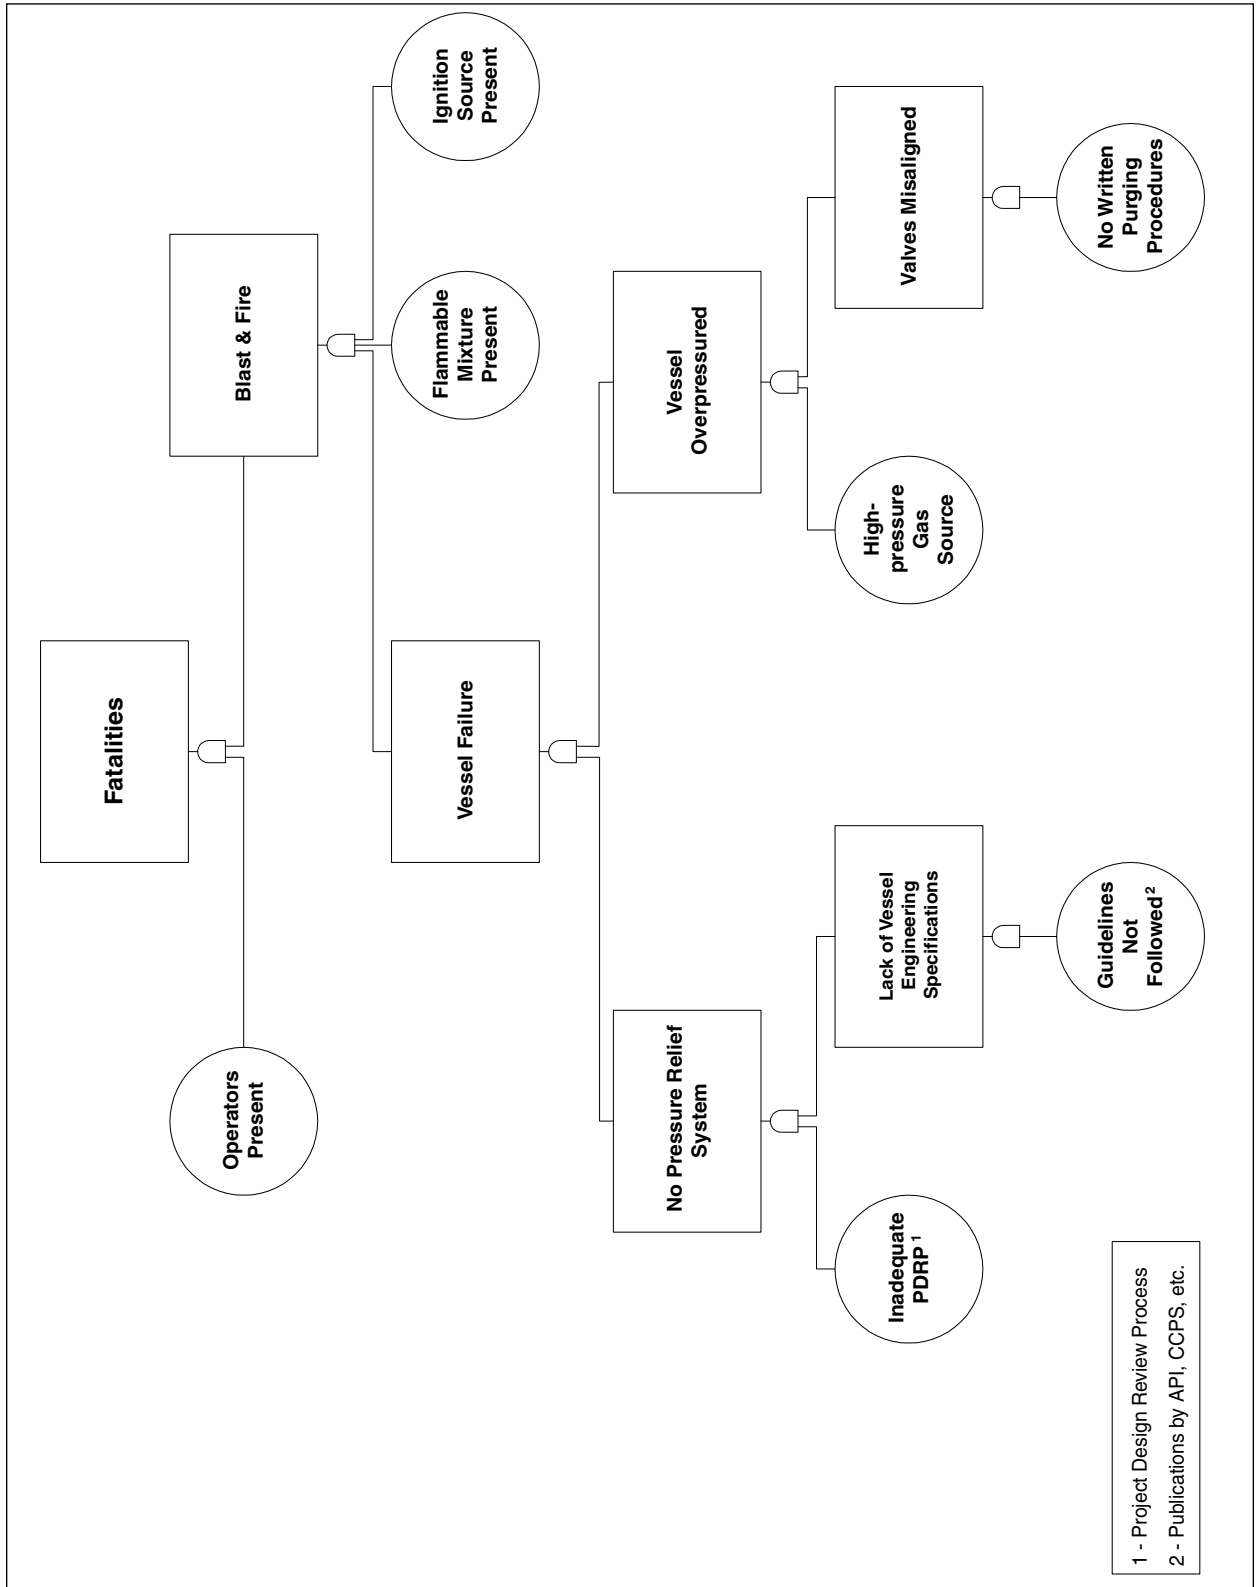
# APPENDIX A: CAUSAL TREE ANALYSIS DIAGRAM

1 - Project Design Review Process  
 2 - Publications by API, CCPS, etc.
