U.S. CHEMICAL SAFETY AND HAZARD INVESTIGATION BOARD

INVESTIGATION REPORT

CHLORINE RELEASE

DPC ENTERPRISES, L.P.

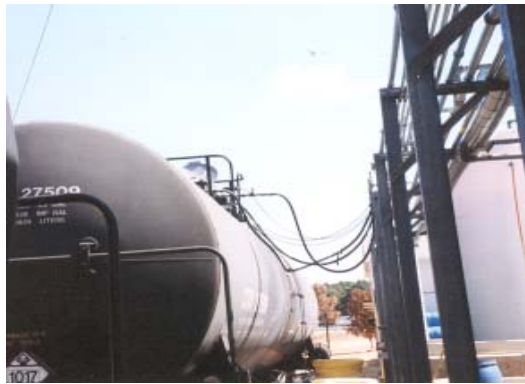
Around 9:20 am on Wednesday, August 14, 2002, a 1-inch chlorine transfer hose (CTH) used in a railroad tank car unloading operation at the DPC Enterprises, L.P., facility, near Festus, Missouri, catastrophically ruptured (Figures 1 and 2). The facility is located in an unincorporated area of Jefferson County. The hose rupture initiated a sequence of events that led to the release of 48,000 pounds of chlorine. The release continued unabated for nearly 3 hours.

Figure 1. Railroad tank car unloading station #3.

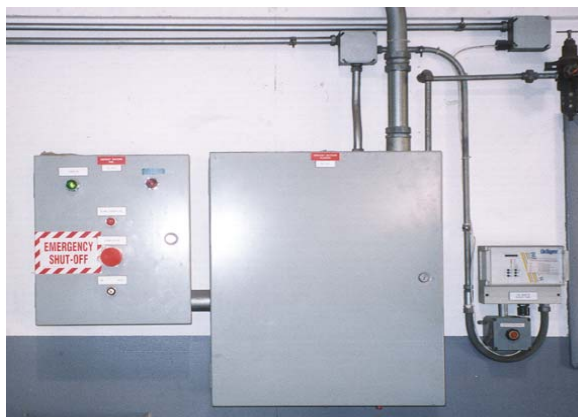
magnitude and intensity of the release, the employees evacuated the building. The operations manager pushed the ESD button (Figure 15) as he exited in an attempt to manually shut off the chlorine release.

Figure 15. ESD panel with emergency shutdown button.

The chlorine repackaging system ESD valves are intended to close either automatically based on chlorine detection levels or through hand-operated ESD buttons. Although both methods were activated during the incident, several critical ESD valves failed to close, which allowed the release to continue unabated. The ESD system was not designed to provide a signal of actual valve closure.

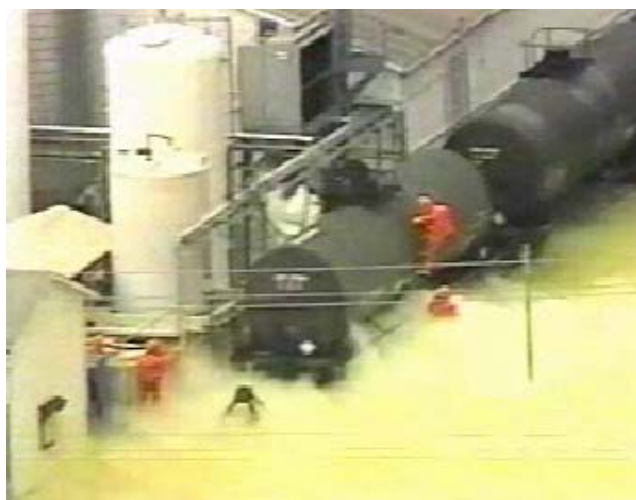
Three HAZMAT personnel and one DPC employee (who had specialized HAZMAT training) entered the release area around noon, where a yellowish-green fog about 4 feet high covered the area surrounding the tank car. Visibility was very poor. Two HAZMAT personnel climbed the tank car ladder to access the top of the car (Figure 17). They closed the liquid valve that supplied the ruptured hose (valve A), but the release did not stop. They then closed the other liquid valve (valve C) and vapor valve D halfway; then they completely closed both valves. The release stopped when valve C was closed.

Figure 17. HAZMAT personnel accessing the top of tank car to close valves.

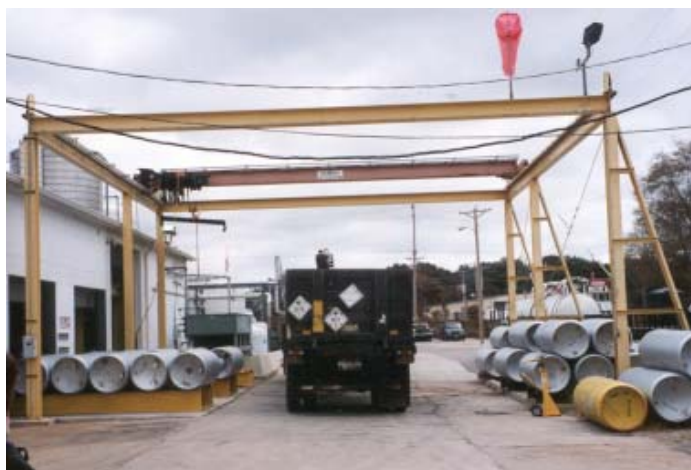
Another incident at DPC Festus, in January 1999, demonstrated the need for improved community notification. In that incident, a 1-ton container of chlorine was dropped as it was being loaded onto a truck (Figure 26). The fall damaged the container valves and released 1,500 pounds of chlorine. Twenty-two residents and two DPC employees sought medical evaluation due to exposure; one person was admitted and released the following day. Several residents and community officials interviewed by CSB in the course of the 2002 investigation indicated that DPC had committed to update its community notification procedures and implement a notification system as result of the 1999 incident. However, DPC did not follow through on this commitment.

Figure 26. Truck loading station at DPC Festus.
