U.S. CHEMICAL SAFETY AND HAZARD INVESTIGATION BOARD

INVESTIGATION REPORT

LPG FIRE AT VALERO – MCKEE REFINERY

REPORT NO. 2007-05-I-TX

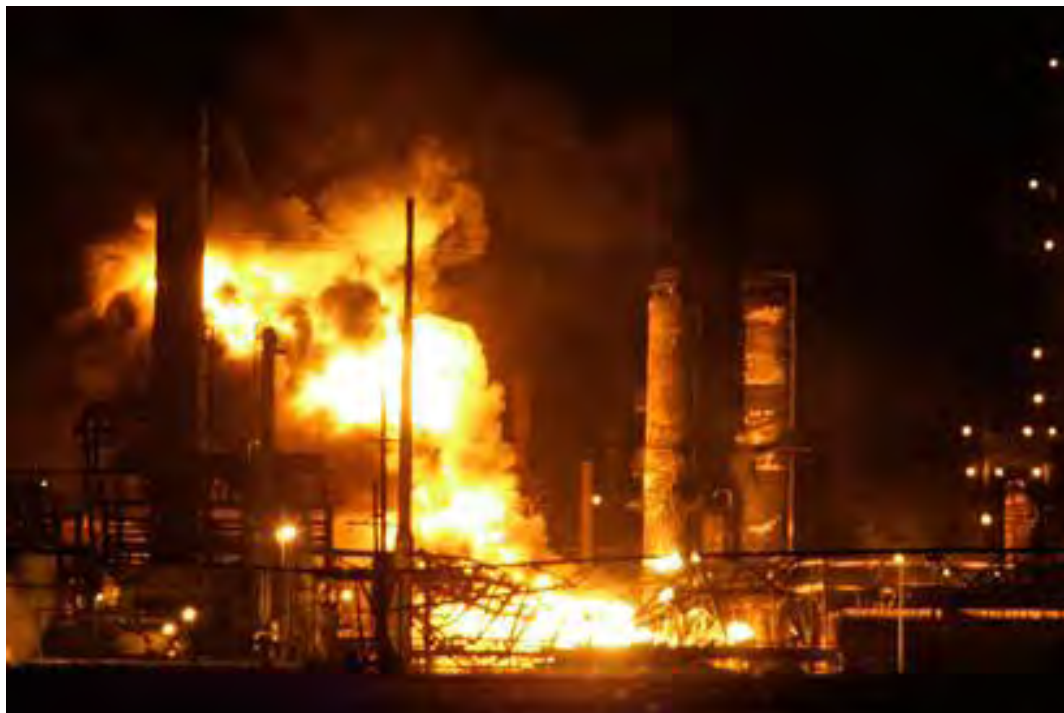
(Four Injured, Total Refinery Evacuation, and Extended Shutdown)

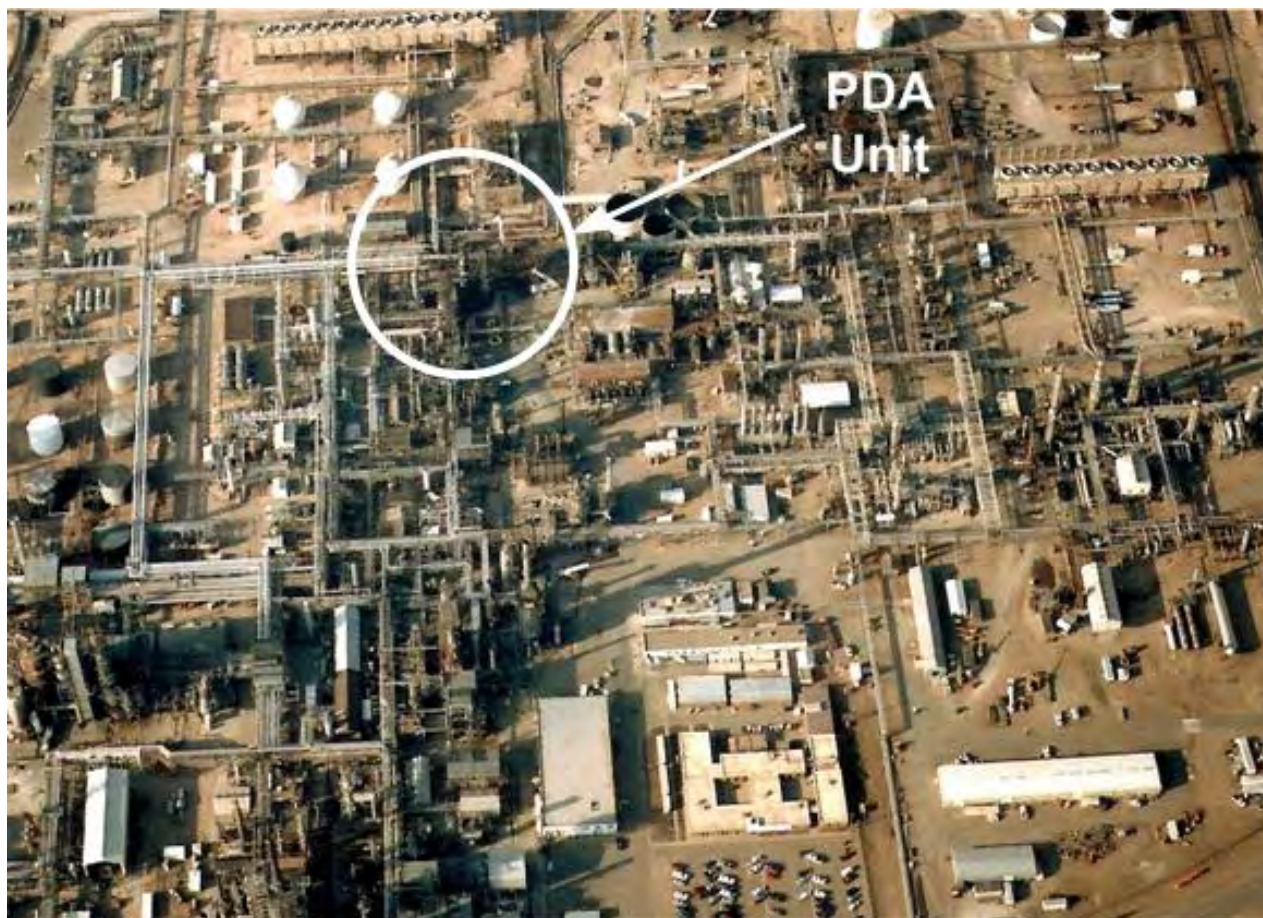
Figure 1. PDA unit location in the McKee Refinery

The PDA unit (Figure 1) recovered fuel feedstock and paving-grade asphalt from the heavy bottoms (pitch⁶) produced in the refinery's vacuum crude oil fractionator. In the McKee PDA process, two liquid/liquid extraction towers used liquid propane as a solvent to extract gas oil⁷ from the pitch under approximately 500 pounds per square inch (psi)(3,447 kPa) pressure. The recovered gas oil was processed into gasoline in another refinery unit. The asphalt produced was sold for use in paving materials. Figure 2 is a simplified process flow diagram for the No. 1 Extractor, including the location from which the propane was initially released.

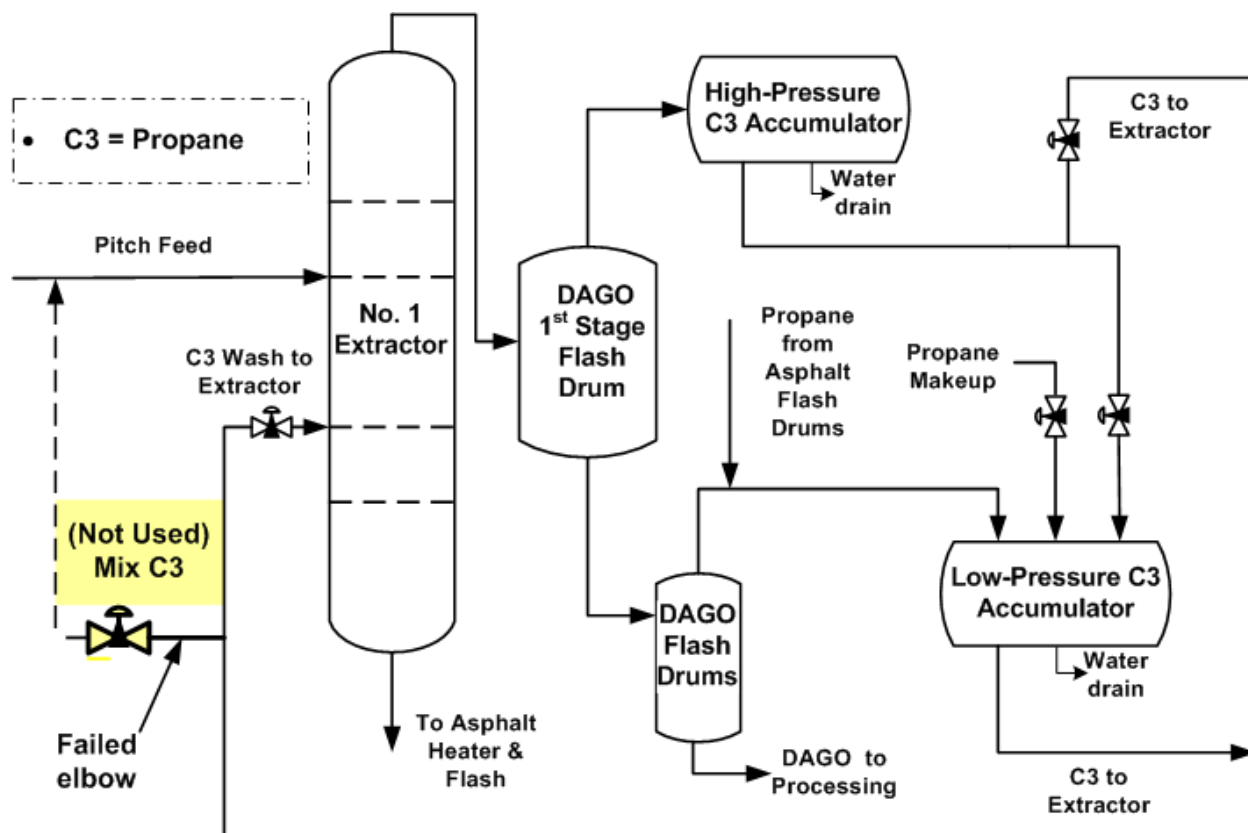
Figure 2. No. 1 Extractor simplified process flow diagram

The relatively dense pitch entered an upper section of the extractor and flowed to the bottom of the tower. Less dense liquid “wash” propane entered a lower section and flowed to the top of the extractor. Internal structures in the tower promoted effective contact between the two streams. DeAsphalted Gas Oil (DAGO) extracted from the pitch flowed out of the top of the tower with much of the propane. This liquid flowed through a series of flash drums⁸ to remove propane from the gas oil. The DAGO was sent elsewhere in the refinery for processing.

A mixture of asphalt and propane flowed from the bottom of the extractor. This stream was also heated and flashed to remove entrained propane, and the asphalt sent to storage.

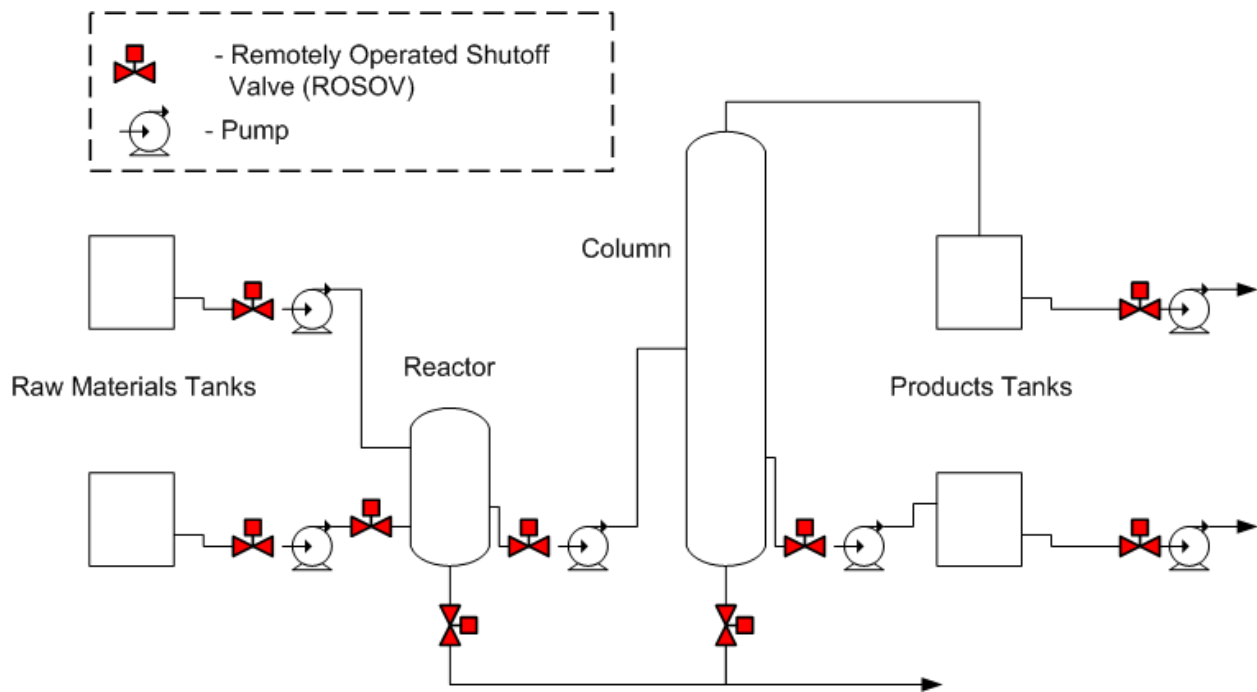
Figure 12. Insurer-recommended locations for ROSOVs

Although the PDA unit contained large inventories of high-pressure propane, it was not equipped with remotely operable shut-off valves (ROSOVs)³⁷ to rapidly stop propane releases. ROSOVs should be used in facilities, such as the PDA unit, where fast and effective isolation is needed to reduce the impact of major hazardous releases (HSE, 1999).

Figure 12 shows insurer-recommended ROSOV locations for a typical process unit. ROSOVs should be installed on large inventories of highly flammable materials,³⁸ especially when downstream pumps are present that could produce pressurized releases. Such pumps should be interlocked to shut down when ROSOVs are closed.

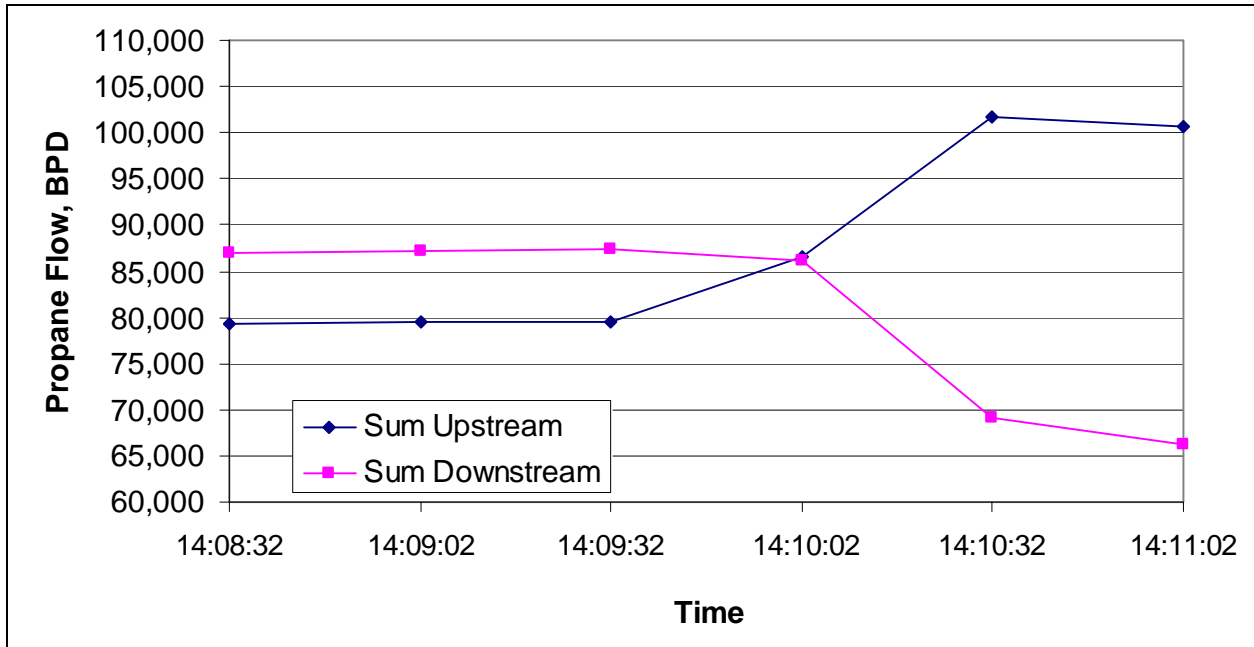
Figure D- 1. Changes in propane flows upstream and downstream of the cracked elbow

Figure 1 plots the sum of the upstream and downstream flow meter readings, in bpd.² The offset prior to the incident is due to an unmeasured process flow between the low- and high-pressure propane supplies upstream of the leak point. Assuming that this offset was fixed during the incident is conservative – the actual release rate was likely modestly higher than estimated here.

$$[21,900] + [19,500] = 41,400 \text{ bpd.}$$

Based on a liquid propane density of 27.7 lb per cubic foot at process conditions, the CSB estimated an initial release rate of 4,500 lb/min.

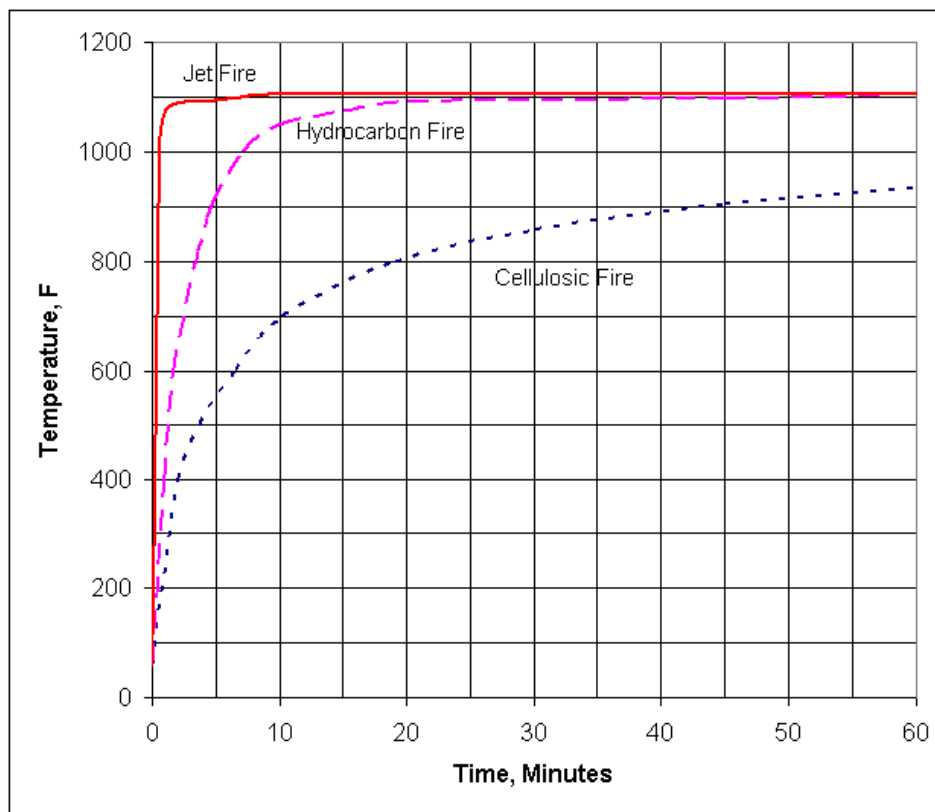
Figure E-1. Time temperature curves for fire tests (CCPS, 2003)

Facilities discusses the importance of fireproofing during the early stages of a fire, when “if non-fireproofed equipment and pipe supports fail due to fire related heat exposure, they could collapse and cause gasket failures, line breaks, and equipment failures, resulting in expansion of the fire.” This type of knock-on damage was a significant factor in the damage caused by the PDA unit fire. As Figure E-1 illustrates, exposure to a jet fire, as can occur in pressurized LPG fires, can lead to rapid heating and the failure of exposed steel within a few minutes.¹

In this incident, the severity of the fire caused rapid knock-on damage before fuel supplies could be isolated or effective water sprays established. The use of ROSOVs, combined with fireproofed pipe rack supports, would likely have significantly reduced the damage caused by this fire.
