# INVESTIGATION REPORT

## XCEL ENERGY HYDROELECTRIC PLANT

### PENSTOCK FIRE

REPORT No. 2008-01-I-CO

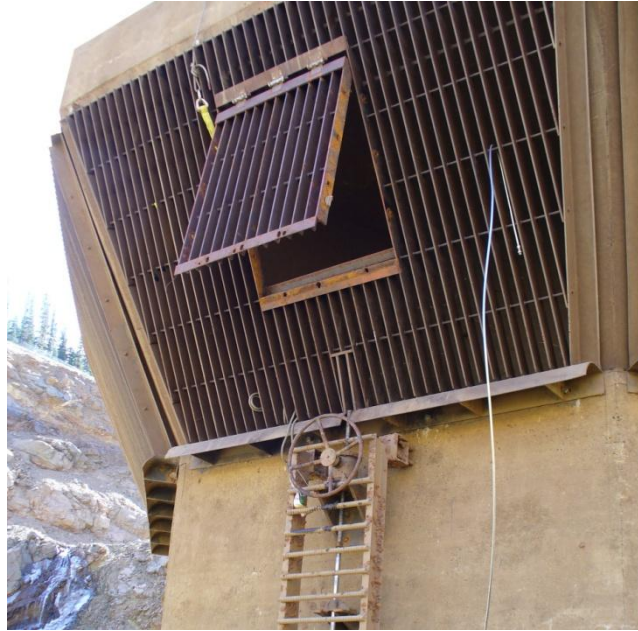
Figure 3. Upper reservoir mushroom access hatch

At the highest elevation point of the penstock in the upper reservoir is the intake structure known as the “mushroom.” The mushroom is a 40-foot (12 meter) tall, cylindrical concrete and steel tower with screened openings near the top that open to the penstock. The mushroom has an access hatch approximately 20 feet (6.1 meters) above grade at a reverse incline position that requires climbing skill and significant physical strength to enter (Figure 3).

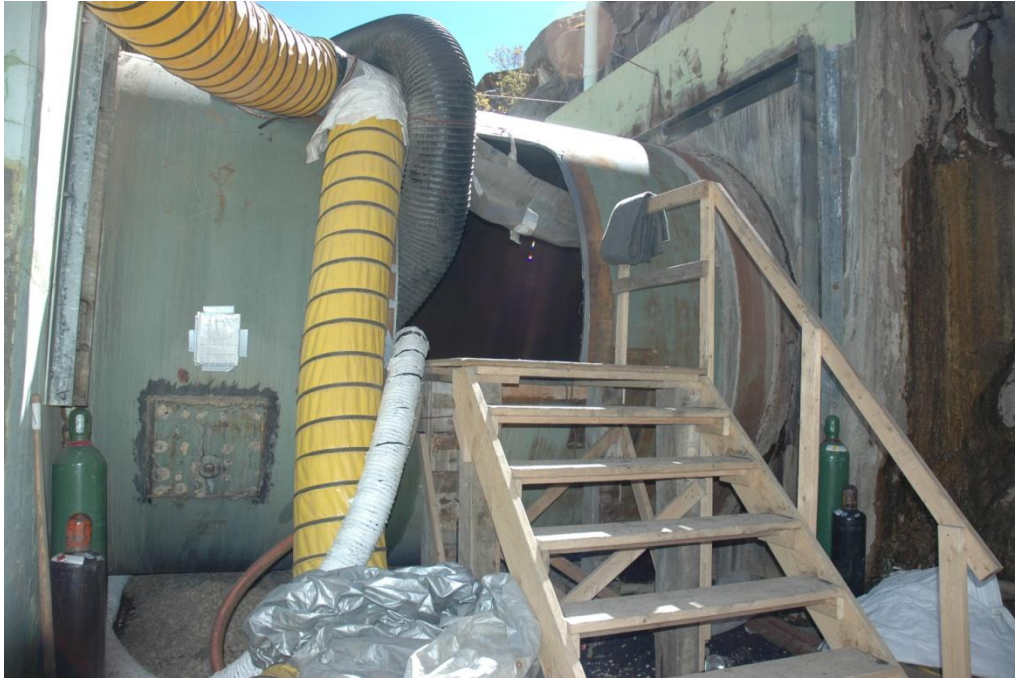
Figure 4. Access door cut into penstock for recoating work

While the penstock runs underground for most of its length, as it exits the mountain rock face near the lower reservoir, a 15-foot (4.6 meter) section is accessible from the powerhouse yard. In this portion of the penstock, a 4 by 6 foot (1.2 by 1.8 meter) opening was flame-cut into the steel penstock pipe to provide access for the recoating project workers and equipment.

Wooden stairs and a ladder at the access door provided means for personnel to enter and exit the penstock (Figure 4).

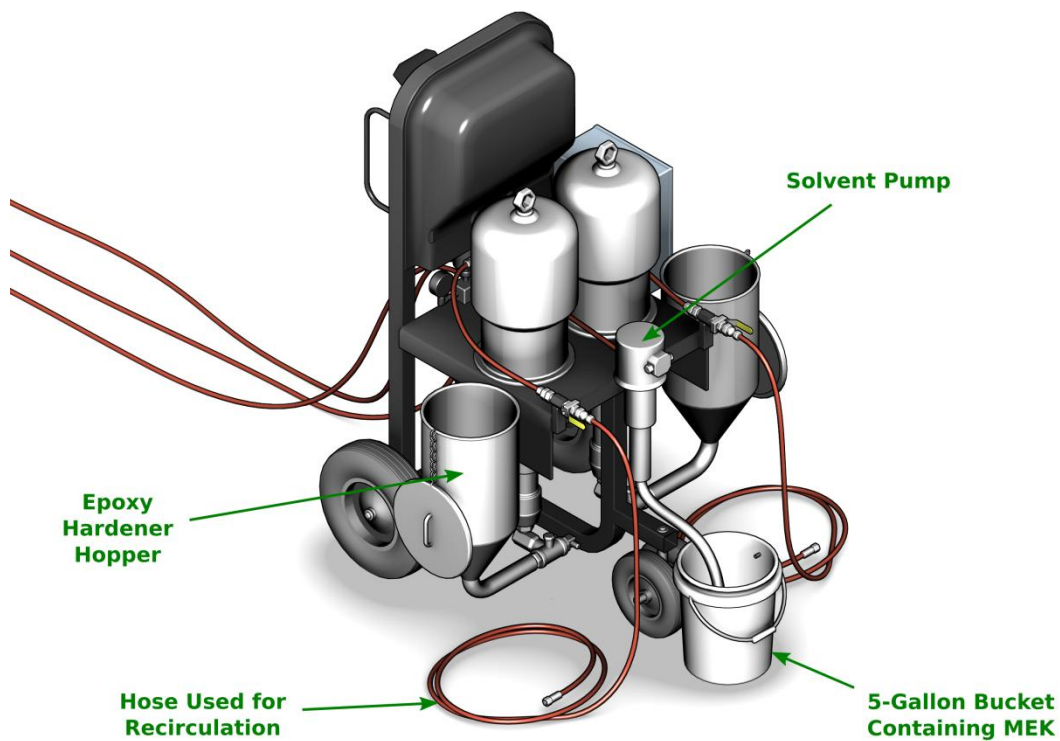
Figure 6. The solvent pump on the back side of the epoxy sprayer

Solvent, such as MEK, is needed if problems arise when applying the epoxy mixture. If the combined epoxy product was to set, it would harden within the hoses and spray wands, destroying the equipment. Solvent would be used to flush out the mixing block and hoses to the spray wands to ensure that the epoxy mixture was fully removed from the equipment and would not permanently render it unusable. Solvent would be introduced into these portions of the spray system using a third smaller pump on the back of the machine that would take in solvent from an open bucket placed on the ground at the back of the sprayer (Figure 6). A hose ran directly from this pump to the mixing block.

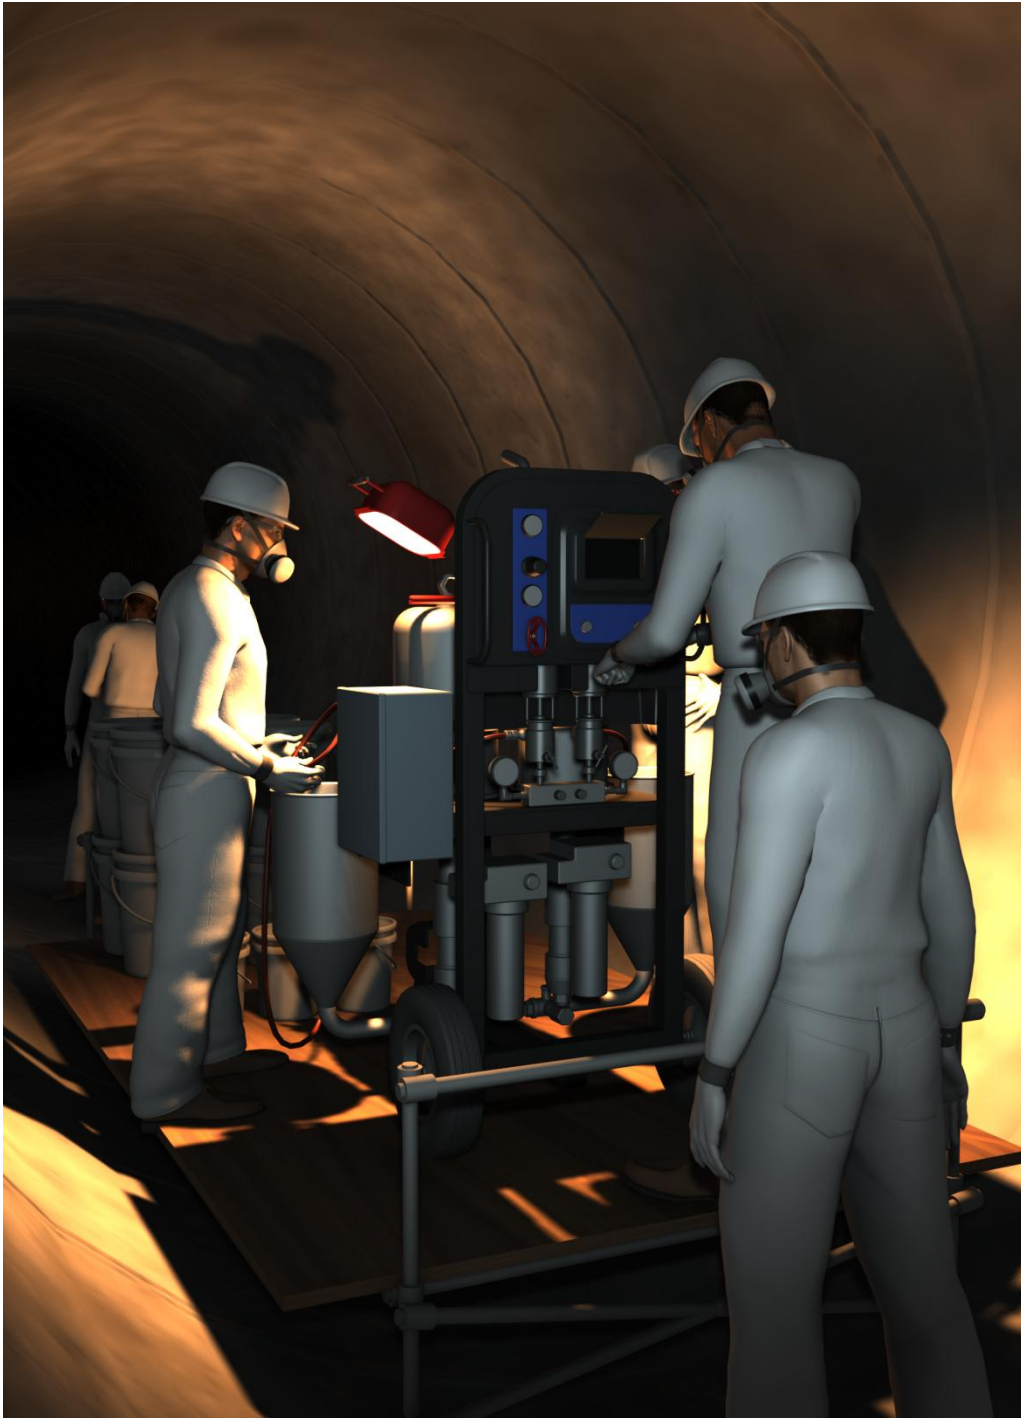
Figure 8. Depiction of contractors working with the sprayer immediately prior to the flash fire

In the hour leading up to the incident, five of the 13 contractors were working around the sprayer system (Figure 8). Three of these individuals – two of whom were foremen – worked the controls of the sprayer, while two others were stationed on the sides, each responsible for manning a hopper. Four additional contractors were runners, bringing epoxy, solvent, and other equipment to and from the work area to assist the five at the sprayer, and one person was stationed as the “hole watch” attendant at the access door 1,450 feet (442 meters) away.<sup>22</sup>

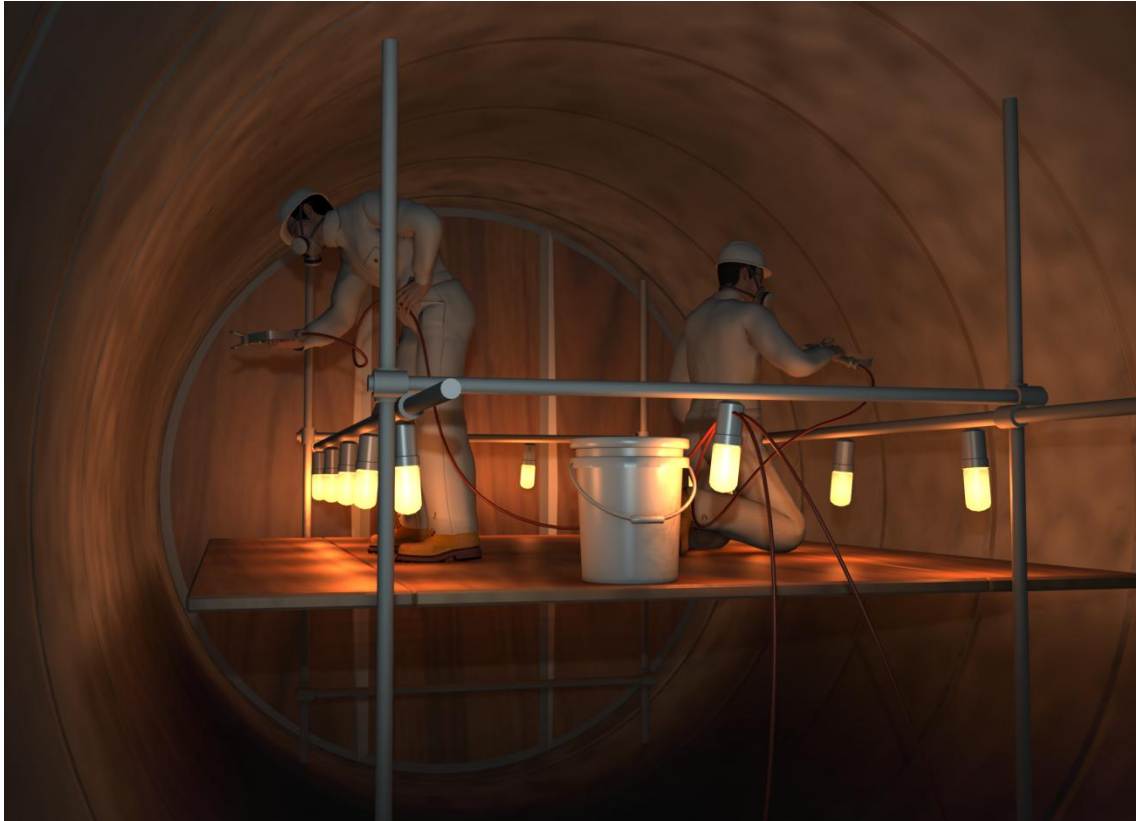
Figure 9. Depiction of contractors recoating the penstock interior near the temporary west bulkhead

The last two of the 13 contractors – besides the general foreman – were at the far end of the work area near the temporary west bulkhead, preparing to begin recoating the penstock interior using a wheeled scaffold that had been built for the crew as they used spray wands to recoat the penstock interior (Figure 9).
