# FINAL INVESTIGATION REPORT

## CARIBBEAN PETROLEUM TANK TERMINAL EXPLOSION AND MULTIPLE TANK FIRES

### **CARIBBEAN PETROLEUM CORPORATION (CAPECO)**

REPORT NO. 2010.02.I.PR  
U.S. CHEMICAL SAFETY AND HAZARD INVESTIGATION BOARD

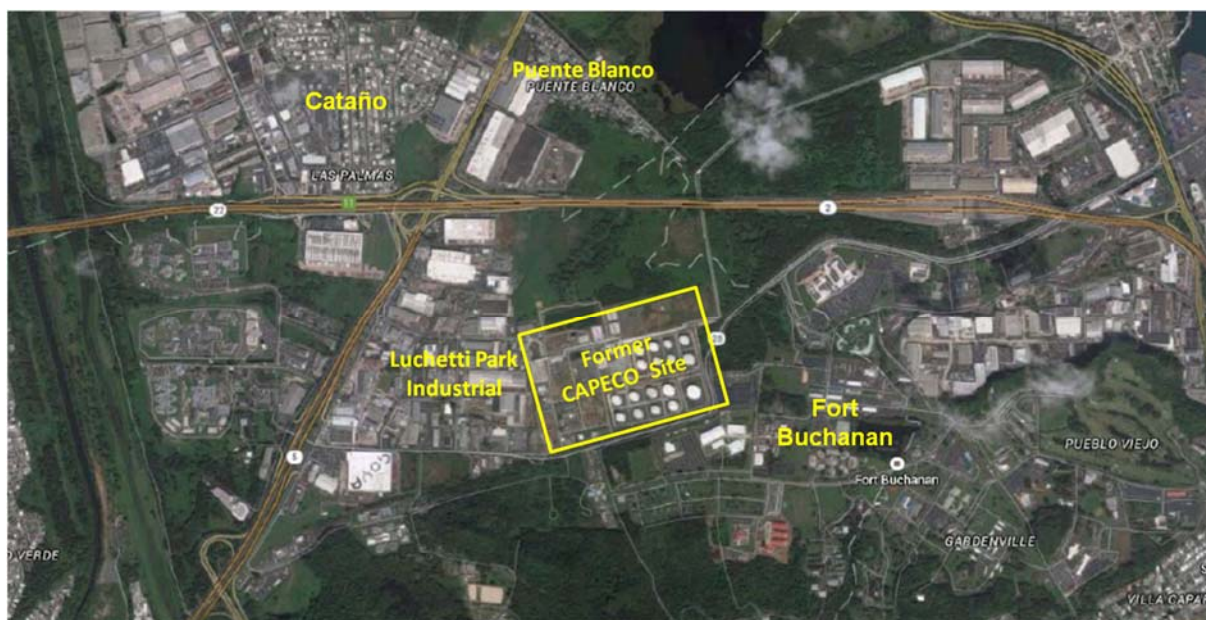
Figure 9: Communities neighboring the CAPECO facility

Despite approximately 1,600 people residing adjacent to the CAPECO facility in the Puente Blanco community<sup>38</sup> and about 48,500 residents living in Cataño three miles from the incident site (Figure 9), the 2009 explosion and fires did not result in any fatalities. However, shrapnel and glass from the blast caused minor injuries to three people at Fort Buchanan. Nearby residents of the surrounding communities were awakened by the blast and ensuing fire. The CSB learned, regulatory authorities in Puente Blanco issued unclear evacuation orders by bullhorn as they drove through the community. With no planned evacuation routes or shelters, residents crowded into the narrow streets. Some members of other nearby communities evacuated voluntarily to escape damaged homes and potential health effects from the smoke and vapors generated by the fire.

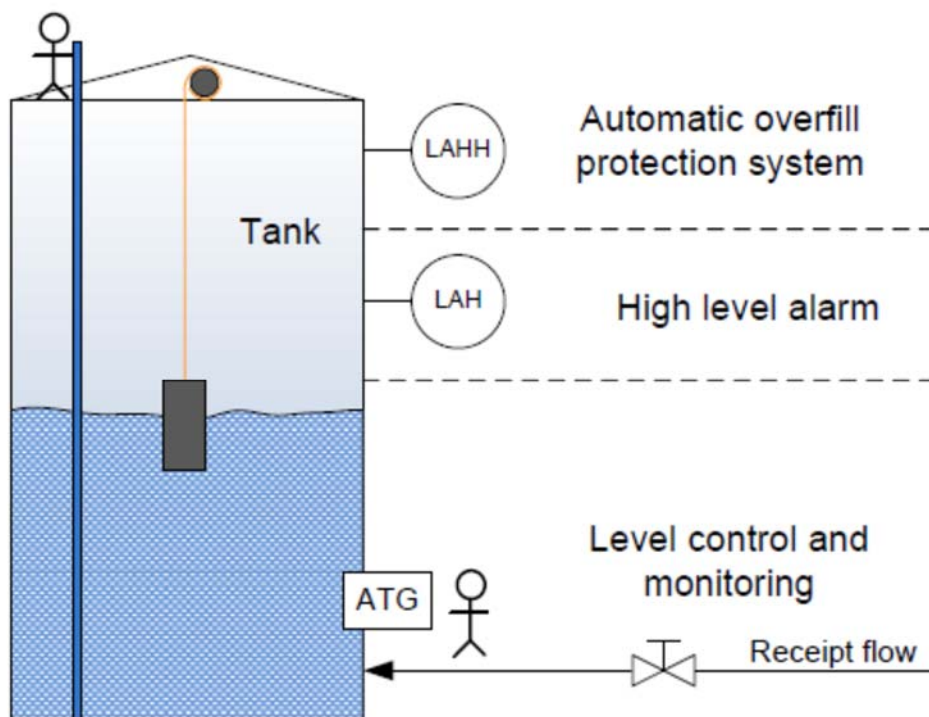
The CSB found that CAPECO purchased the least effective level-measurement system and employed an inadequate maintenance program to care for that system. These shortfalls in safety critical equipment in the level control and monitoring system, including the transmitters on the side gauge and the float and tape device in the tank, prevented operators from determining tank levels during filling operations. Figure 10 illustrates the issues with the level control system at CAPECO.

Figure 13: A comprehensive overfill prevention system includes the ATG, high-level alarm (LAH), and automatic overfill protection system (LAHH), in addition to the operator and facility procedures that govern, monitor, and control the flow of fuel into a tank.

CAPECO lacked a reliable automatic level control and monitoring system for measuring tank levels. (See Figure 13.) The automatic gauging system at CAPECO, described in Section 3.6.3, had a history of repeated failures and prolonged out-of-service periods. On the night of the incident, the float and tape device inside Tank 504 became stuck and the transmitters for Tanks 107 and 409 were not receiving data from the side gauge on Tank 409; therefore, data on the tank liquid level and a calculated fill rate into 409 were not available in real time on the computer. The computer monitoring system was often compromised by outages from lightning strikes and accidental breakage of the computer cables after maintenance activities in the tank farm area. In addition, the transmitters<sup>56</sup> that sent the data to the computer were also susceptible to electromagnetic interference and frequently needed replacing after lightning storms.

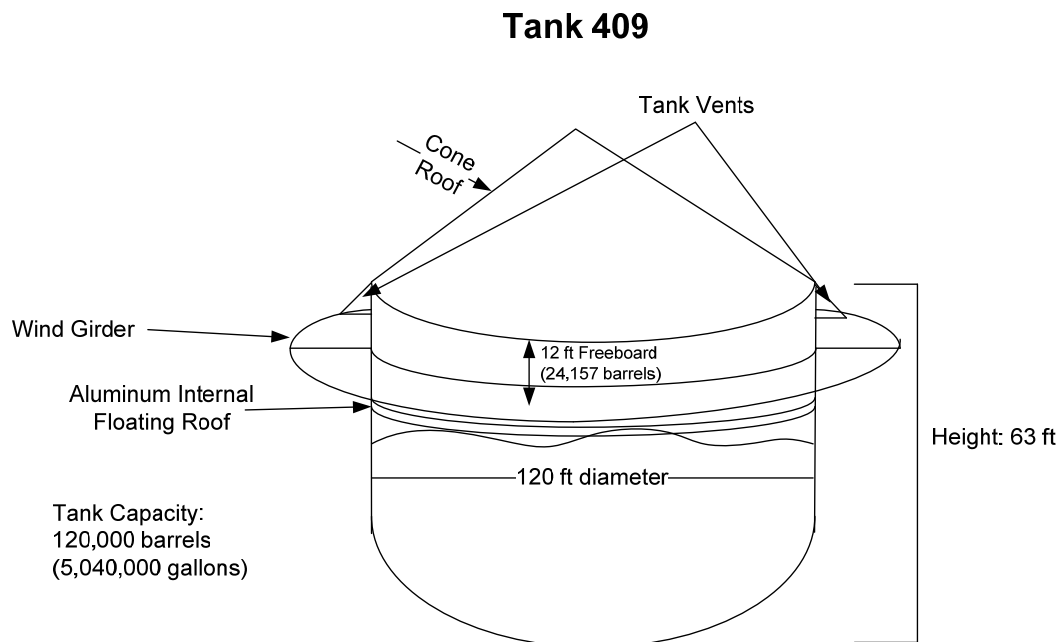
Figure 14: Tank 409 Specifications

Tanks 409 and 410 were located within the same secondary containment dike.<sup>23</sup> Similar to the Buncefield incident,<sup>24</sup> during the overflow, gasoline sprayed from the tank vents, hitting the Tank 409 wind girder and aerosolized,<sup>25</sup> forming a vapor cloud.<sup>26</sup> A CSB topographic survey of the site shows that Tanks 409 and 411 were located at the highest point within the tank farm area, allowing the vapor cloud to spread to lower lying areas in the direction of the WWT (Figure 7). See Figure 14, Tank 409 Specifications.

The destruction of the Tank 409 internal floating roof in the explosion prevented the CSB from determining if it failed during filling operations. Therefore, internal floating roof failure might have contributed to the overfilling of Tank 409. The roof construction of Tank 409 was subject to numerous operational limitations. Tank 409 had a fixed cone roof with an aluminum internal floating roof (IFR), and a freeboard<sup>71</sup> of 12 feet (24,157 bbls). (See Figure 14 for Tank 409 specifications.) Aluminum IFRs are prone to corrosion when exposed to caustic liquids but sufficient for petroleum and organic materials. An internal floating roof can fail by means of turbulence,<sup>72</sup> roof submersion,<sup>73</sup> seal issues, and fatigue.<sup>74</sup>
