Investigation Report

Published: December 2019

KEY ISSUES:

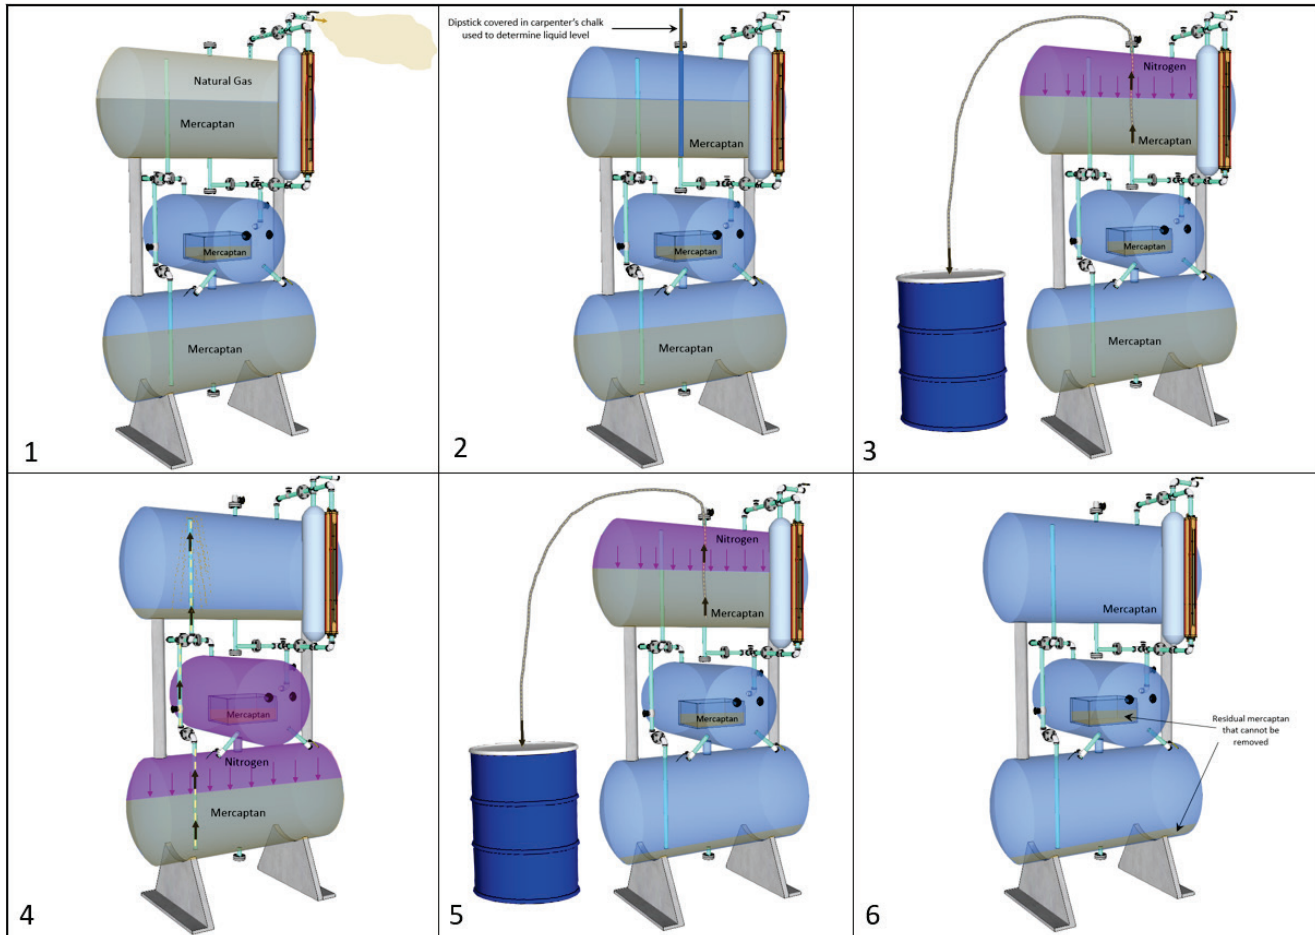
MRR technicians do not perform any testing to analyze or characterize what chemicals are present in the MP odorizer. Also, due to the design of the odorizer itself and the decommissioning process MRR established, MRR technicians do not have a way to remove all the uncharacterized liquid from the bottom chamber or the middle chamber.^a

Figure 3. Odorizer Decommissioning and Draining. These graphics outline the steps MRR technicians typically performed to drain liquid from MP odorizers tanks in preparation for transport and chemical treatment. (Credit: CSB).

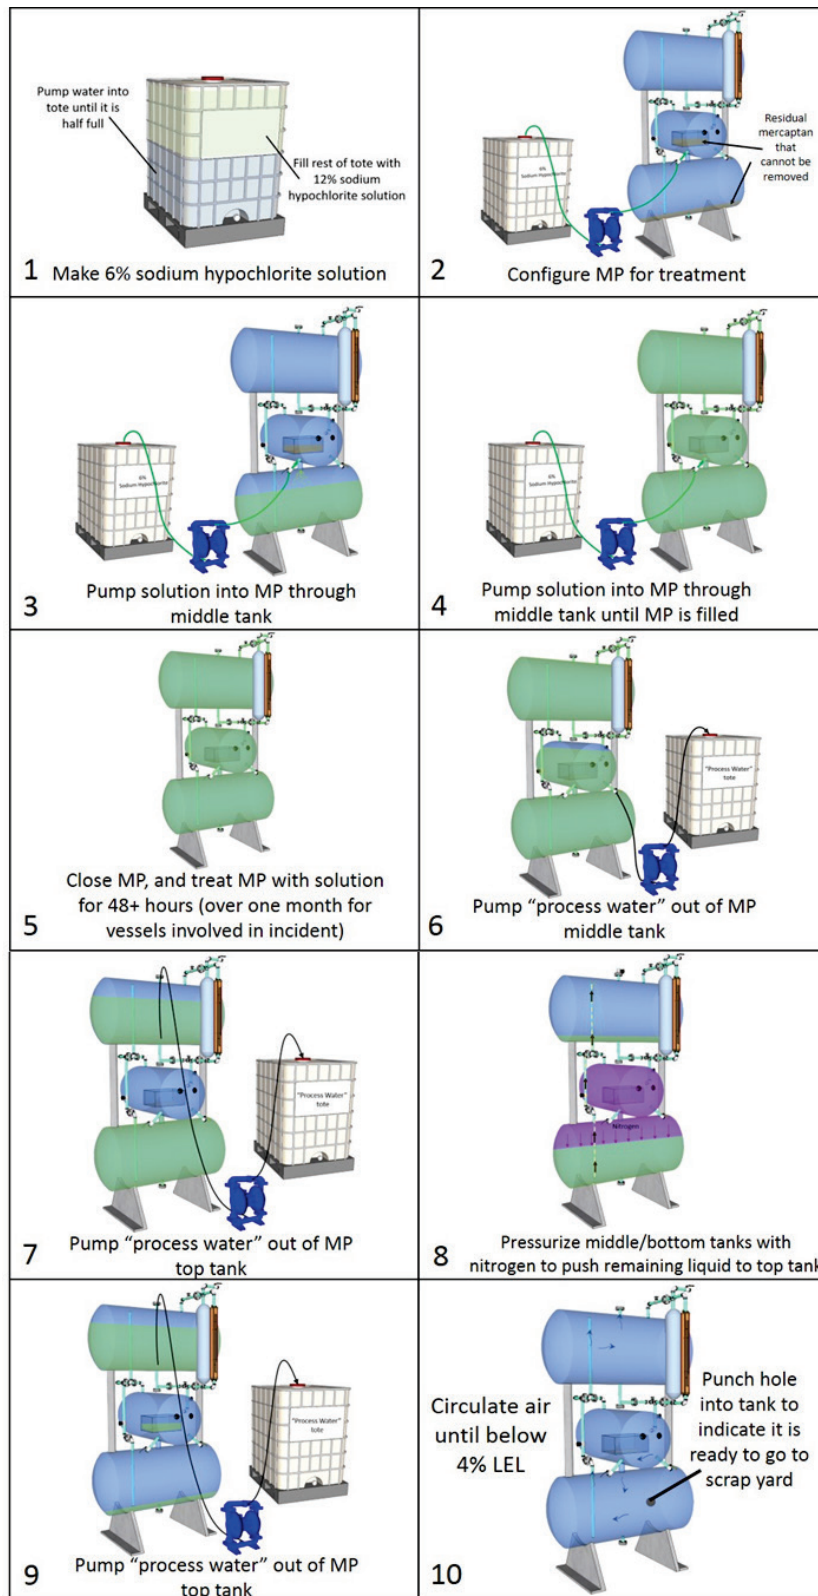
Figure 6. Chemical Treatment. This graphic depicts the typical steps MRR technicians perform to chemically treat MP odorizers to remove the smell of mercaptan from the steel. (Credit: CSB); LEL refers to the Lower Explosive Limit.

MRR technicians typically observed an operating pressure of -0.25 to 5 psig during the chemical treatment process. The tanks are rated at 125 to 1,000 psig. MRR therefore did not install pressure relief on the tanks because the company thought it was not needed.

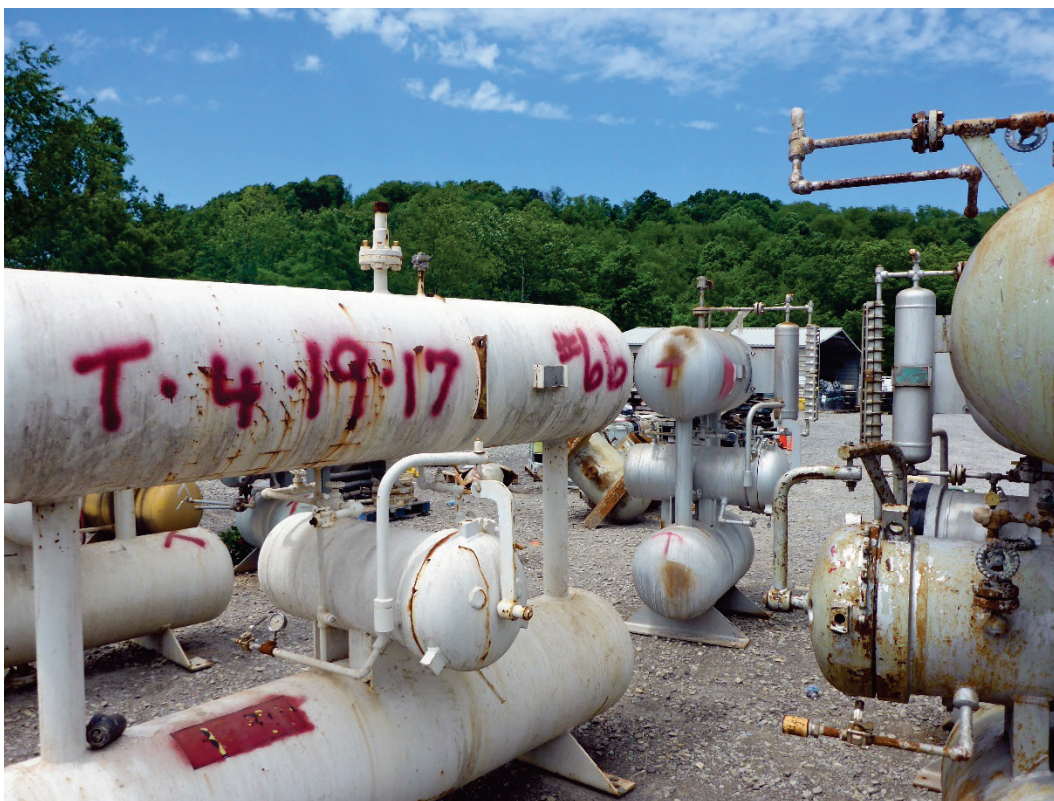
Figure 7. Treatment Status. This photo shows how MRR technicians used red spray paint to record the date the MP was chemically treated, April 19, 2017. (Credit: CSB).

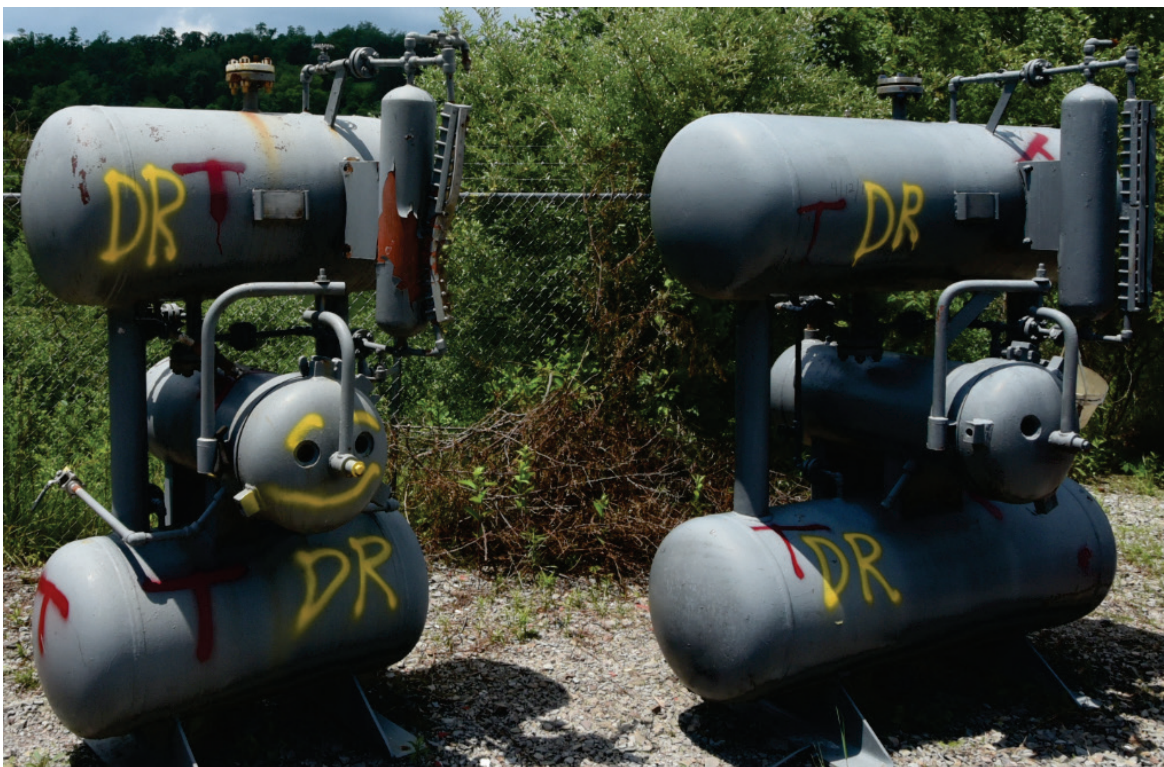
In May 2017, after roughly one month of chemical treatment with the sodium hypochlorite, MRR personnel began draining the treated MP odorizers. Spray paint markings (Figure 8) and equipment connections indicated that three of the 16 treated MP odorizers had been drained.

Figure 8. Drained Status. This photo shows how MRR technicians spray painted odorizer equipment with a “D” or a “DR” for *drained* (in yellow) after they drained the sodium hypochlorite treatment solution from the odorization equipment. (Credit: CSB).

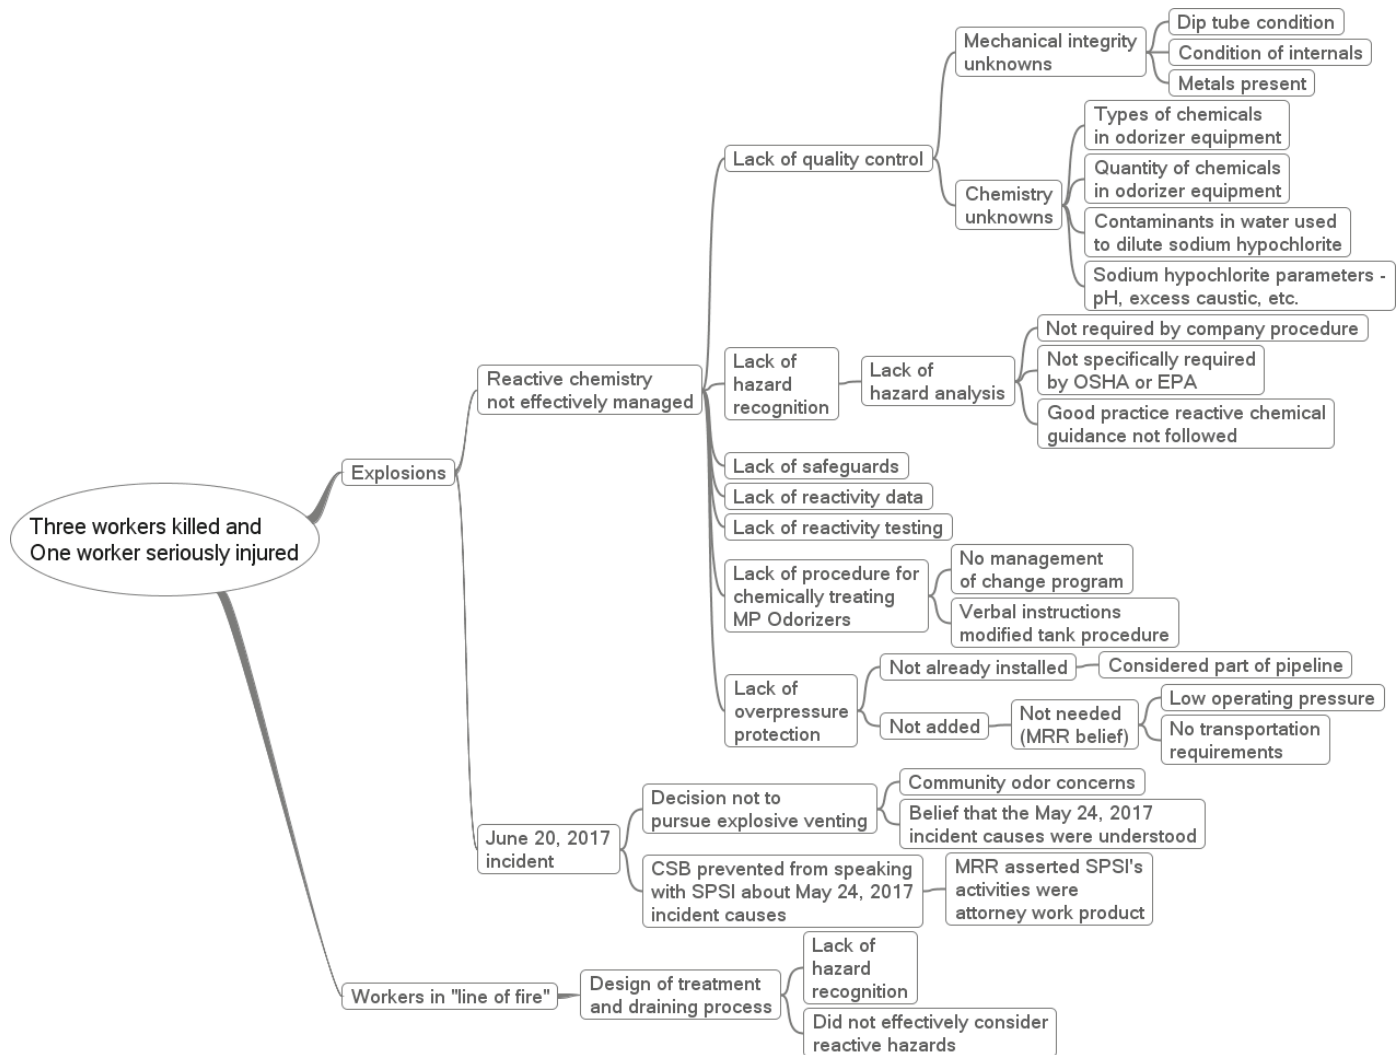
The CSB determined that the probable cause of these incidents was reactive, unstable chemicals that exploded when workers tried to drain the uncharacterized, chemically treated liquid from natural gas odorizer equipment. The CSB investigation found that MRR lacked an effective safety management system to identify and control hazards from reactive chemicals. Among other things, MRR had no formal hazard identification process in place to analyze or characterize what chemicals were inside the odorizer vessels—and in what quantity—before decommissioning and chemically treating this equipment with sodium hypochlorite. The company also lacked effective safeguards to prevent unexpected or uncontrolled chemical reactions.

Figure 22. Causal Analysis. This image shows a simplified version of the CSB causal analysis. (Credit: CSB).
