Perspectives on Containment Wall Failure at ITC Deer Park, Texas
Fire at First & Second 80's Tank Farm at
Intercontinental Terminals Company
Event of March 17, 2019 at Deer Park, Texas

Issued Date

April 24, 2023

U.S. Chemical Safety and Hazard Investigation Board
1750 Pennsylvania Avenue, NW Suite 910
Washington, DC 20006

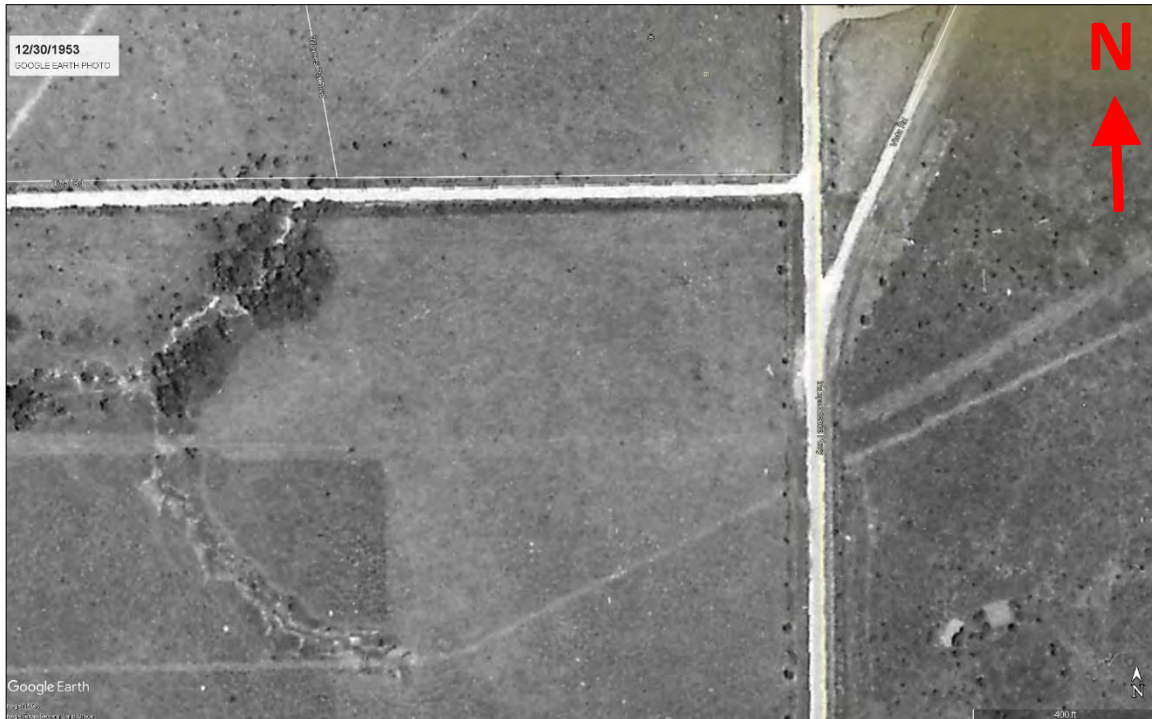
The roads currently named as Tidal Road and Independence Parkway existed at the site prior to the construction of the tank farm in a general location that is consistent with the existing roads.⁵ There did not appear to be a concrete lining to the drainage ditch on the south side of Tidal Road in this aerial photo (photo 1). The tank farm was not constructed at this point in time.

Photo 1: Site of tank farm prior to construction, aerial imagery date: 1953, source: Google Earth Pro

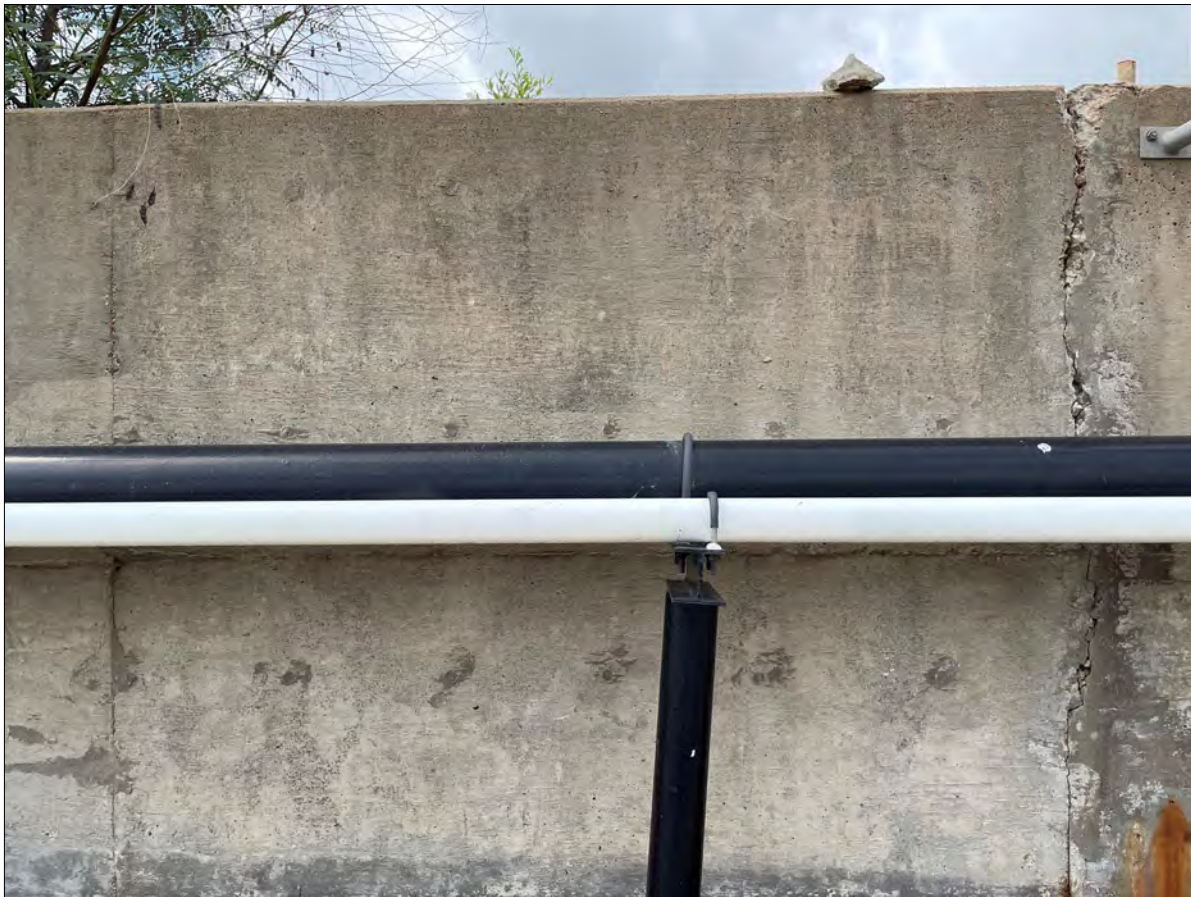
The containment wall was a cast-in-place concrete wall 8-inches thick and extending above the interior grade of the tank farm approximately 4 feet. The depth of the containment wall into the soil was not able to be determined at this visit. The wall had impressions from a panelized formwork system and through-wall break-off form ties, or snap-ties, spaced regularly in the horizontal and vertical direction, indicating it was constructed free-standing with a panelized formwork system on each face (photo 12). The wall was reinforced with two layers of deformed mild-steel reinforcing bars. The wall was cast in sections, with a construction joint every 40 feet. The joints were formed with a shear-key at the joint and a ribbed-wing centerbulb PVC waterstop incorporated into the construction joints to prevent liquids from leaking through the wall at the joints (photo 13 & 14).

Photo 12: North concrete retaining wall, outside face. Form tie marks on wall

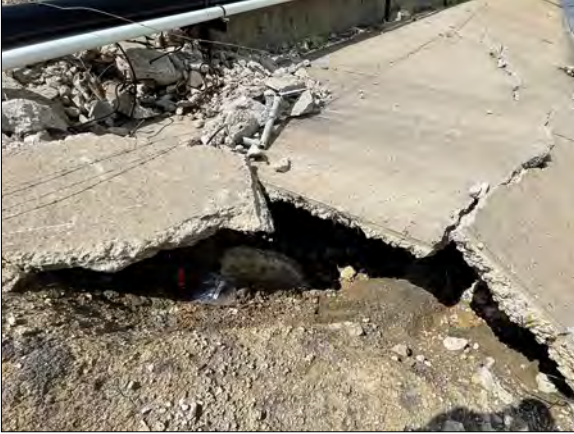
Photo 19: Location of Sample 1

Sample 1 appears to be a stiff mottled tan and gray silty deltaic clay. Its classification would be most likely “CH” when classified in accordance with the Unified Classification system. Sample 2 appears to be a dark gray deltaic clay, also likely to be classified as a CH. Sample 3 appears to be a moist soft gray marine clay CH. Both Samples 1 and 2 appear to have been disturbed and are poorly consolidated, whereas Sample 3 is fine grained and well consolidated. Samples 1 and 2 are assumed to be typical of the soils located underneath the sloped side slab of the drainage ditch. Sample 3 is assumed to be similar to the soils inside the containment area at the containment wall. The soil in Samples 1 and 2 appears to be moderately sensitive. Soil sensitivity is a characteristic describing the loss of soil strength when changing from an undisturbed natural condition to a disturbed condition through excavation and re-compaction. Soils with higher sensitivity lose a greater proportion of their strength when disturbed. Sample 3 appears to have a high shrink-swell potential, or a potential to change volume as water content in the soil changes. Soil swelling can increase the pressure on retaining walls considerably higher than normal pressures.
