Investigation Report

Published: December 2023

The April 2, 2019, explosion and fire at the KMCO facility in Crosby, Texas, fatally injured James Mangum.

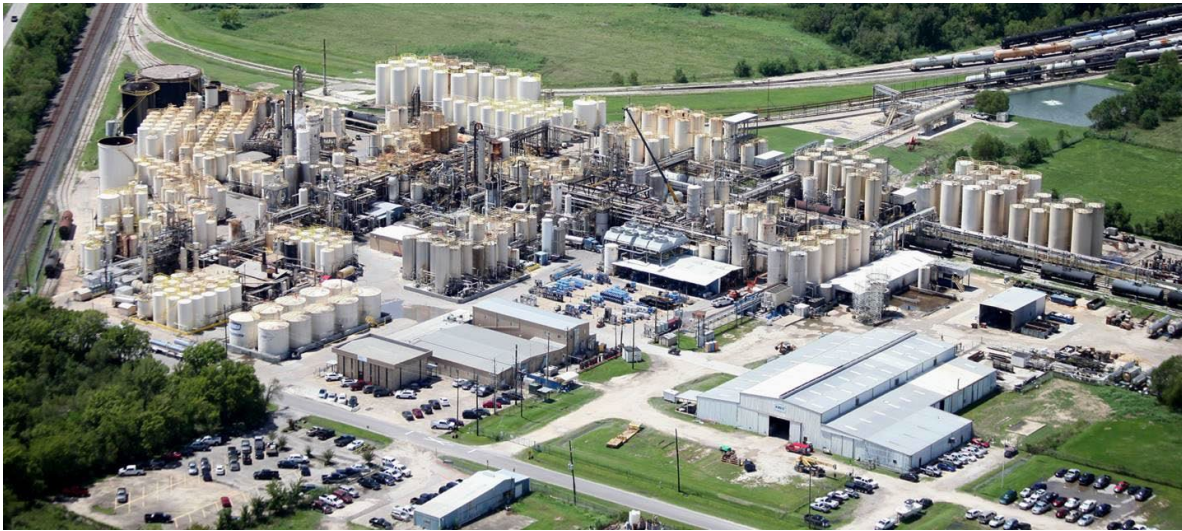
Figure 1. KMCO Facility in Crosby, Texas.^a (Source: KMCO)
