Investigation Report

Published: June 2024

SAFETY ISSUES:

The September 20, 2022, naphtha release and fire at the BP-Husky Toledo Refinery fatally injured two employees, who were brothers:

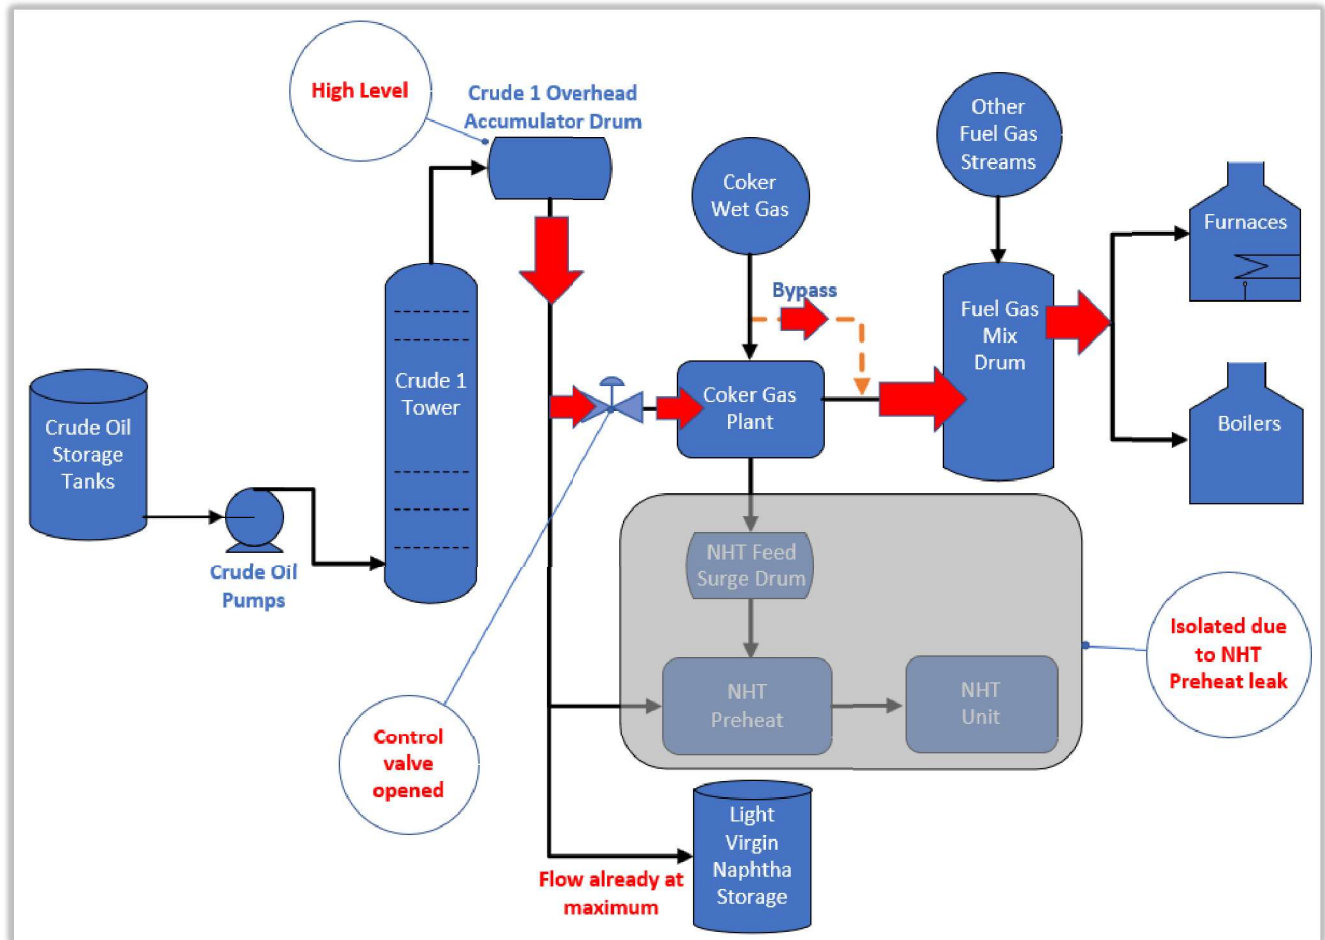
Figure 9 shows the liquid naphtha overflow from the Crude 1 Overhead Accumulator Drum to the Absorber Stripper Tower, the overflow from the Absorber Stripper Tower to the Fuel Gas Mix Drum, and the overflow to the furnaces and boilers downstream of the Fuel Gas Mix Drum.

Figure 9: Summary of overflow from the Crude 1 Overhead Accumulator Drum to the Absorber Stripper Tower in the Coker Gas Plant, and on to the Fuel Gas Mix Drum and downstream furnaces and boilers. (Credit: CSB)

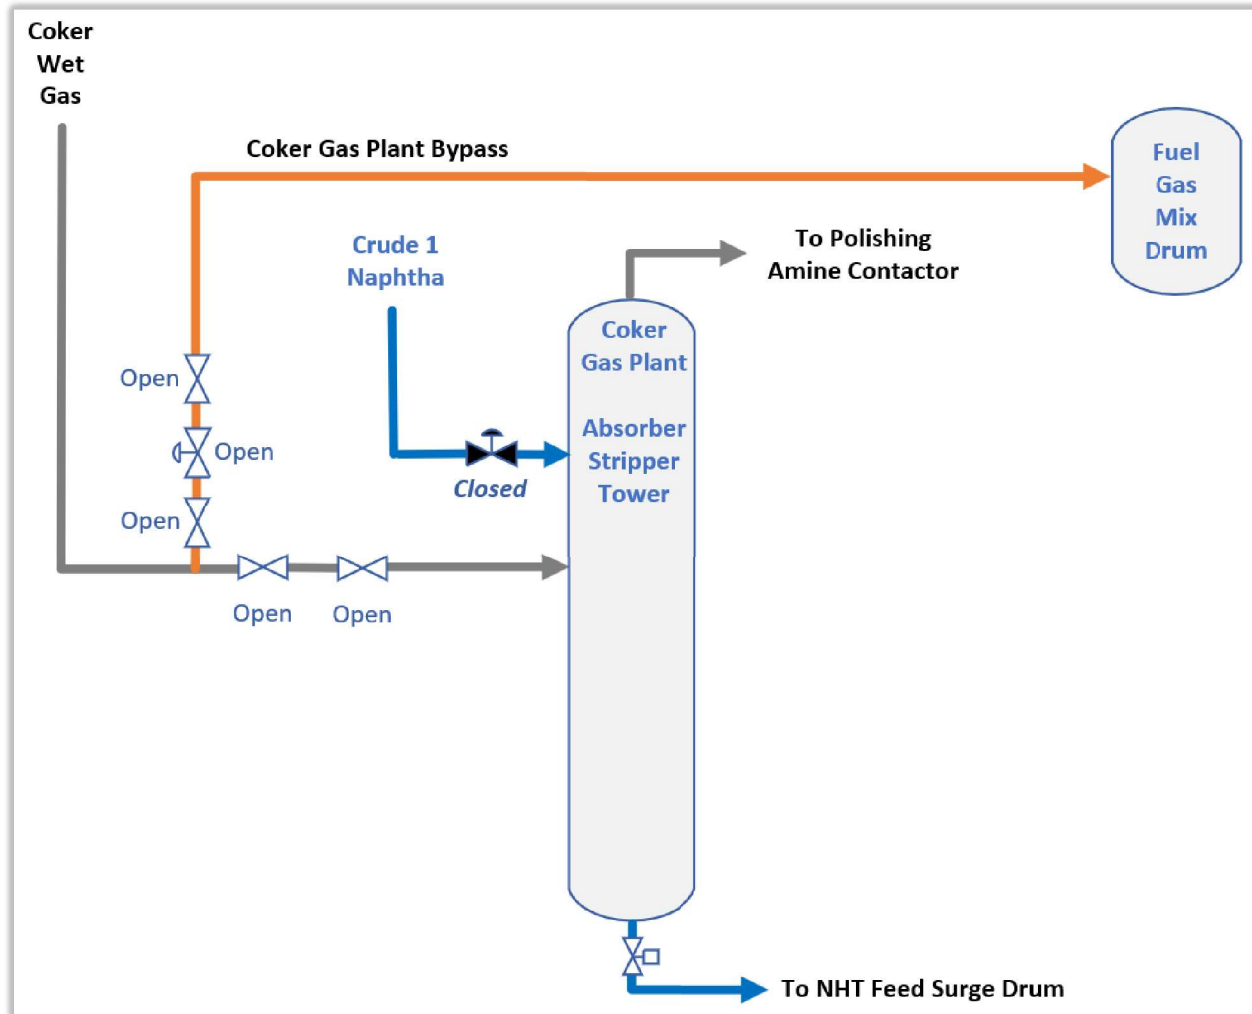
Figure 18: Coker Gas Plant bypass configuration on the day of the incident. (Credit: CSB)

The CSB concludes that the NHT unit emergency shutdown necessitated bypassing the Coker Gas Plant, but the Coker Gas Plant was not fully isolated, even though its operational state was considered “in bypass.” Bypassing the Coker Gas Plant left an open flow path from the Absorber Stripper Tower to the Fuel Gas Mix Drum.

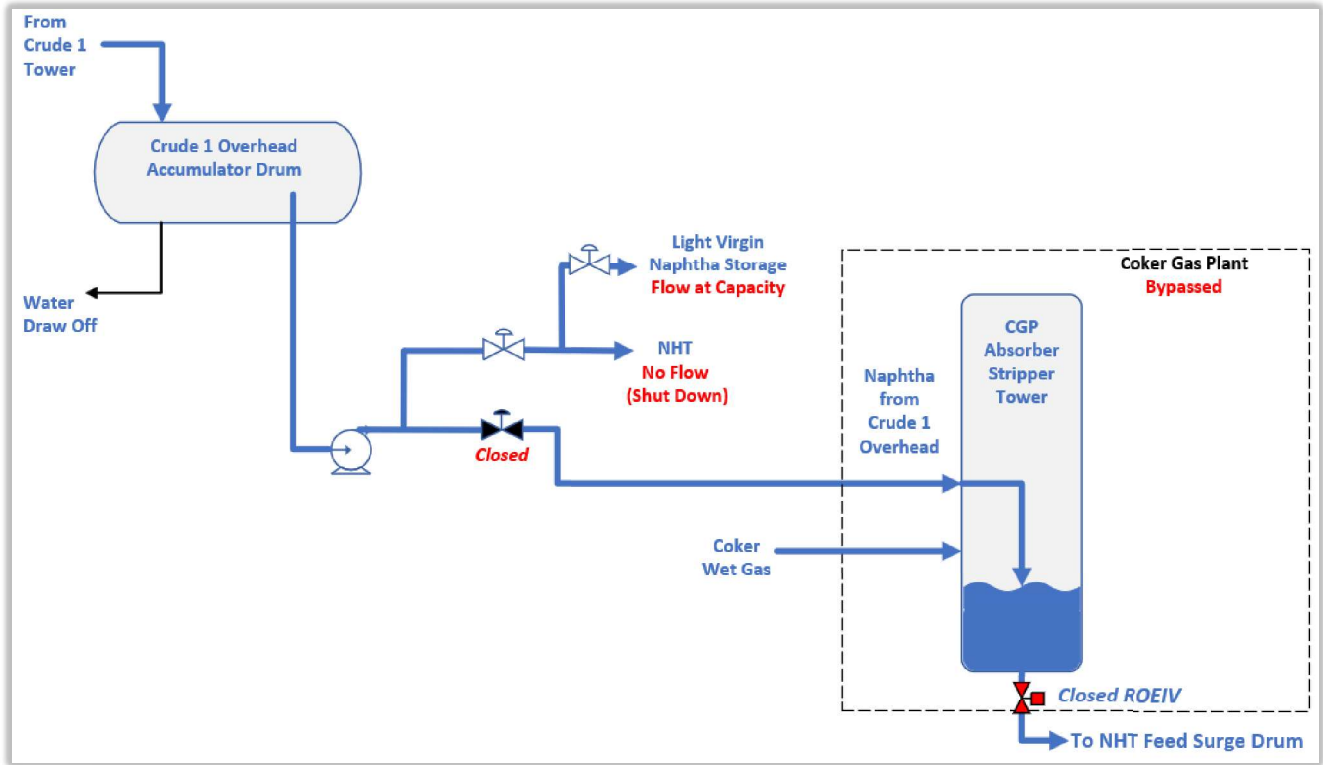
Figure 19: Liquid naphtha flow paths out of the Crude 1 Overhead Accumulator Drum. (Credit: CSB)

The CSB concludes that there was only one destination available for Crude 1 Overhead flow after the NHT unit was shut down and the Coker Gas Plant was bypassed.

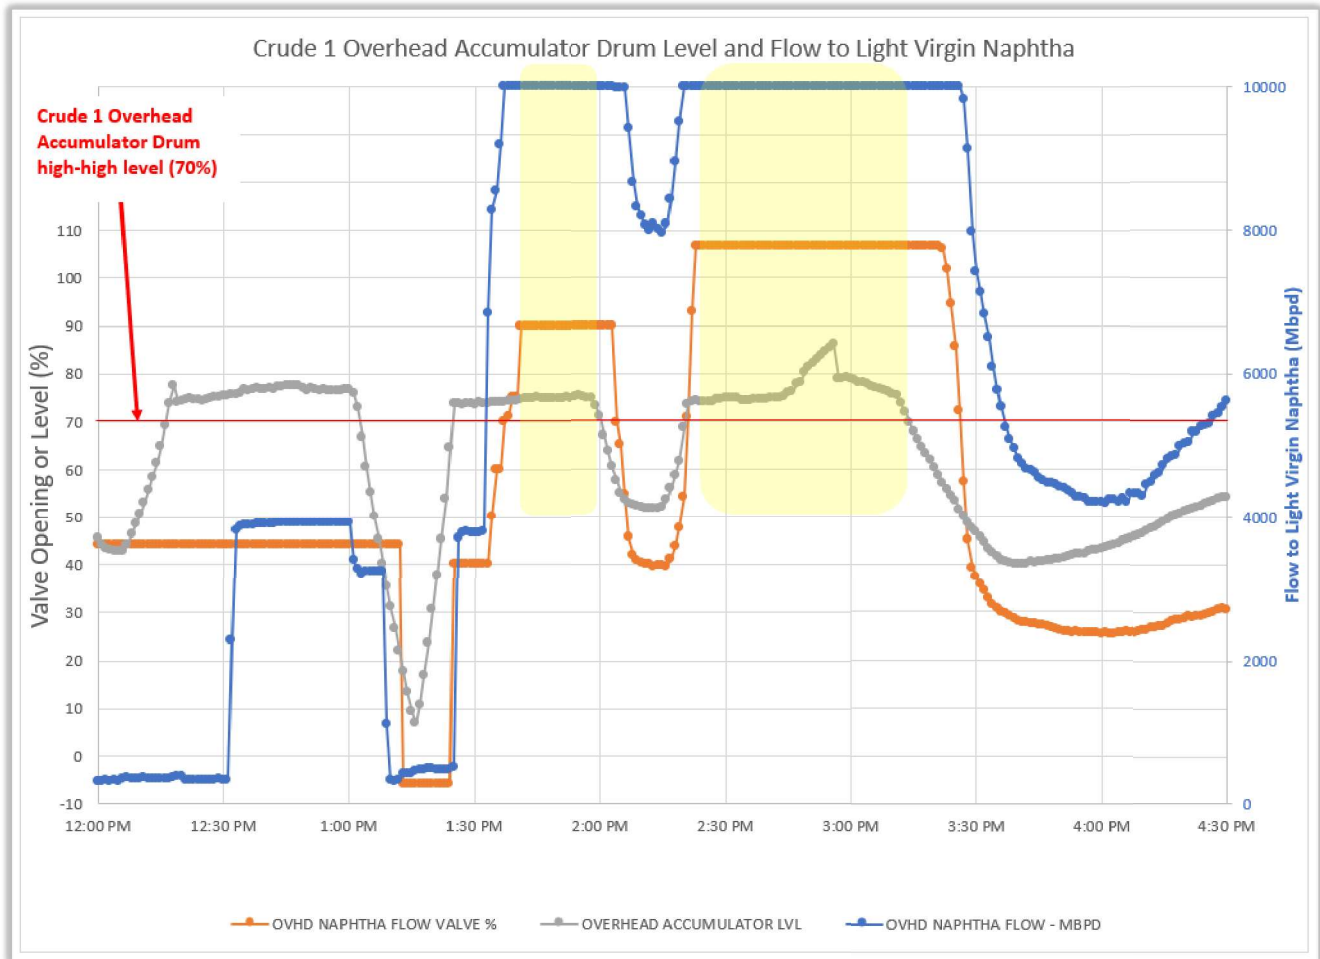
Figure 20: Crude 1 Overhead Accumulator Drum level control and flow to Light Virgin Naphtha. The yellow shaded areas indicate periods of accumulator level (gray) over the high-high alarm setpoint, while the flow meter to Light Virgin Naphtha (blue) was out of range and the flow control valve (orange) nearly or fully opened. (Credit: CSB)

unit shut down and the Coker Gas Plant bypassed. Ultimately, it was decided that neither shutdown nor circulation would be done at that time, which allowed the crude oil feed to Crude 1 to continue, even though the Crude 1 Tower had overpressured eight times (**Figure 21**), and the Crude 1 Overhead Accumulator Drum level had been above the high-high alarm point for approximately two hours (**Figure 20**), by 3:00 p.m.

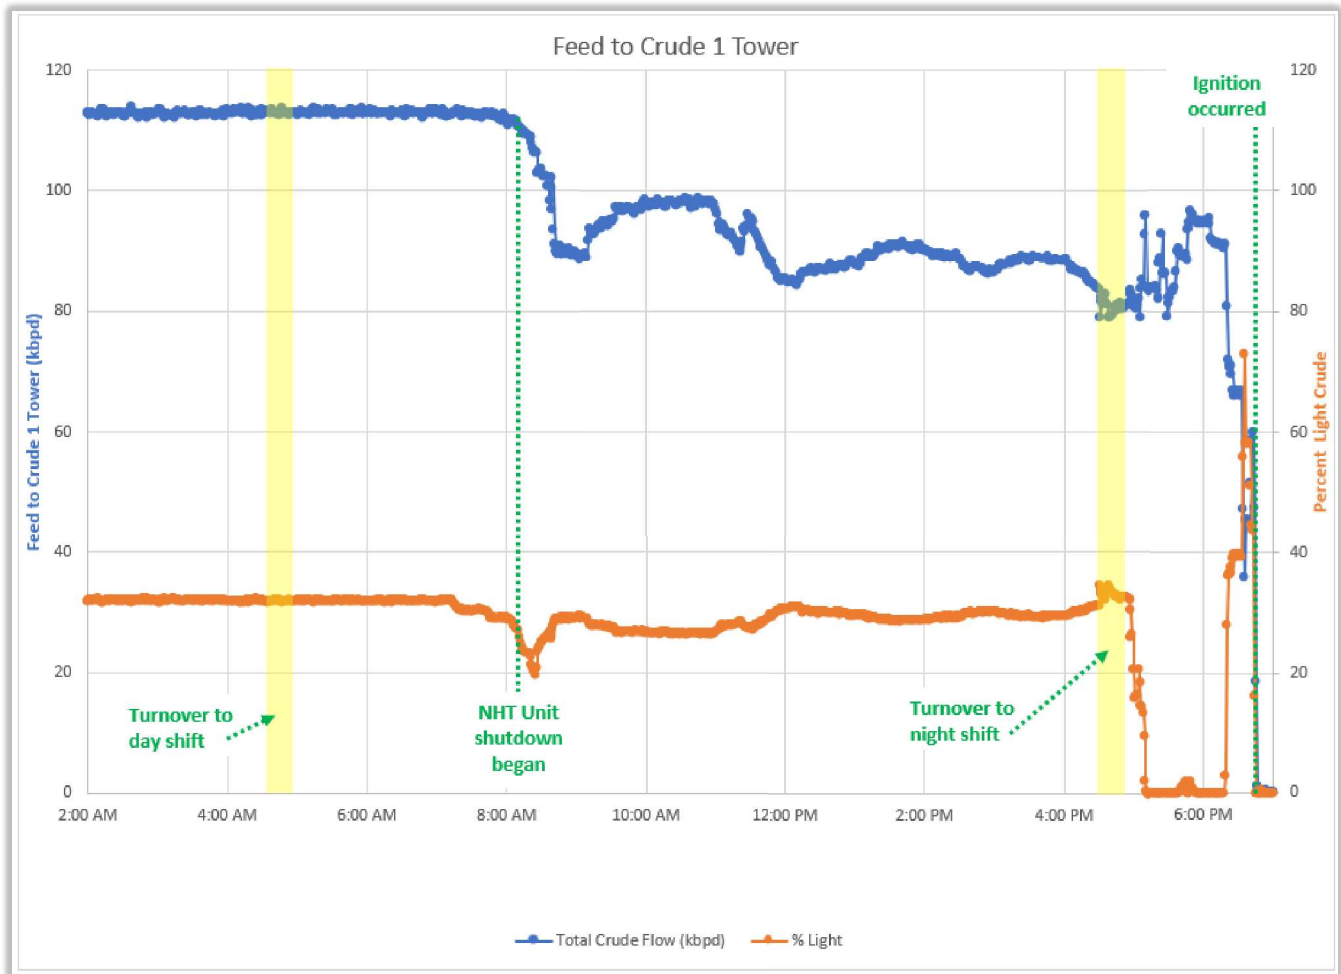
In response to the NHT unit shutdown and Coker Gas Plant bypass earlier that day, the crude slate to the Crude 1 Tower had been adjusted several times throughout the day as operations personnel worked to stabilize the tower. Night shift personnel arrived at approximately 4:30 p.m. on September 20, 2022, and shortly afterward, a significant crude slate change to the Crude 1 Tower occurred. Light crude oil flow was 26,000 barrels per day, or approximately 32 volume percent of the total feed, at 4:56 p.m., but it was eliminated entirely by 5:10 p.m. A board operator cut the light crude feed because he thought the light crude oil flow was too high given that the NHT unit was down. Another online crude oil pump, connected to heavy crude oil storage, automatically increased speed to maintain the total feed flow rate to the Crude 1 Tower. Abruptly replacing light crude oil feed with heavy crude oil created a large and rapid change in the crude oil composition, which reached the Crude 1 Tower approximately 40 minutes later. **Figure 22** shows the crude oil compositions and flow rates feeding the Crude 1 Tower before and after the light crude oil flow stopped.

Figure 22: Crude 1 Tower Feed rate (blue) and percent light feed composition (orange) day of incident. The yellow bars indicate shift change turnover. (Credit: CSB)

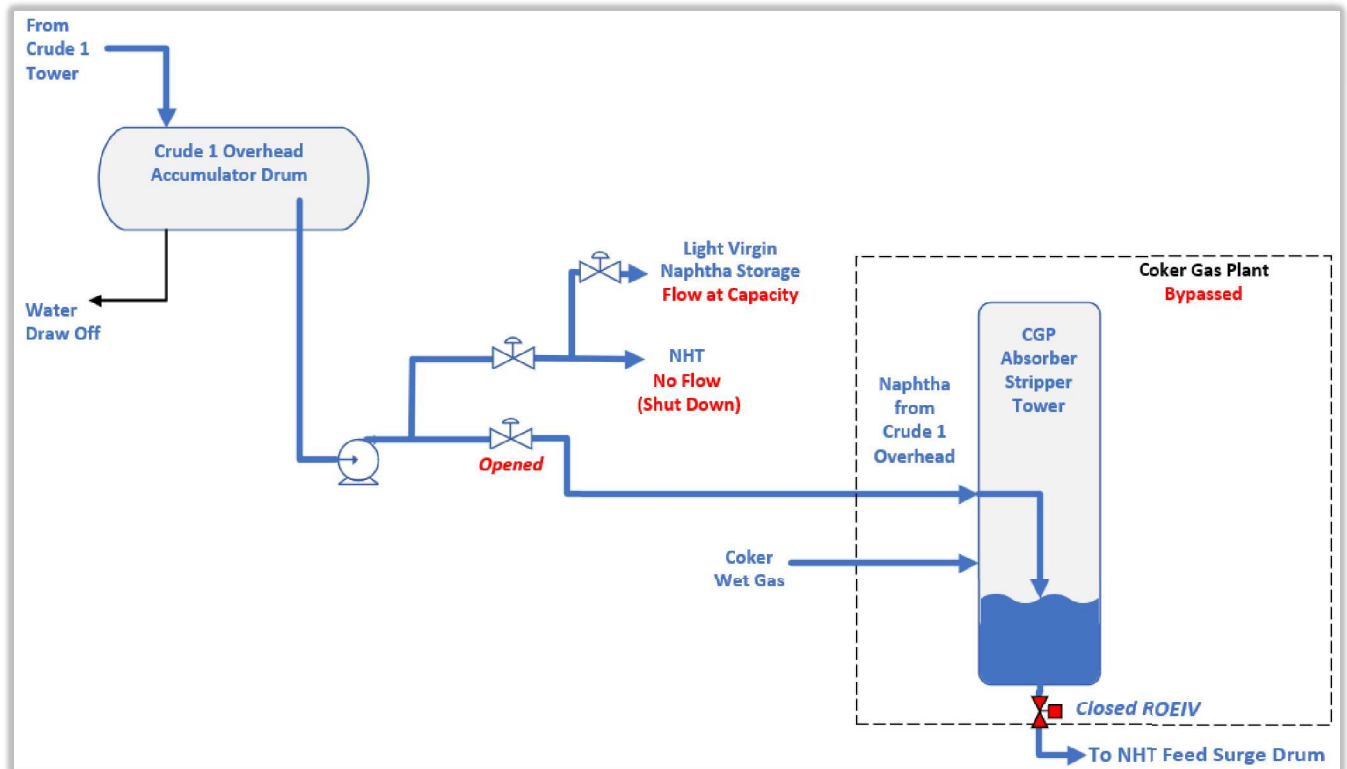
The night shift board operators were unaware that earlier that day, the day shift had closed a valve on the Coker Gas Plant Absorber Stripper Tower bottoms piping, known as a Remotely Operated Emergency Isolation Valve (ROEIV). This closed valve prevented flow through the Absorber Stripper Tower bottoms into the NHT Feed Surge Drum, so the liquid naphtha began to fill the Coker Gas Plant Absorber Stripper Tower more quickly than if the ROEIV had remained open. **Figure 25** illustrates the flow path from the Crude 1 Overhead Accumulator Drum to the Coker Gas Plant Absorber Stripper Tower.

Figure 25: Flow path from Crude 1 Overhead Accumulator Drum to Coker Gas Plant. (Credit: CSB)

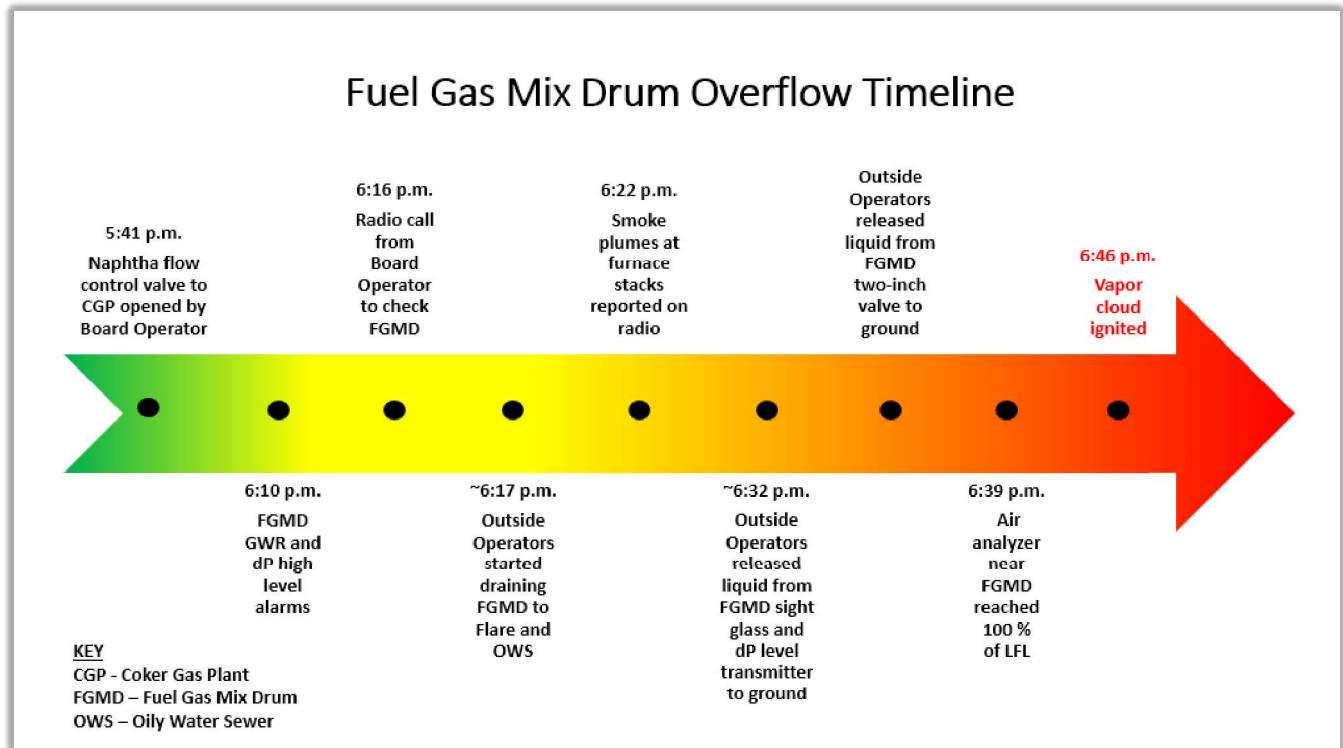
Figure 27 shows a summary timeline of some of the key events in the hour preceding the incident, showing limited time available to refinery personnel for decision-making. **Appendix A.2.9.4** contains a detailed timeline of the event.

Figure 27: Summary timeline of some key events for the hour preceding the incident. (Credit: CSB)

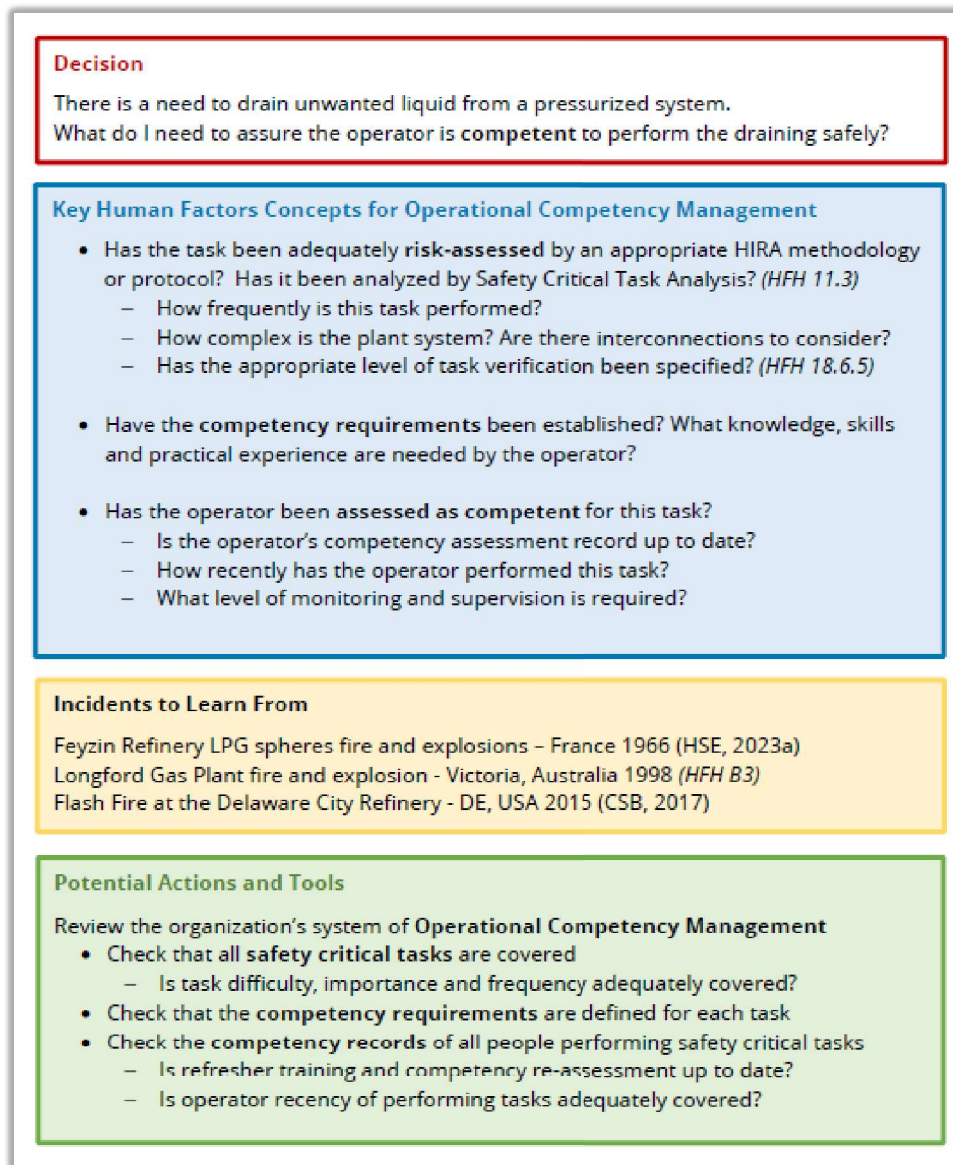
Figure 31: Draining unwanted liquid from a pressurized system. (Credit: CCPS)

In **Figure 31** above, the CCPS states that the task of draining a pressurized vessel should be adequately risk-assessed by considering the frequency of the task, the complexity of the system including interconnections, and the levels of required task verification. Had the BP Toledo Refinery conducted a similar assessment of the task of manually draining the Fuel Gas Mix Drum, it may have identified the potential for naphtha filling the drum

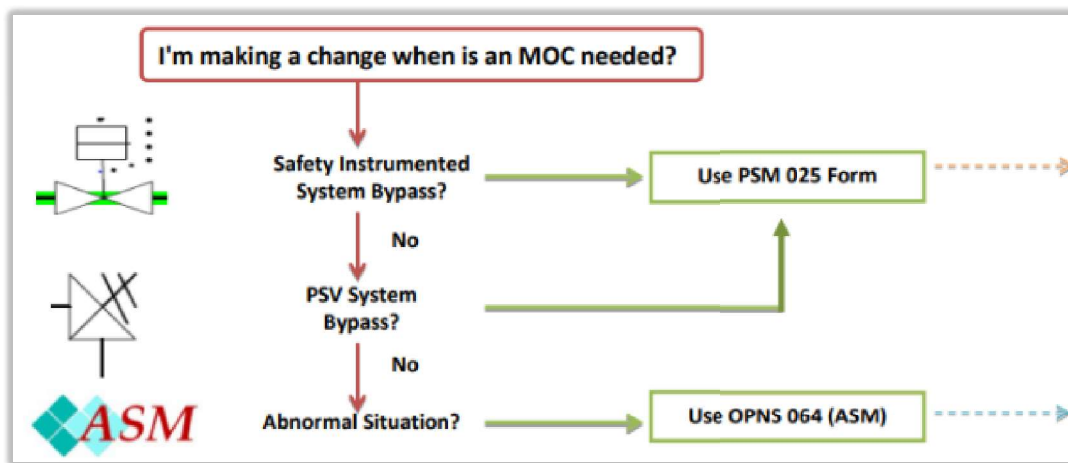
In effect, the BP Toledo Refinery’s ASM policy was more of an emergency MOC procedure than instructions for truly handling abnormal situations as the ASM[®] Consortium defines them.^b This is shown in the BP Toledo Refinery ASM policy itself, in **Figure 33** below, where it is indicated as a type of MOC.

Figure 33: Excerpt of the BP Toledo Refinery ASM procedure, indicating its relation to MOC. (Credit: BP)

Because the refinery had a procedure to bypass the Coker Gas Plant and the NHT unit emergency shutdown procedure included switching the Crude 1 Tower overhead flow to Light Virgin Naphtha, these situations did not constitute “abnormal situations” by the policy’s definition. Moreover, other abnormal situations that occurred that day, such as those listed above, were not recognized as such by refinery personnel during the day of the incident.

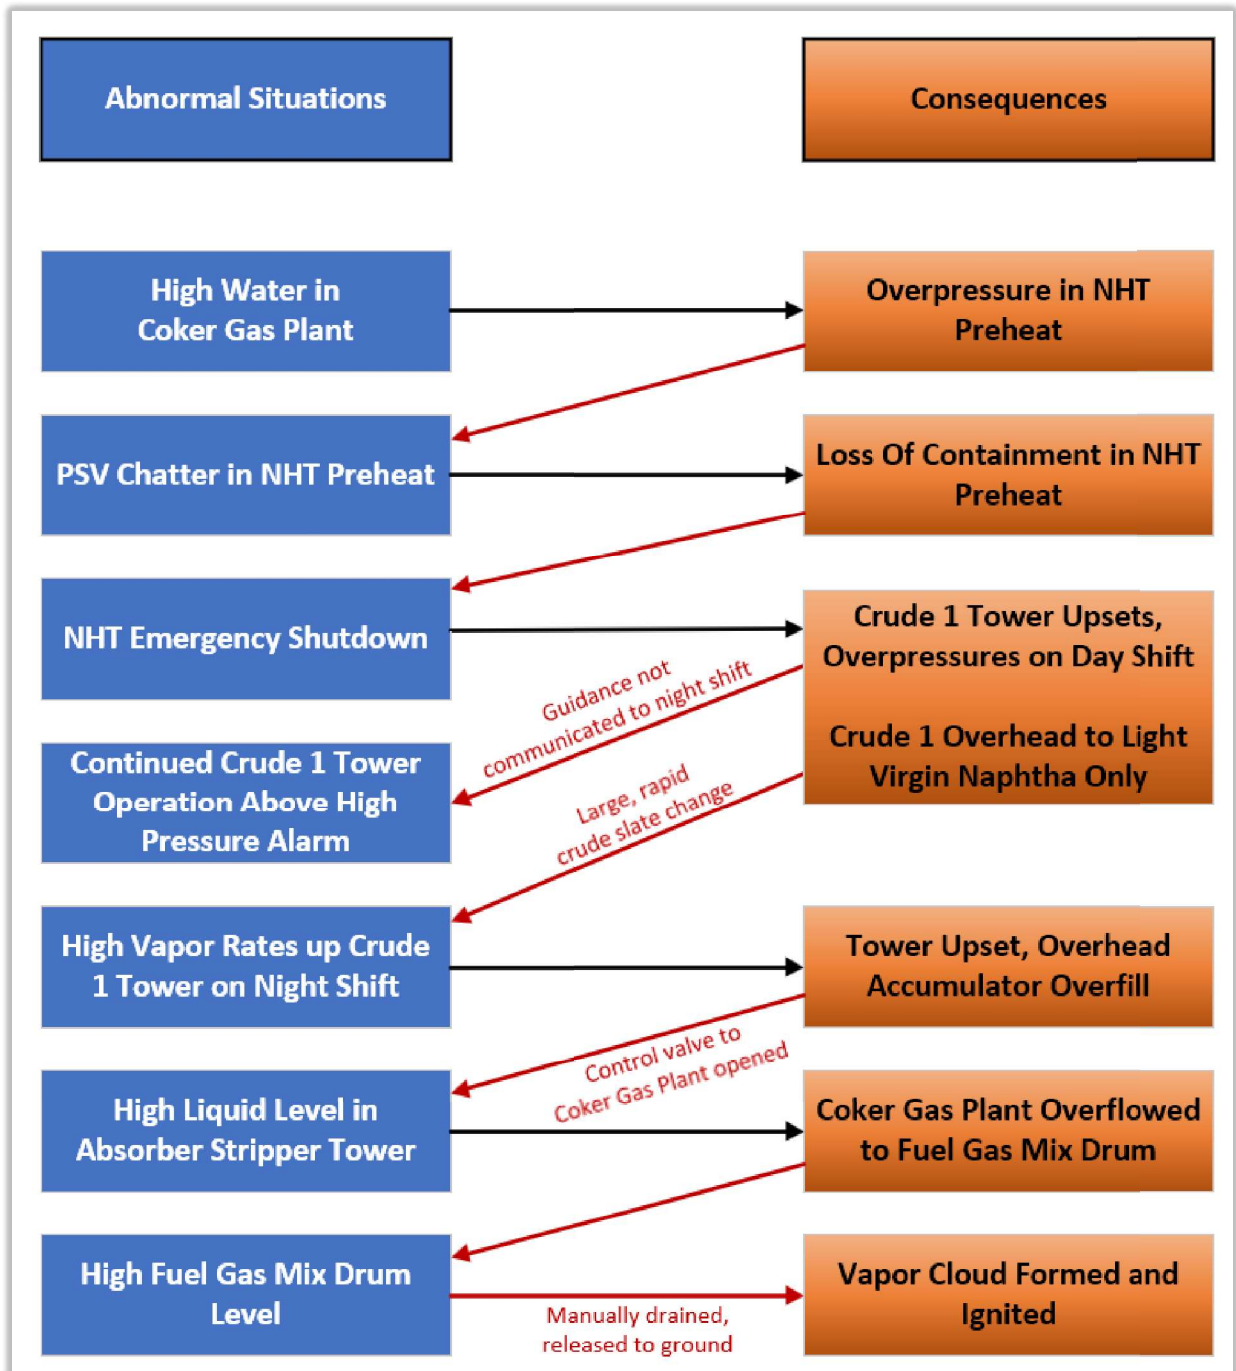
As an illustration of how some abnormal situations can cascade to escalating consequences, **Figure 35** shows several abnormal situations that occurred on the day of the incident, their consequences, and how those consequences and other decisions led to the next abnormal situation, escalating throughout the day.

Throughout the day, abnormal situations continued to escalate, culminating in the release of naphtha from the Fuel Gas Mix Drum to the ground, resulting in a fatal fire. None of the decisions made that day were made in a vacuum; instead, they were frequently made in response to other previous abnormal situations and their consequences (shown in red in **Figure 35** below). These are examples of situations that can affect the performance of board operators, outside operators, or refinery management performance [1, pp. 87-88].

Figure 35: Examples of abnormal situations the day of the incident (in blue), and the consequences of them (in orange). Note that in some cases, consequences and decisions contributed to the next abnormal situation (in red). (Credit: CSB)

Thinking through abnormal situations *before* they occur, having plans in place, and practicing those plans can greatly improve operator and manager confidence and decision-making during an abnormal situation. Simulators, desktop drills, incident reviews, or field walkthroughs can improve abnormal situation management skills.

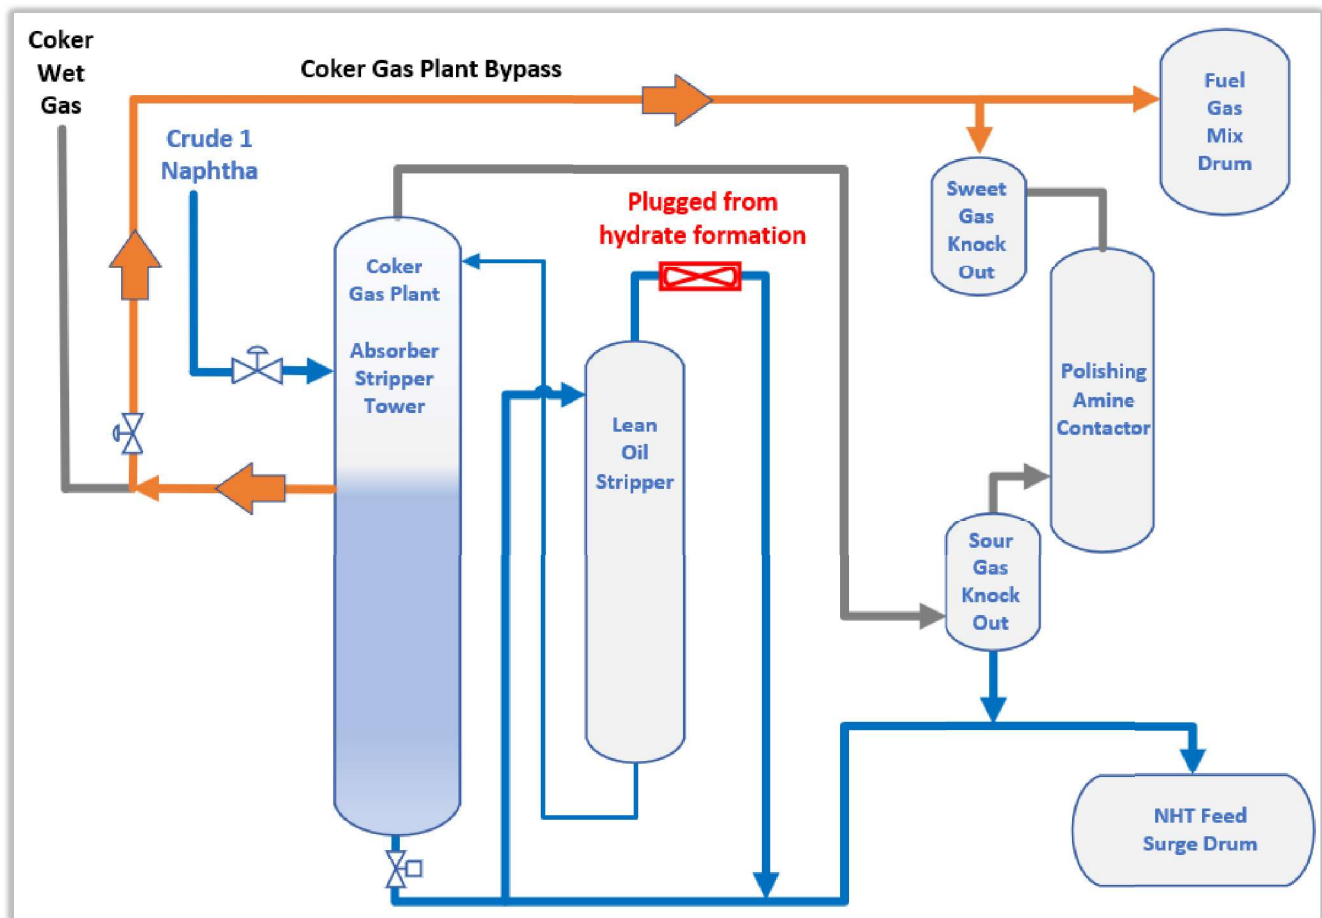
As in the September 20, 2022, incident, during the 2019 incident, naphtha began to fill the Coker Gas Plant Absorber Stripper Tower and, according to the 2019 incident investigation, the naphtha backed up through the Coker Gas Plant bypass due to high pressure that had developed in the Lean Oil Stripper from the hydrate formation. As shown in orange in **Figure 44**, naphtha flowed from the Absorber Stripper Tower through the Coker Gas Plant bypass line. A high liquid level developed in the Fuel Gas Mix Drum and the Polishing Amine Contactor Sweet Gas Knockout Drum. In the 2019 incident, the high liquid level in the Fuel Gas Mix Drum was drained to the Flare Knockout Drum and the Oily Water Sewer. Operations changed the crude slate being fed to the Crude 1 unit to reduce naphtha production and reduced the opening of the naphtha flow control valve to the

Figure 44. Coker Gas Plant. Configuration of the Coker Gas Plant during a 2019 refinery upset. (Credit: CSB)

The CSB concludes that the facts, conditions, and circumstances of the 2019 incident show that while operating the Coker Gas Plant with the bypass open, the BP Toledo Refinery did not have adequate safeguards to prevent overflow of naphtha from the Coker Gas Plant to the Fuel Gas Mix Drum.

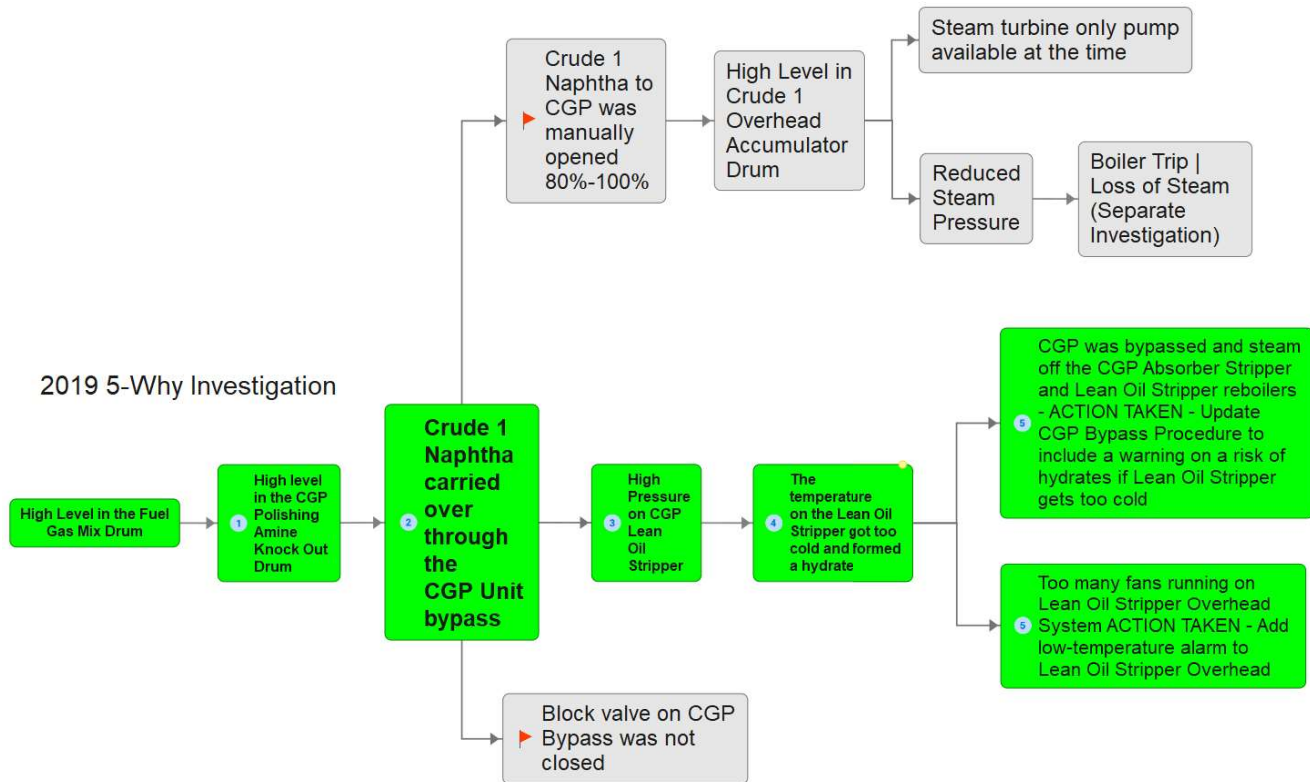
Figure 46 is a graphical representation of the 2019 Five Whys Investigation shown in **Figure 45**. The red flags indicate causes of high level in the Fuel Gas Mix Drum such as high level in Crude 1 Overhead Accumulator Drum and the open Coker Gas Plant bypass that could have prevented the September 20, 2022, incident, but were not addressed with long term actions to prevent future recurrence.

Figure 46. Graphical representation of the Five Whys investigation of high level in the Fuel Gas Mix Drum. (Credit: CSB)

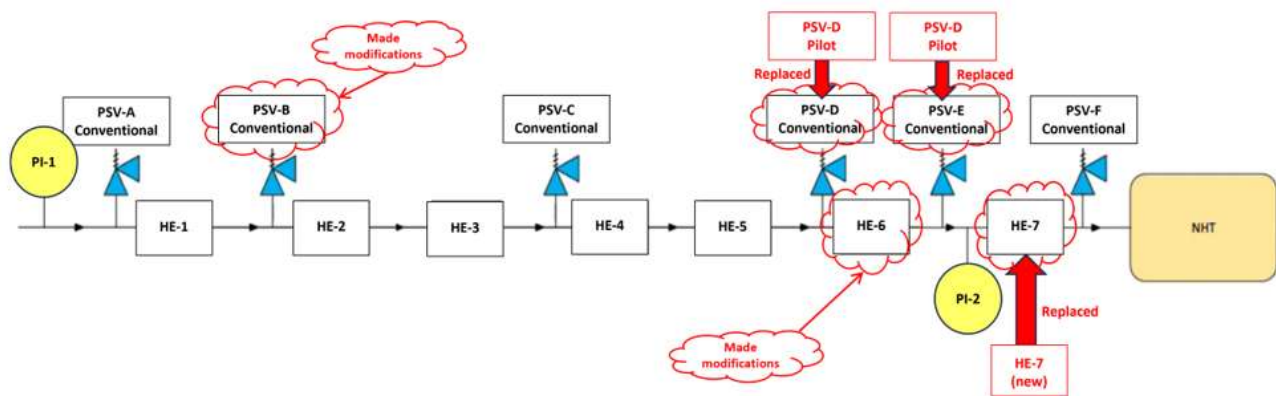
Figure A1-3 shows the 2022 TAR work to NHT Preheat which made modifications to heat exchanger HE-6, replaced heat exchanger HE-7, replaced emergency pressure-relief valves PSV-D and PSV-E, and modified PSV-B.

Figure A1-3. NHT Preheat changes made during 2022 TAR. (Credit: BP with annotations by CSB)

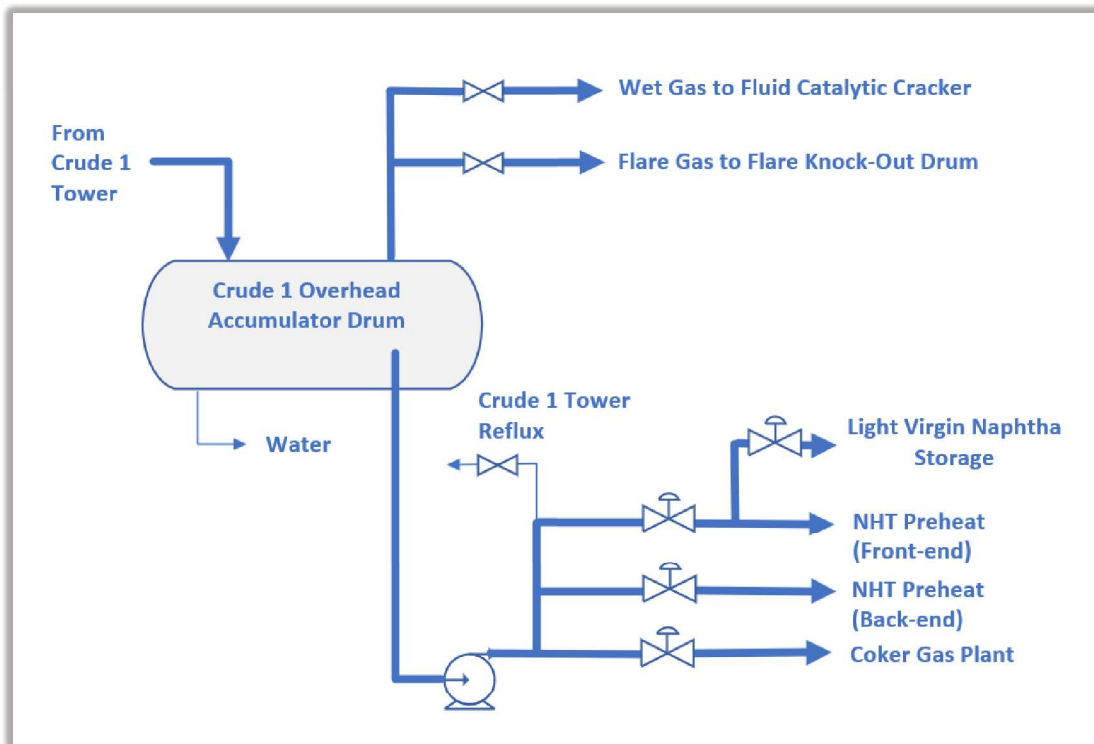
Figure A2-1 shows how high liquid level in the Crude 1 Overhead Accumulator Drum from process upsets is routed to the Flare Knockout Drum after the Fluid Catalytic Cracker (FCC) unit wet gas compressor is isolated from the Crude 1 Overhead Accumulator Drum overhead flow.

Figure A2-1. Crude 1 Overhead Accumulator Drum prior to the installation of the Coker Gas Plant. This simplified schematic shows how high level of liquid in the Crude 1 Overhead Accumulator Drum liquid can overflow to the Flare Knockout Drum. (Credit: CSB)
