BETA LAB NO. M10198, TESORO LS2 AND LS2/CS2 TEE FINDINGS PART: 6600-E HEAT EXCHANGER, LS2 22 IN, 36.5 IN MOUNTS, LS2 T2L SEM FRACTOGRAPHY AND PART 22 LS2-CS2 TEE FINDINGS PARTS 16-1 AND 22	TESORO REFINING AND MARKETING COMPANY ANACORTES REFINERY 10200 W. MARCH POINT ROAD T91WA4428 ANACORTES, WA 98221	CUSTOMER P.O. No.: 4501667904
		DATE: OCTOBER 13, 2010
		PAGE 1 OF 56

LABORATORY REPORT

This report is the tenth of a series of the reports on the failed parts of the 6600E heat exchanger. The LS# and CS# refer to longitudinal and circumferential weld seams respectively, while the part number refers to the chain of custody number. Below is the list of the previously issued reports:

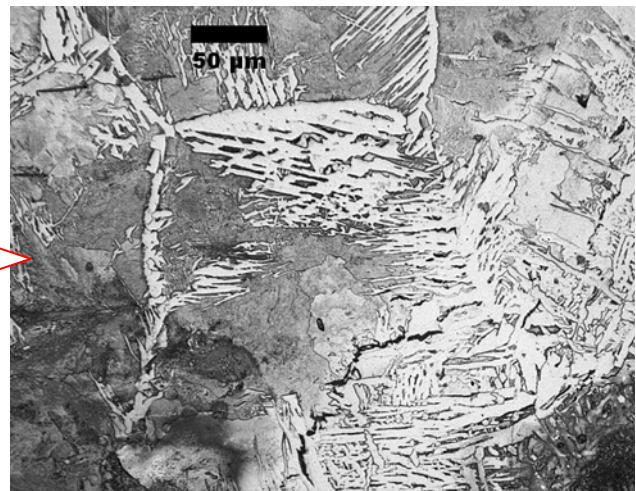
**LABORATORY REPORT
PART 22 SAMPLES
MOUNT LS2-A**

A. Enlarged area from Figure 29 above. Un-etched

B. Same as at left, slightly enlarged. Etched
